ANOKA COUNTY

COUNTY DITCH INSPECTION REPORT

DITCH # 28

DATE: 7/12/94

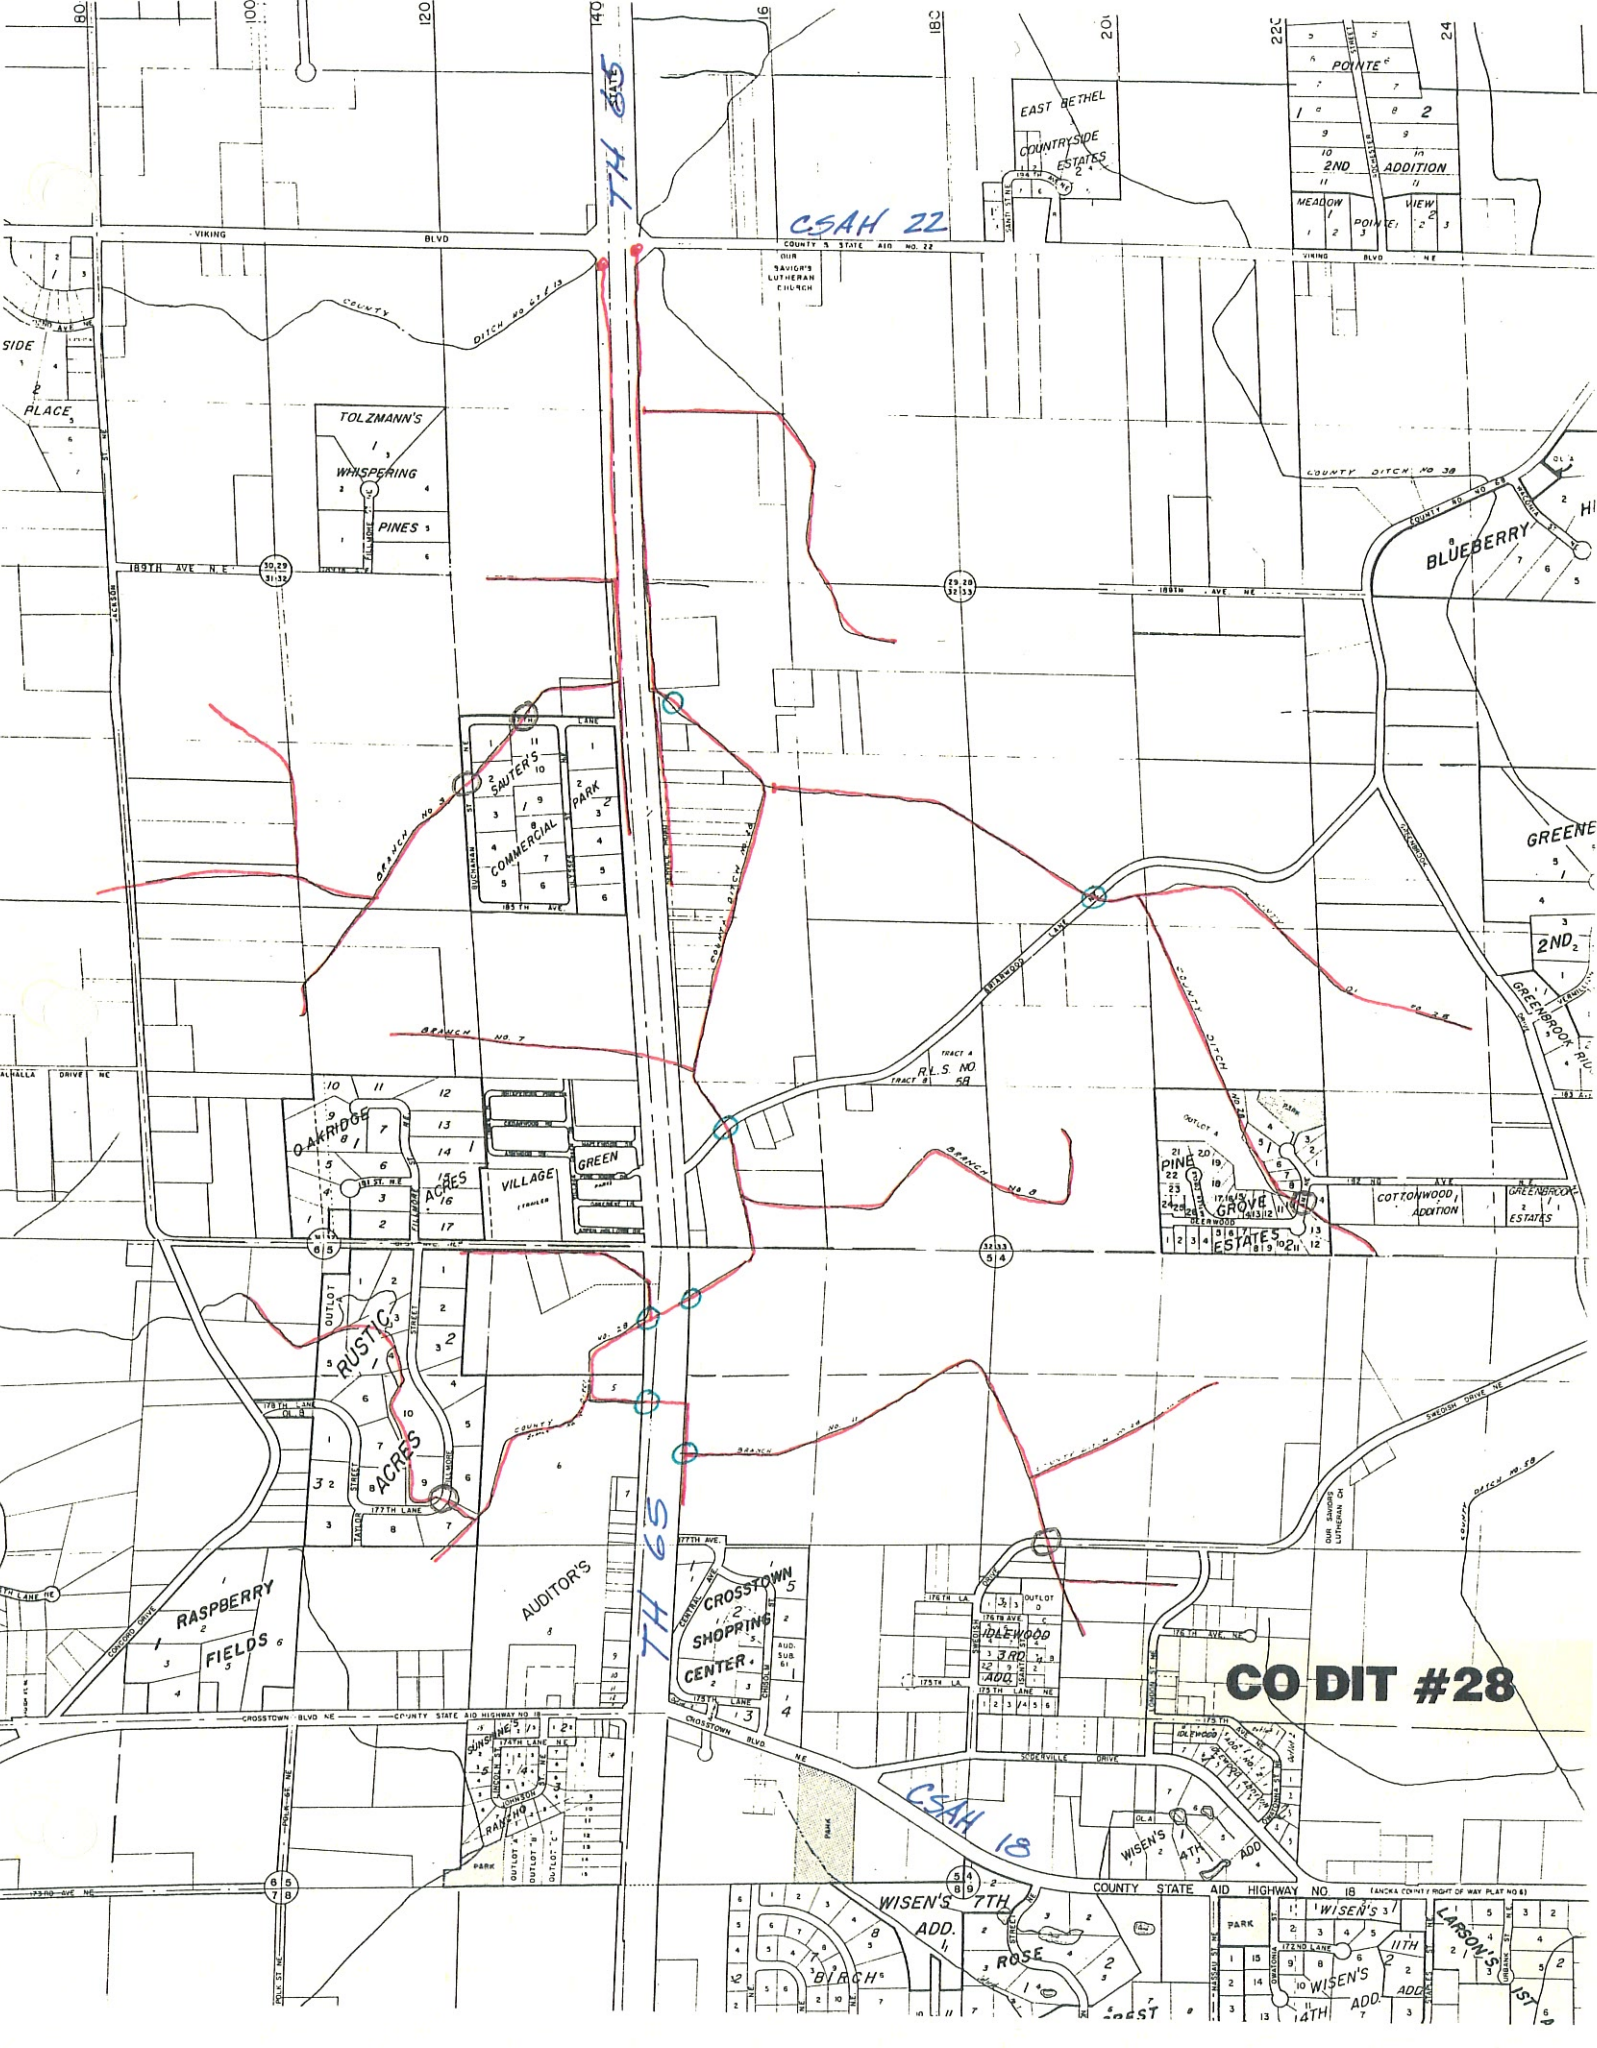
#28

- W Serv Rd TH65 (So.) Ditch defined, no apparent flow.
- W. Serv. Rd. TH65 (No.) Ditch defined, no flow apparent.
- ↓ TH65 (N.B.) (So.) Ditch to east defined. Beaver dam 100' east of R/W.
⊛ No apparent flow from east.
- ↓ TH65 (N.B.) (No.) Ditch well defined, trees lying across ditch. Slow flow to east.
- ↓ Briarwood (W) Ditch well defined & flowing. Culvert @ this crossing proposed for repl. in 1994 on East Bethel Str. Proj. (Tabled.)
- ✓ Entr. Antiques of Meadowmoor Ditch flowing & defined.
- Briarwood (E) Ditch defined on south side of road, but grown over with brush. No apparent flow.

⊛ East TH65 road ditch connects ditches.
