COUNTY DITCH #35

PUBLIC HEARING

On Obstructions in the Ditch

July 25th , 2013

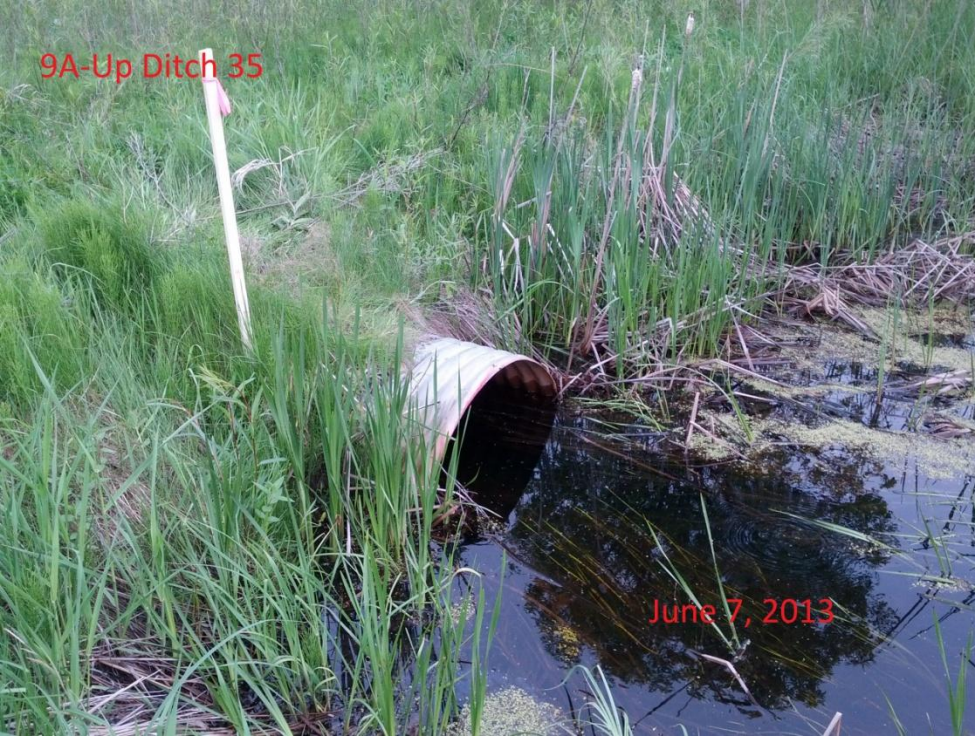
9A-Up Ditch 35

Mr. Gross has responded to the letter sent and indicated that a second culvert is in place. This culvert has been inspected and added to the inventory. No additional work is required at this location.

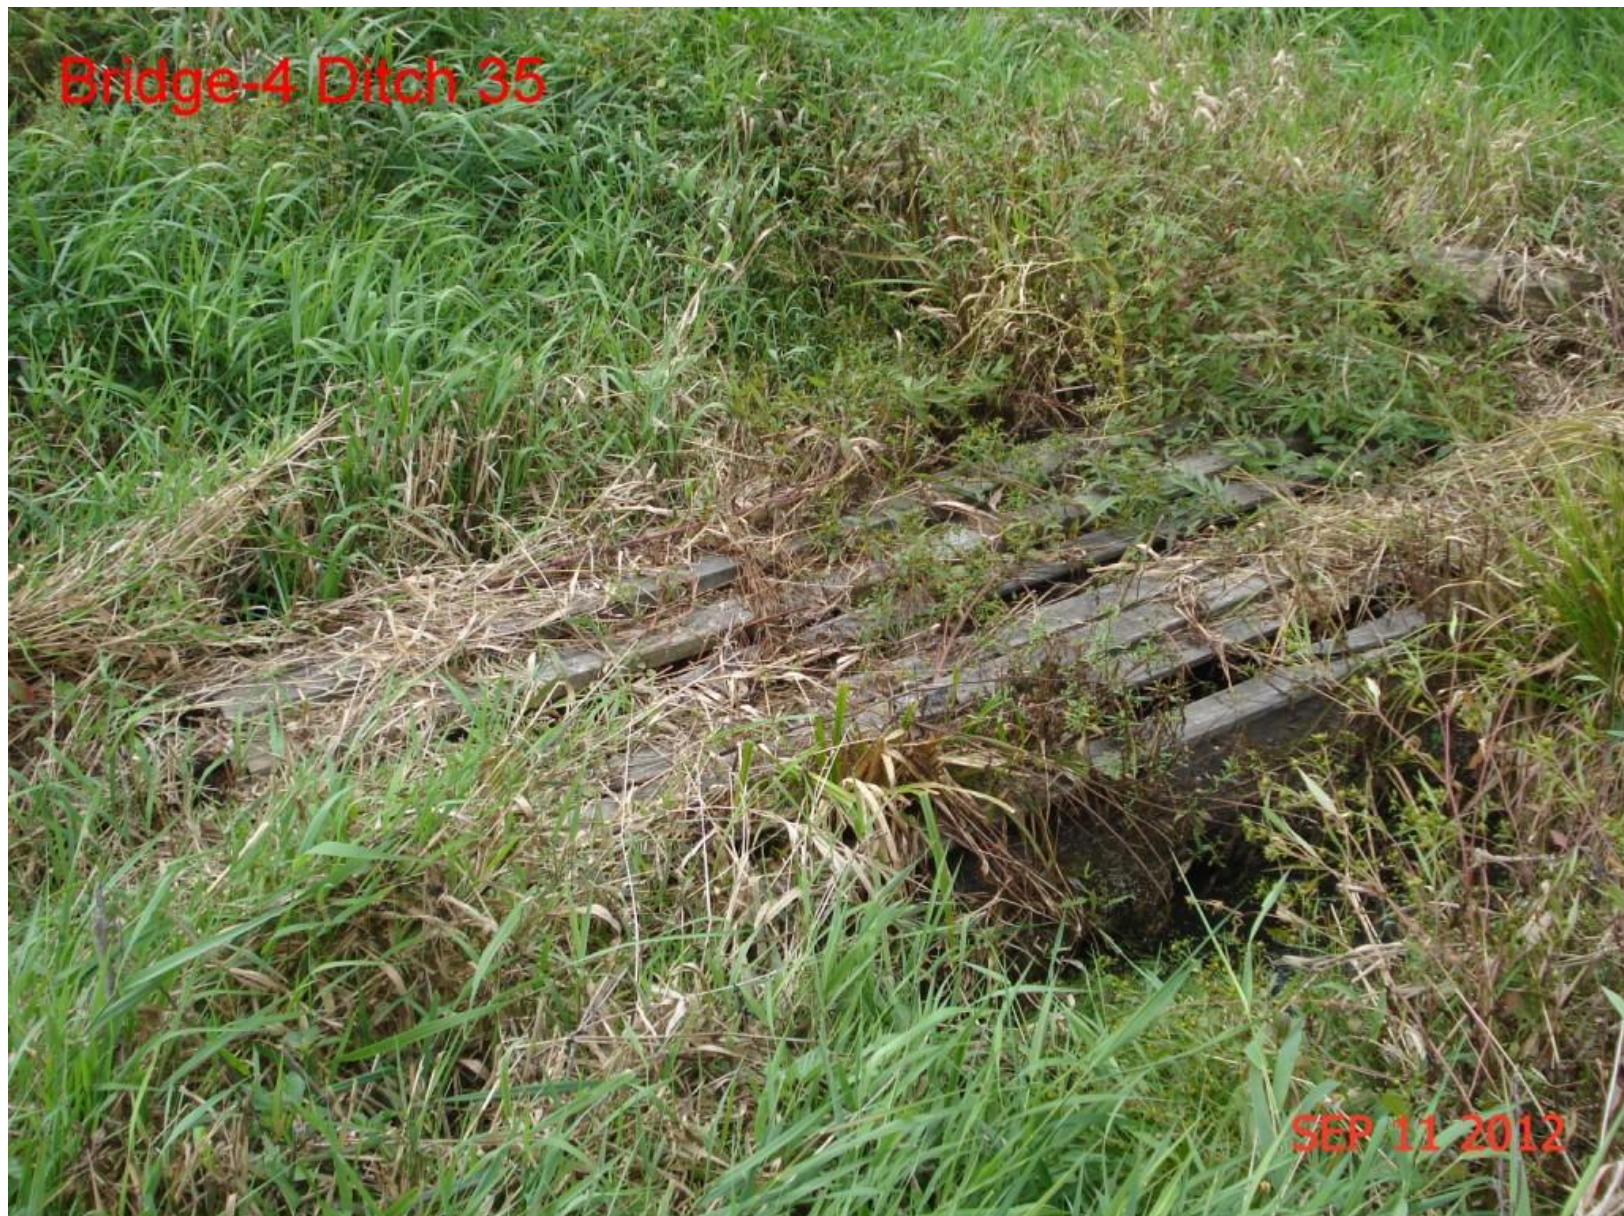
BRIDGE 4 BRANCH 1

Mr. Parker has called and indicated
that bridge has been removed.

Bridge 4 while in bad shape is located in an area of the ditch with a lot of fall, about 3.5 feet in 500 feet. Effect on drainage very localized, no impact on main ditch.

Remove or replace bridge 4 with bridge or 30" culvert

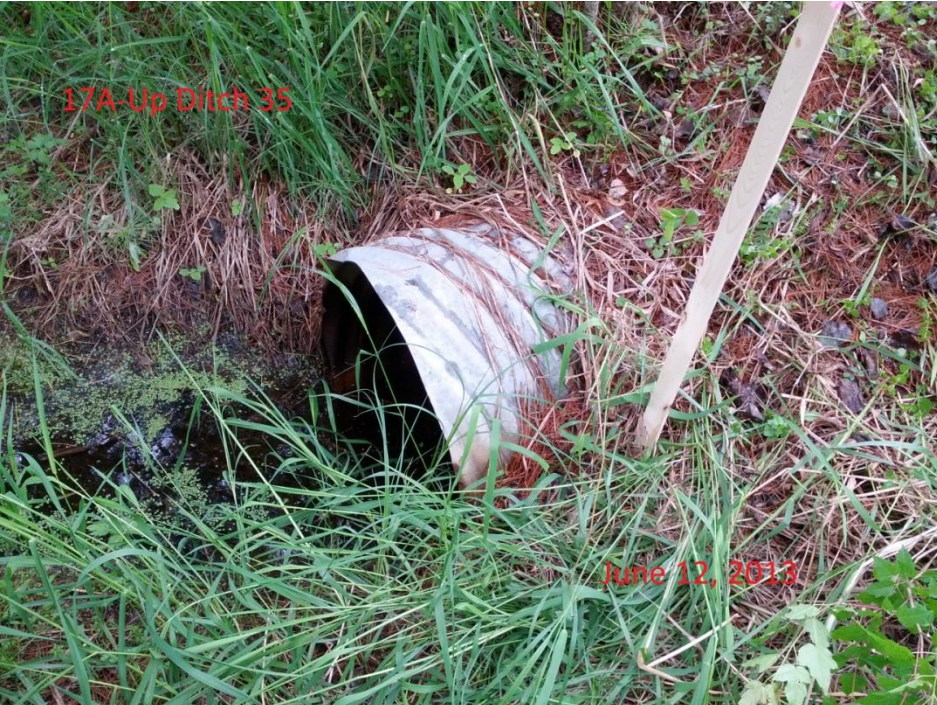
17A-Up Ditch 35

Mr. Penn has called and noted the existence of **bypass culverts** which are at an elevation about 2 feet higher than the original **culvert #17**
