# COUNTY DITCH #35

Discussion on obstructions in the  
Ditch

May 28, 2013

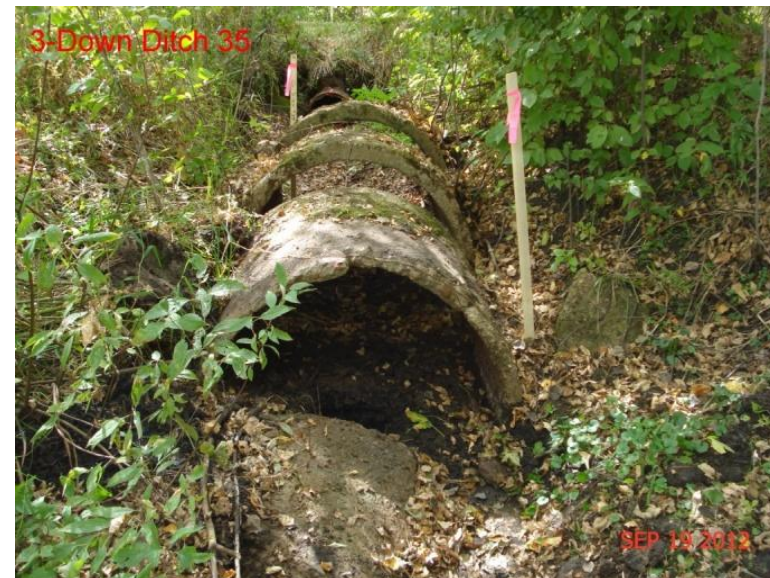
# CULVERTS 2 & 3 MAIN DITCH

Culvert Number	Culvert Location (Cross street or Address)	Date Visited	Culvert Material	Culvert Size (inches)	Culvert Length (feet)	Culvert Condition	Culvert Flowing	Amount of Silt (feet) Up / Down	Upstream Invert Elev. (NGVD 29)	Downstream Invert Elev. (NGVD 29)	Benchmark Location crossings only) (on Road	Benchmark Elevation (NGVD 29)	Picture File Names	Notes	Recommendations
1	County Road No. 19 (Potomac Street), Columbus, MN	09/20/2012	CMP	36	50	good	yes	0.2 / 0.2	898.6	898.5	Anoka County BM at the SE corner of C.S.A.H. No. 18 & County Road No. 19 Rod in ground (Blue 26)	905.03	1-Up / 1-Down	Culvert has flared end section on each end.	None
2	7606 West Broadway Ave., Columbus, MN	09/19/2012	CMP	15	16	poor	dry	0.3 / 0	898.8	898.9			2-Up / 2-Down		REPLACE WITH 36" LOWERE 0.5 FEET
3	7606 West Broadway Ave., Columbus, MN	09/19/2012	RCP	37	9				898.0	898.4			3-Up / 3-Down	Culvert sections are separated and are sitting in ditch. (See Pictures)	REMOVE OR REPLACE WITH 36"

Remove or replace culvert 2, replace 0.5 feet lower with 36 inch

Remove or replace culvert 3, replace at current grade with 36 inch

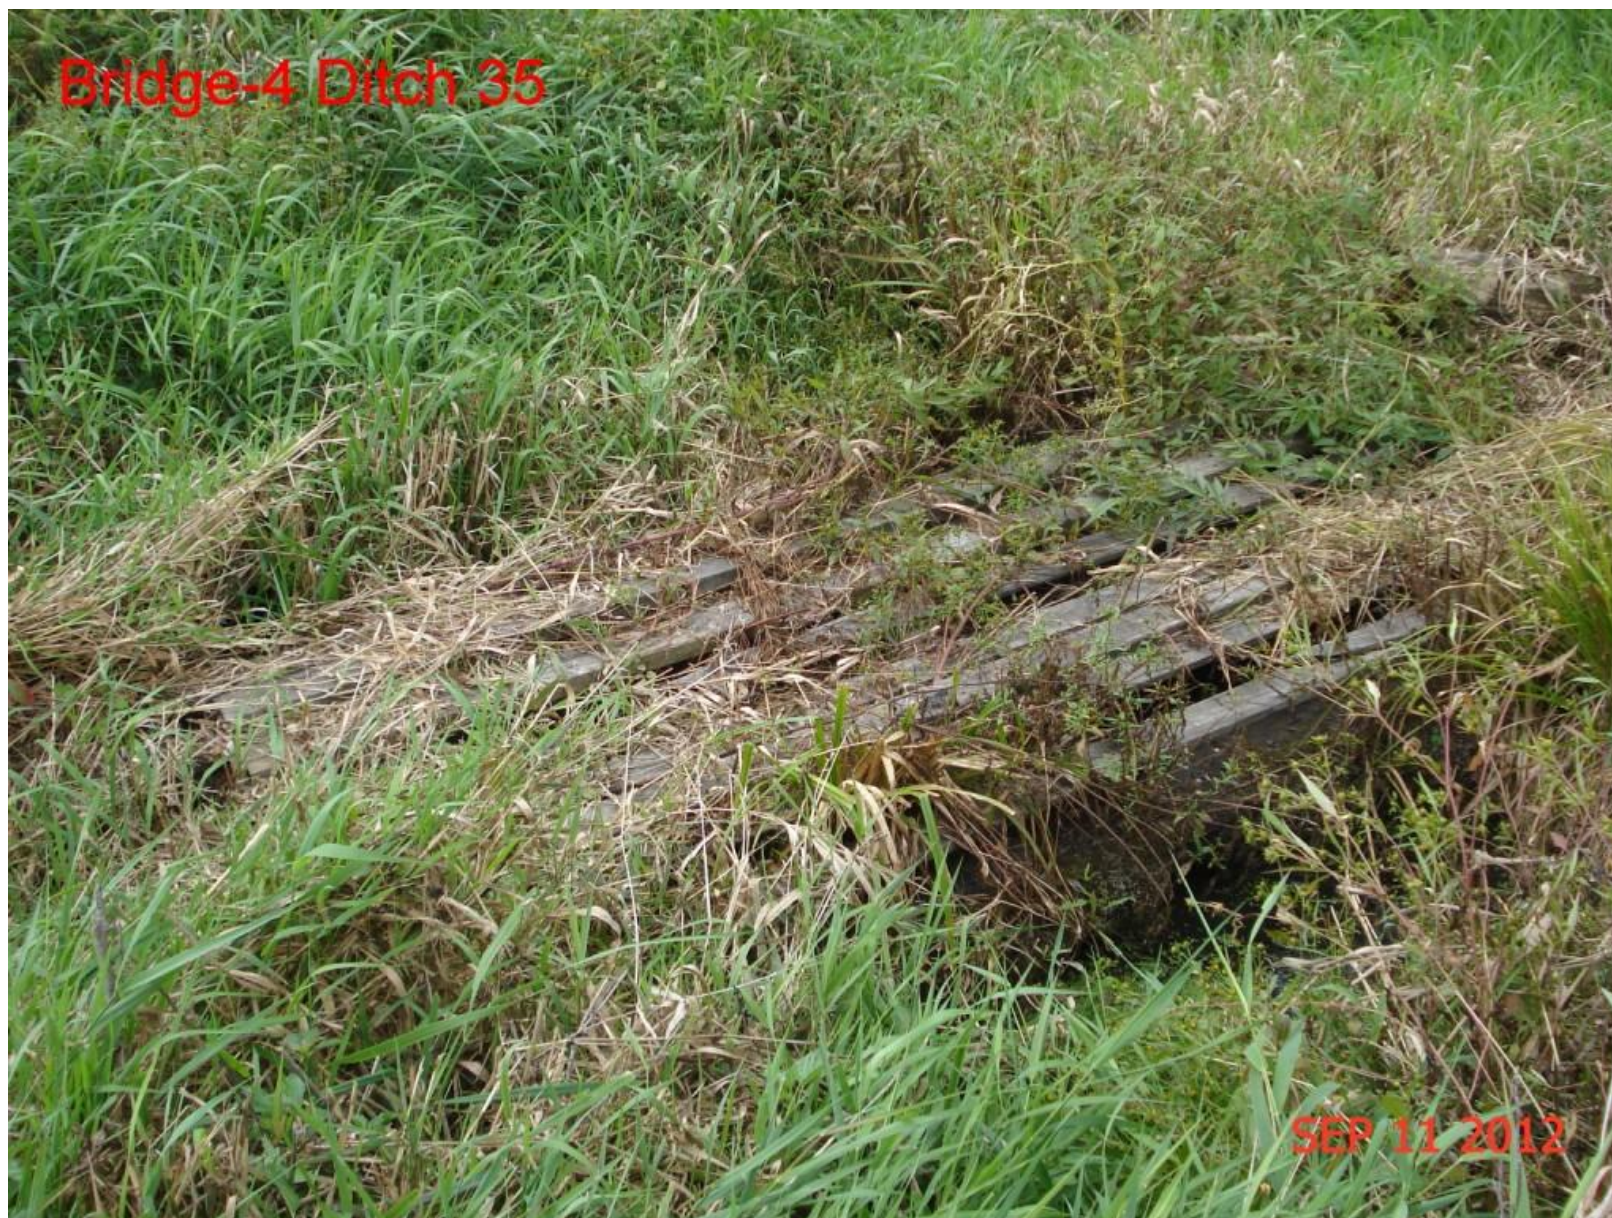
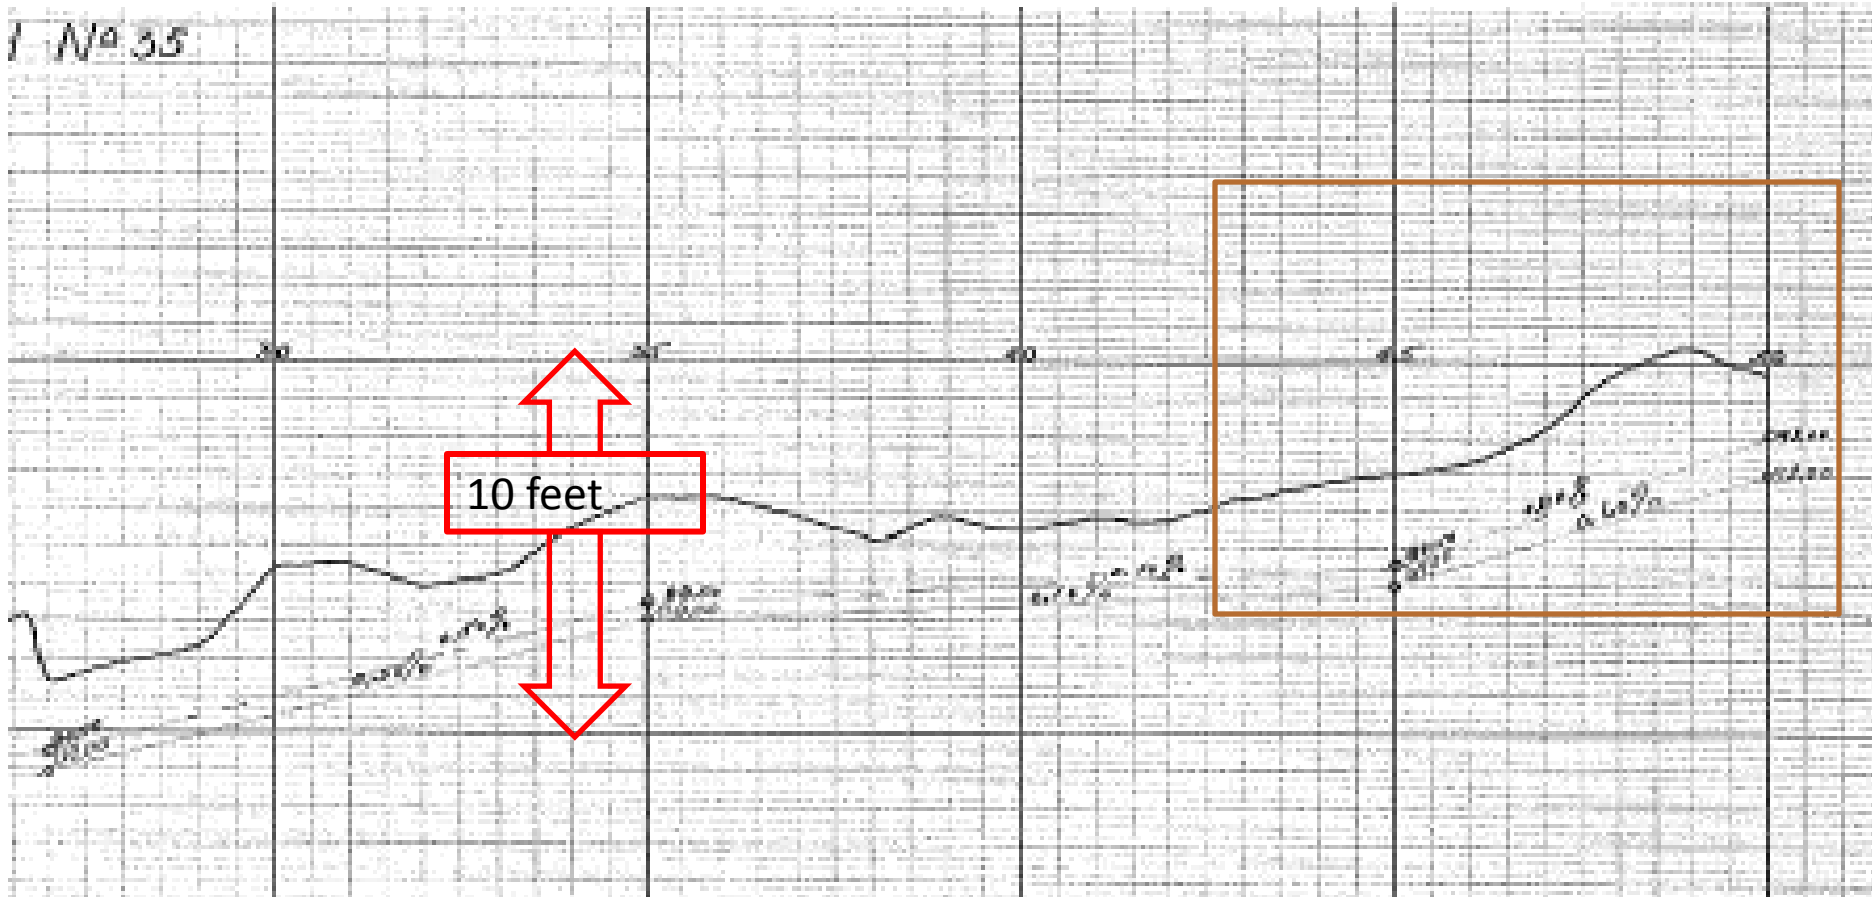
BRIDGE 4 BRANCH 1

Bridge 4 while in bad shape is located in an area of the ditch with a lot of fall, about 3.5 feet in 500 feet. Effect on drainage very localized, no impact on main ditch. Culvert 9 is in the same situation however is g

Remove or replace bridge 4 with bridge or 30" culvert

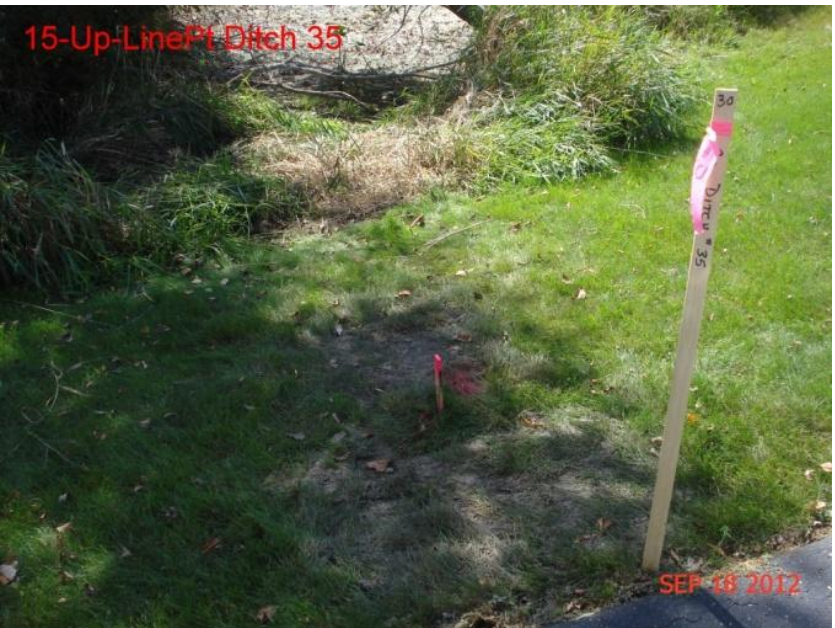
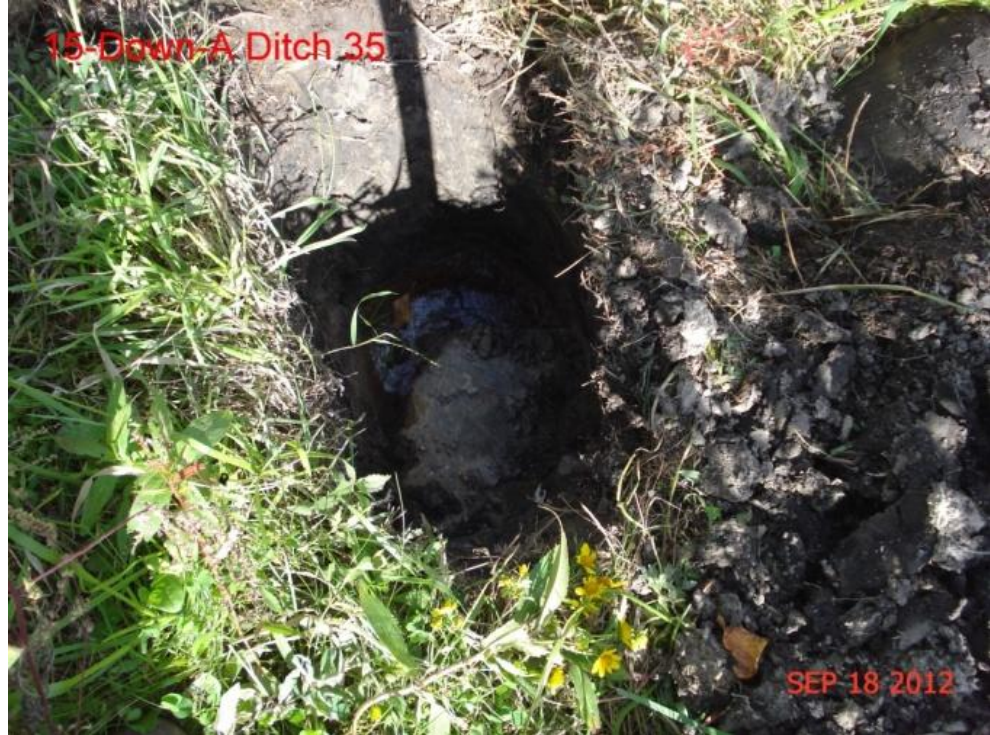
15-Up-Line Pt Ditch 35

Culvert is outlet to pond  
Remove 15 inch culvert 15 and replace with 30"

Culvert is under driveway to 7135, inlet end on property of:  
Daniel R and Kim A Zimmerle  
7237 178th Avenue NE  
Columbus  
PIN# 02-32-22-14-0007

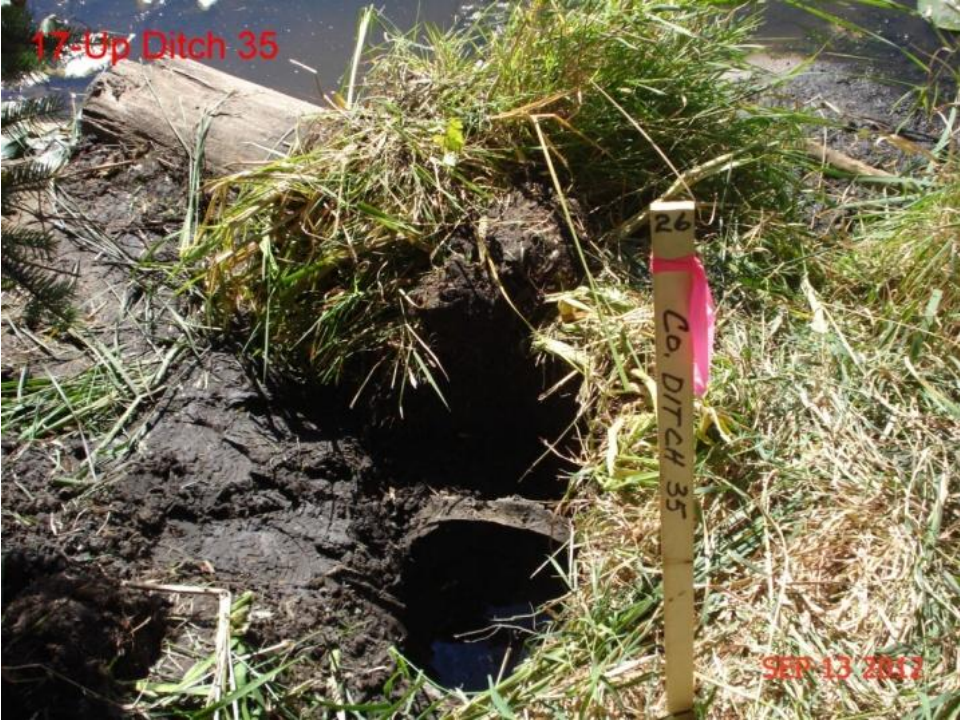
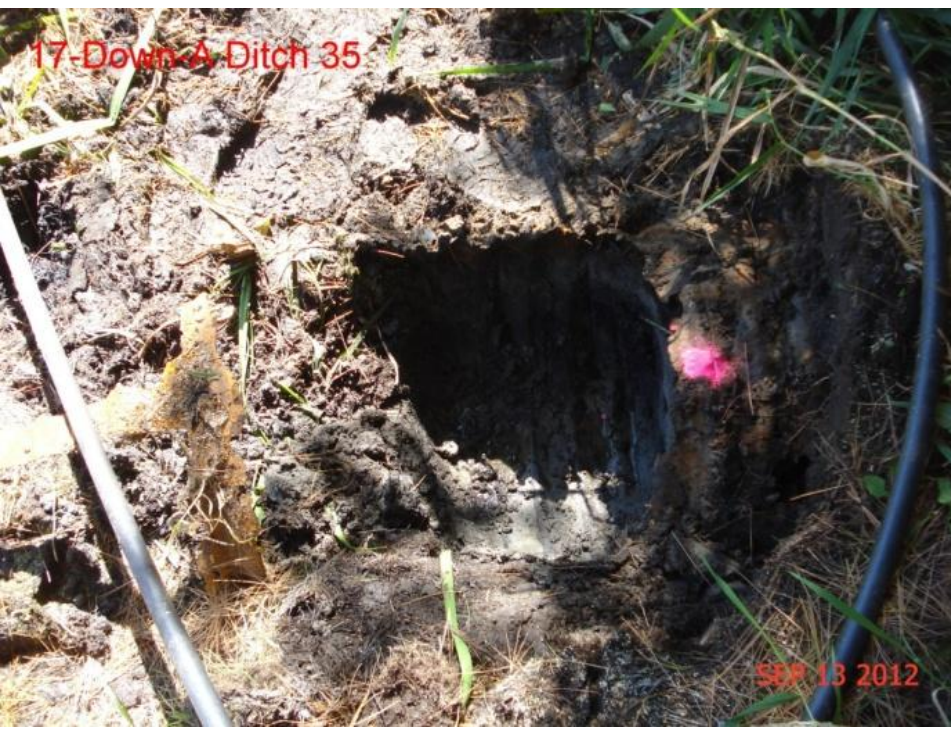
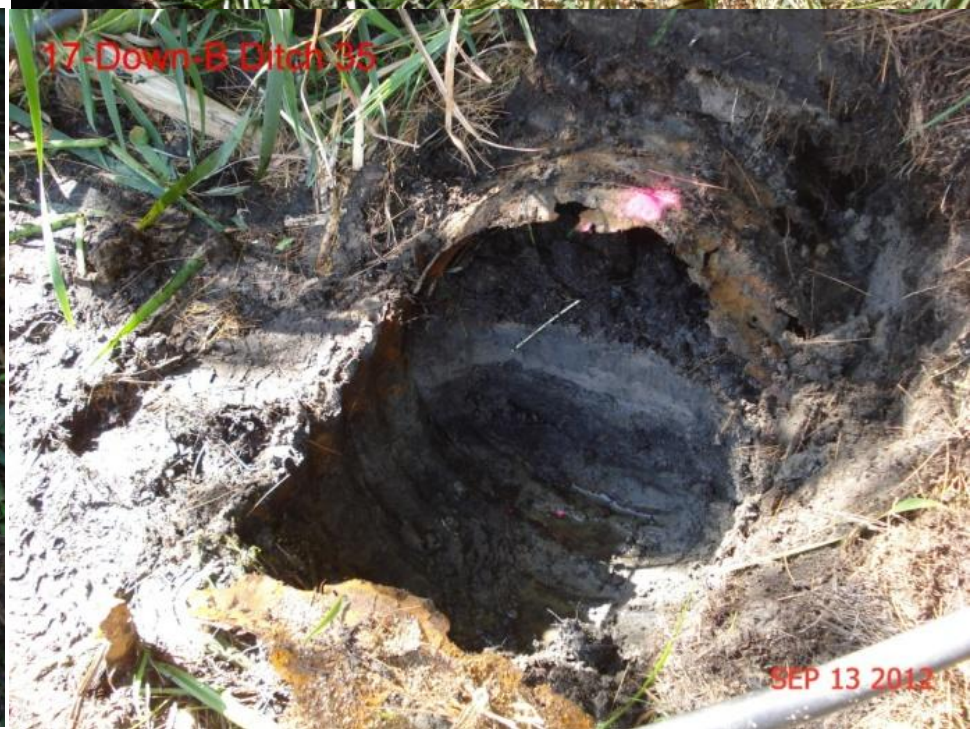
**Jeffrey M and Penny Penn**  
7340 180th Avenue NE  
Columbus  
PIN# 04-32-22-11-0004  
Culvert is outlet to pond  
Remove 18 inch Culvert and replace with 42"

CULVERTS 15 AND 17, ARE ON BRANCH 3 OF COUNTY DITCH 35. THE RESIDENTS HAVE DEVELOPED A SERIES OF PONDS ON THE DITCH AND EVEN AIREATE ONE OF THE PONDS. I BELIEVE THESE PONDS HAVE NO EFFECT ON THE MAIN DITCH. I WOULD SUGGEST A LETTER ADVISING THEM THAT THEIR PONDS ARE ON A COUNTY DITCH AND THAT, IN THE UNLIKELY EVENT THAT A PROPERTY OWNER TO THE WEST OF THEM WANTS THE DRAINAGE THEY ARE ENTITLED TO, THESE OWNERS WOULD BE ORDERED TO RESTORE THE DRAINAGE. AN OPTION HERE WOULD BE TO SUGGEST THAT THE OWNERS INVOLVED PETITION TO HAVE BRANCH 3 ABANDONED UNDER MN STATUTE 103E.806 WEST OF THE NORTHWARD EXTENSION OF THE EAST R/W OF POTOMAC STREET.
