COUNTY DITCH #35

Discussion on obstructions in the
Ditch

May 28, 2013

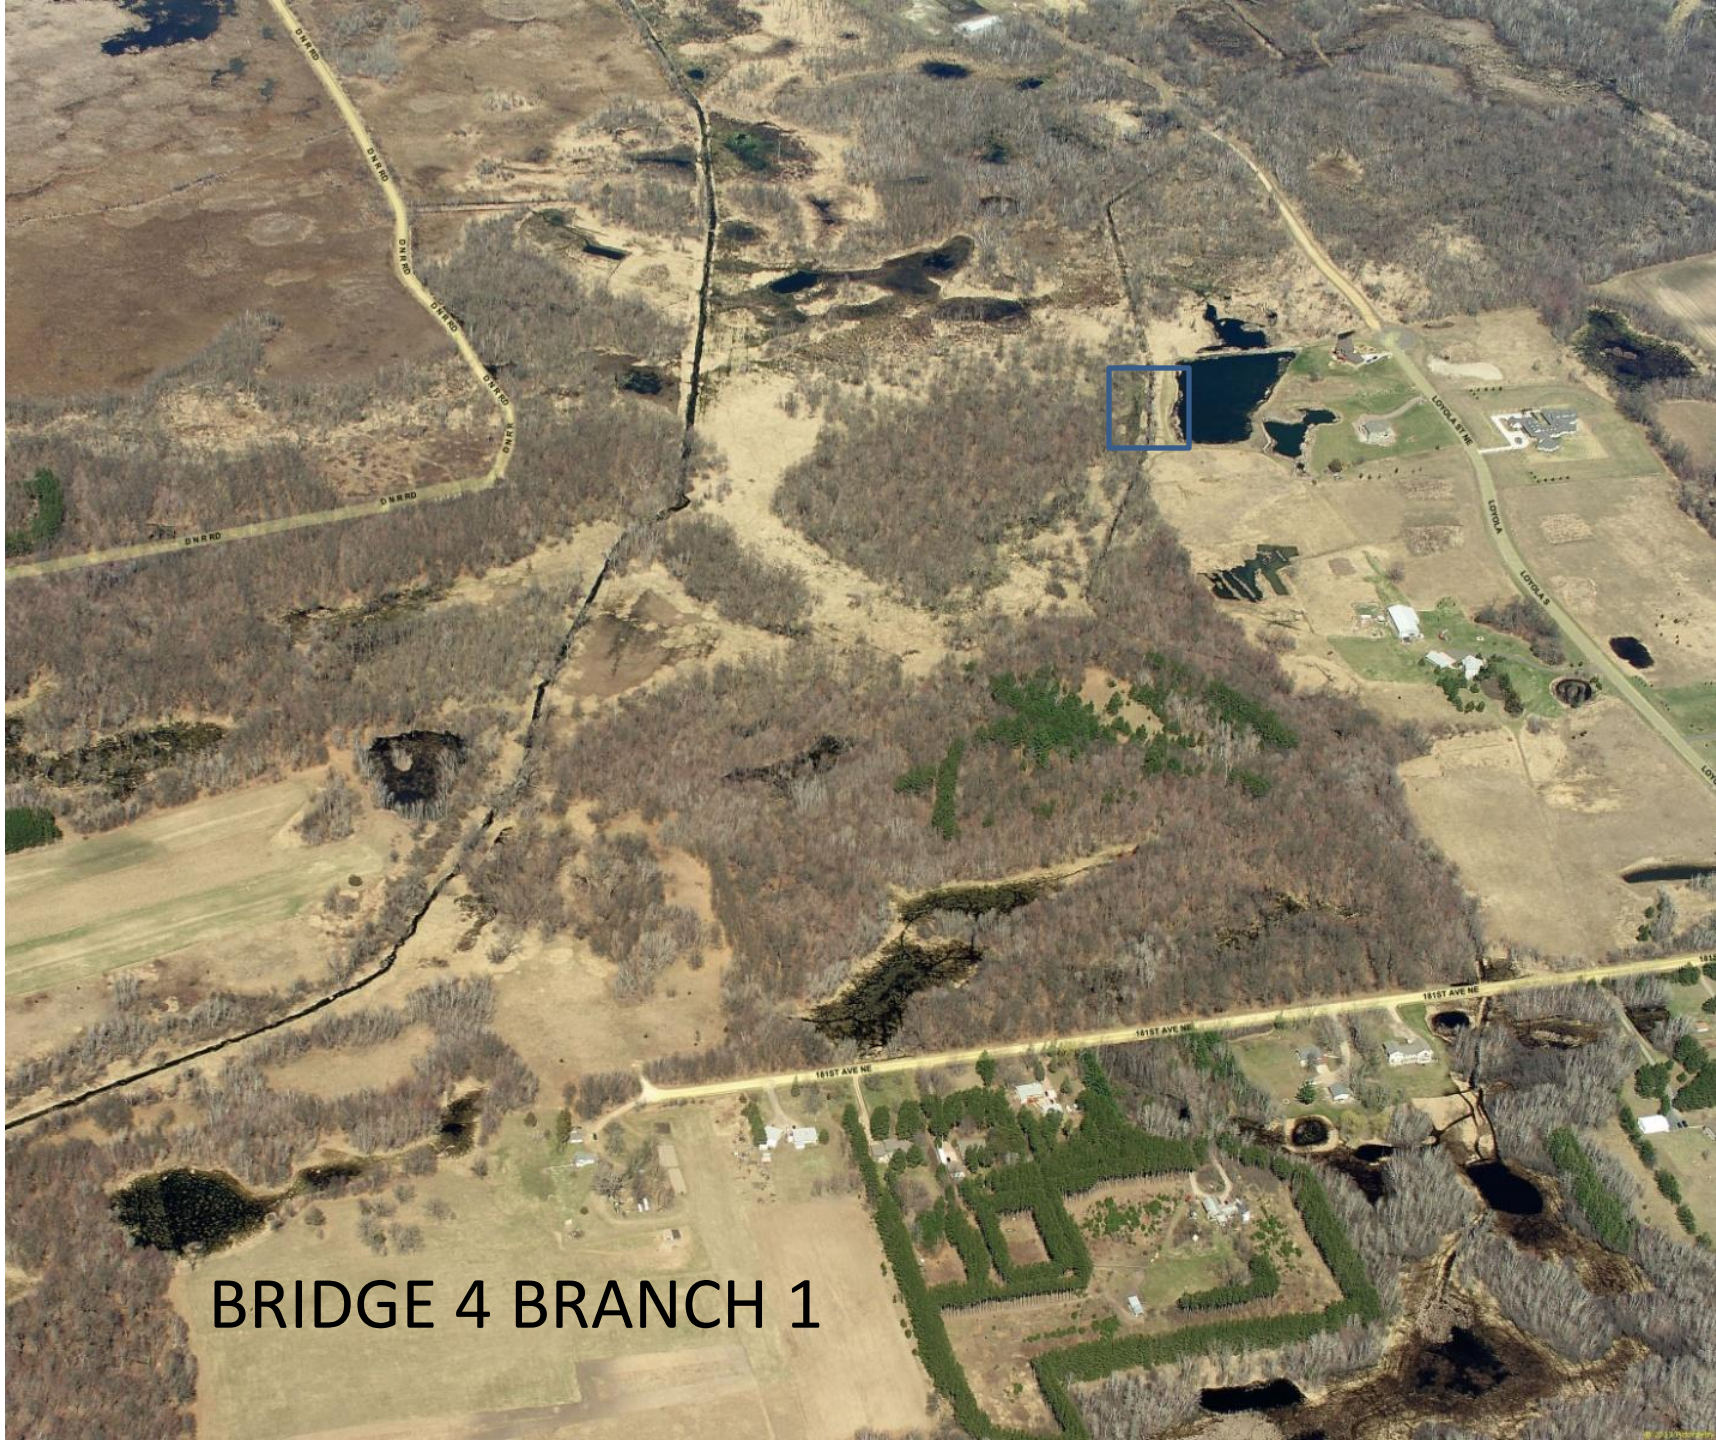
BRIDGE 4 BRANCH 1

Bridge 4 while in bad shape is located in an area of the ditch with a lot of fall, about 3.5 feet in 500 feet. Effect on drainage very localized, no impact on main ditch. Culvert 9 is in the same situation however is g

Remove or replace bridge 4 with bridge or 30" culvert

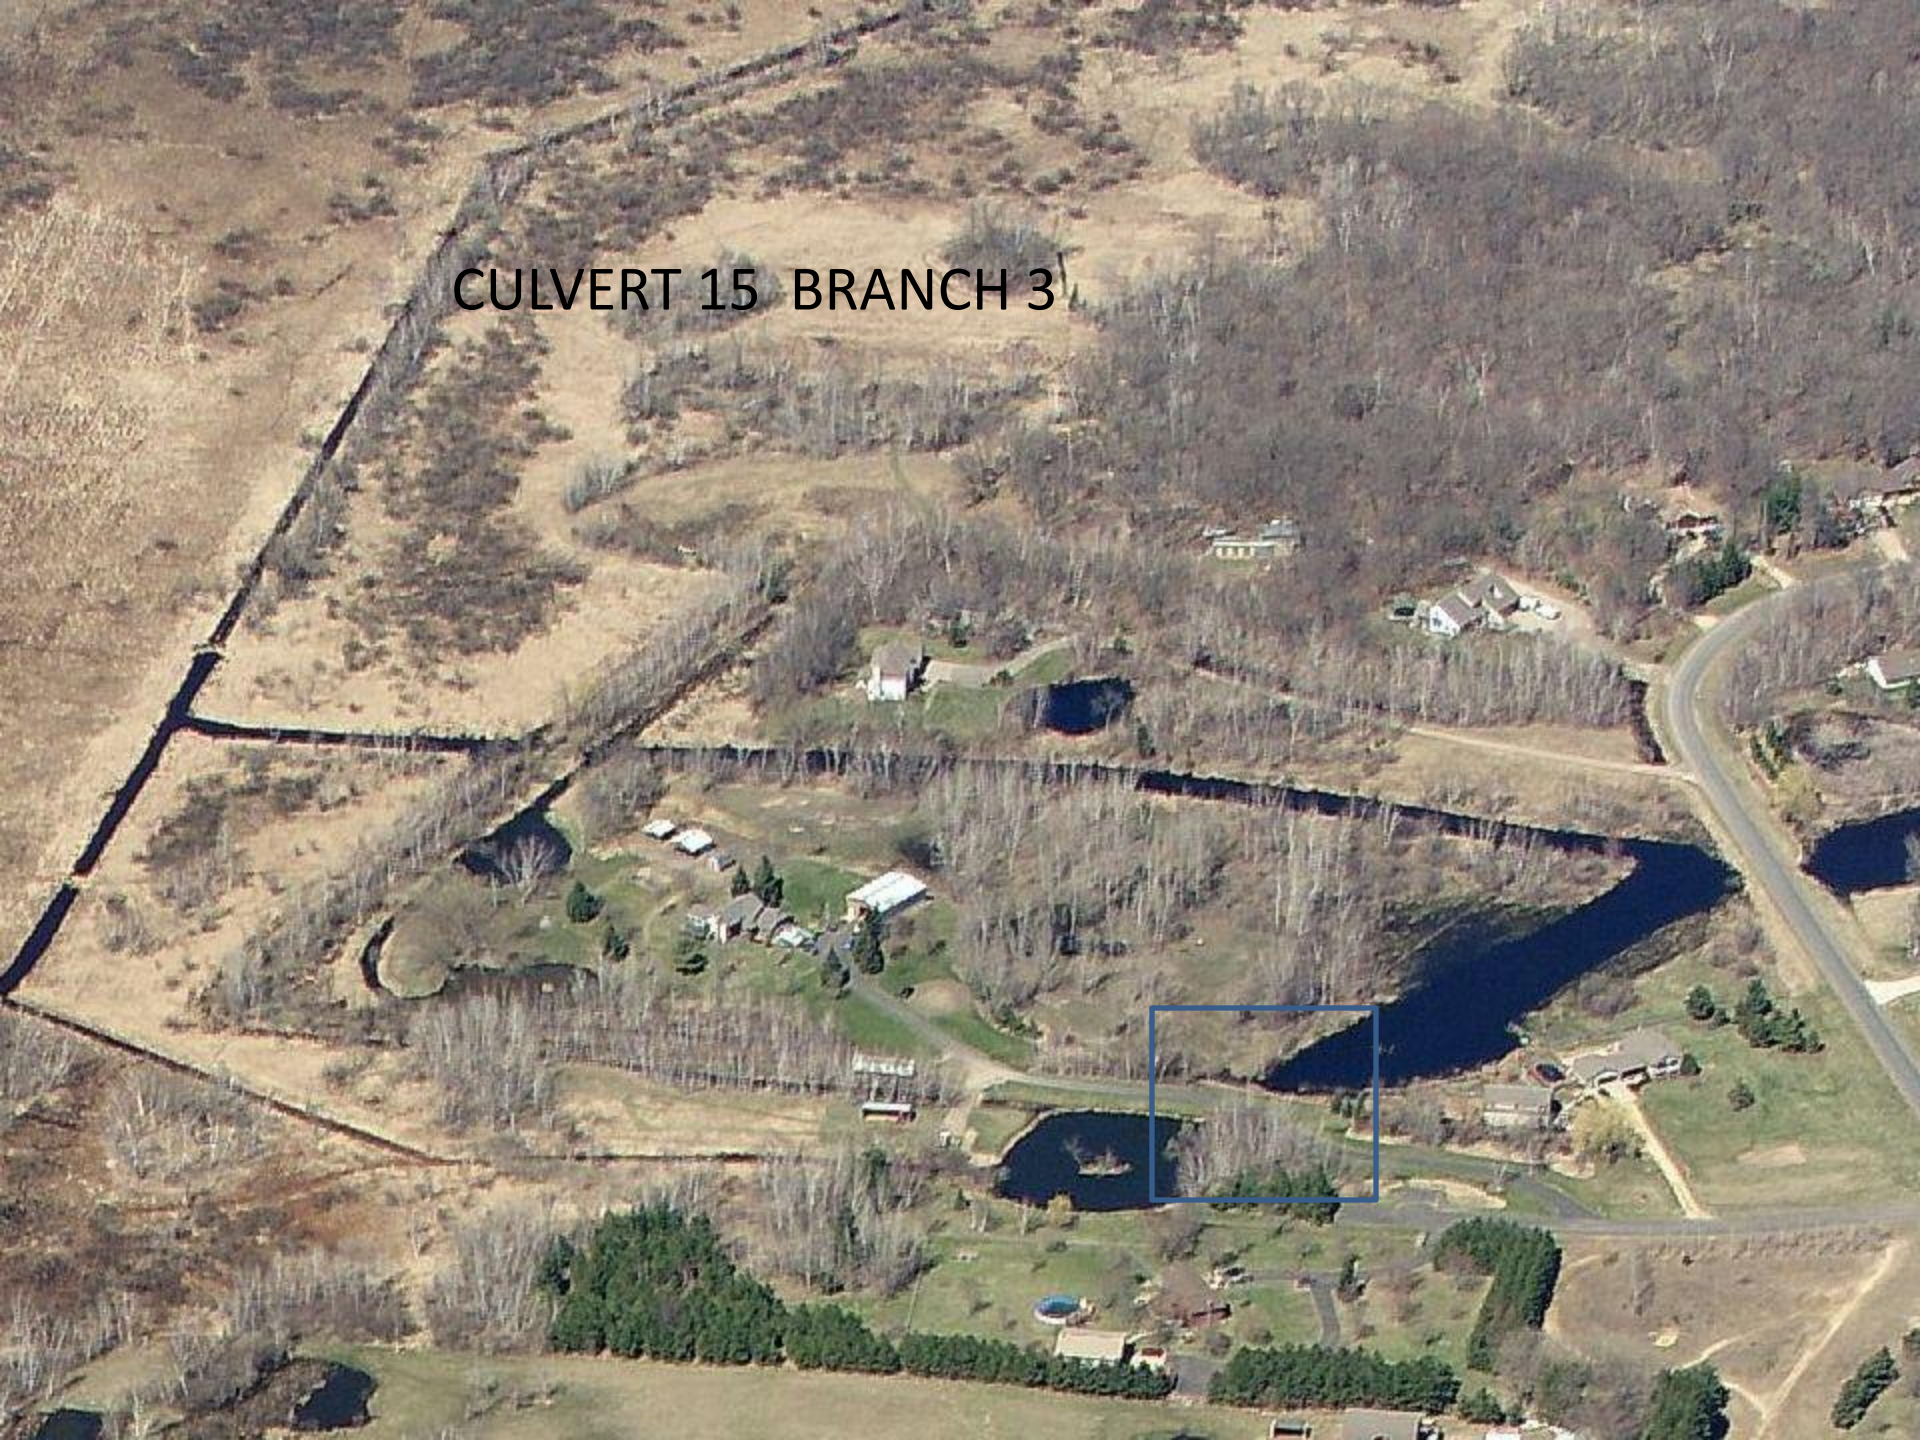
15-Up-Line Pt Ditch 35

Culvert is outlet to pond
Remove 15 inch culvert 15 and replace with 30"

CULVERTS 15 AND 17, ARE ON BRANCH 3 OF COUNTY DITCH 35. THE RESIDENTS HAVE DEVELOPED A SERIES OF PONDS ON THE DITCH AND EVEN AIREATE ONE OF THE PONDS. I BELIEVE THESE PONDS HAVE NO EFFECT ON THE MAIN DITCH. I WOULD SUGGEST A LETTER ADVISING THEM THAT THEIR PONDS ARE ON A COUNTY DITCH AND THAT, IN THE UNLIKELY EVENT THAT A PROPERTY OWNER TO THE WEST OF THEM WANTS THE DRAINAGE THEY ARE ENTITLED TO, THESE OWNERS WOULD BE ORDERED TO RESTORE THE DRAINAGE. AN OPTION HERE WOULD BE TO SUGGEST THAT THE OWNERS INVOLVED PETITION TO HAVE BRANCH 3 ABANDONED UNDER MN STATUTE 103E.806 WEST OF THE NORTHWARD EXTENSION OF THE EAST R/W OF POTOMAC STREET.

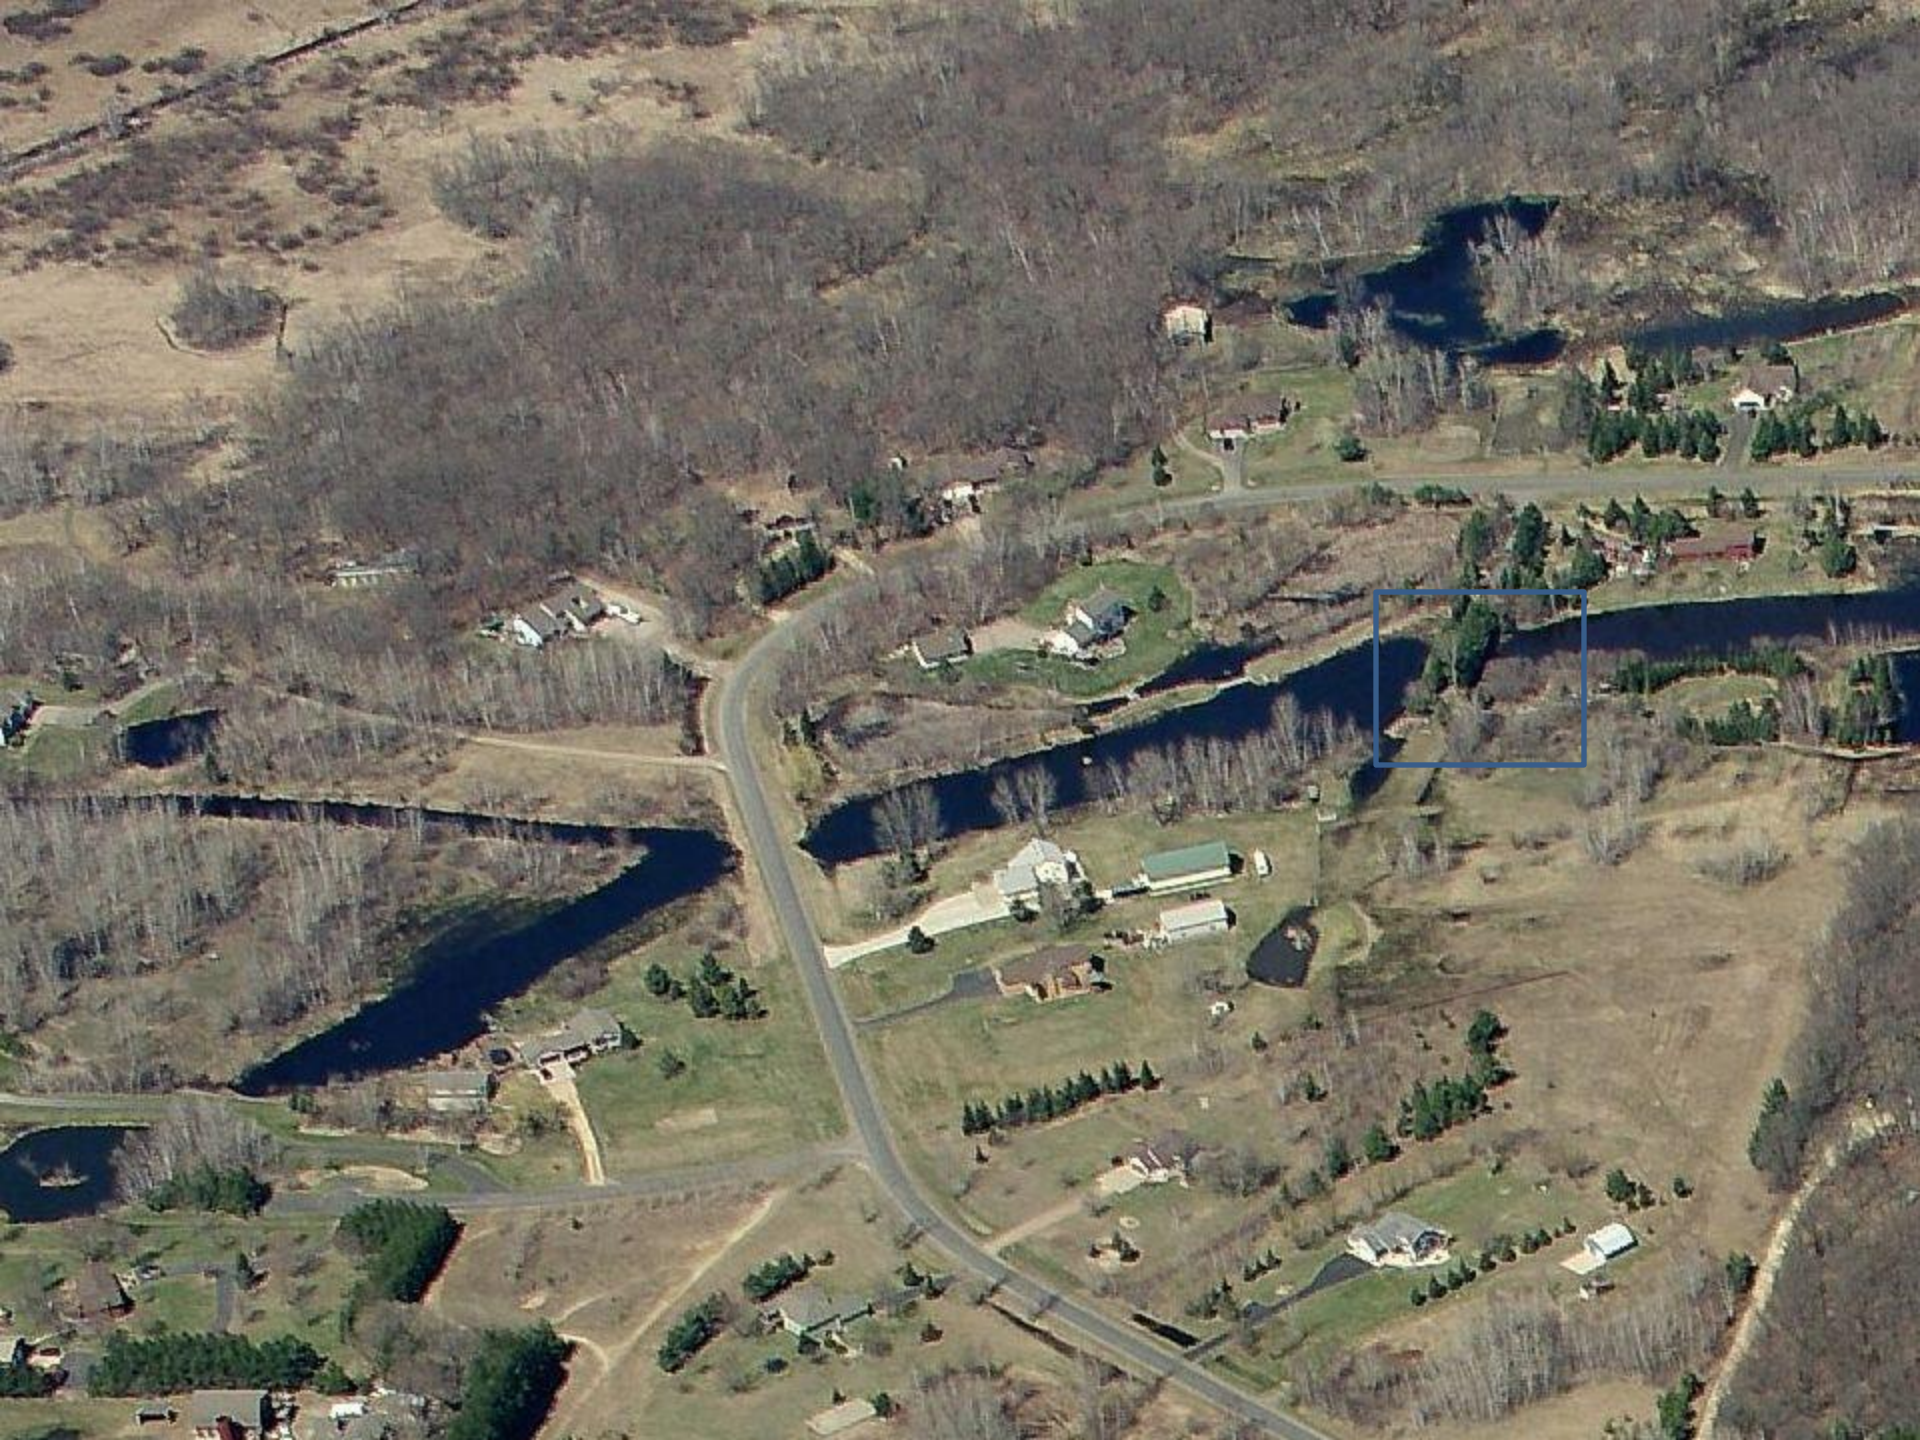
Jeffrey M and Penny Penn
7340 180th Avenue NE
Columbus
PIN# 04-32-22-11-0004
Culvert is outlet to pond
Remove 18 inch Culvert and replace with 42"
