REPAIRS CO. DITCH NO. 49 1915

PROFILE OF MAIN DITCH

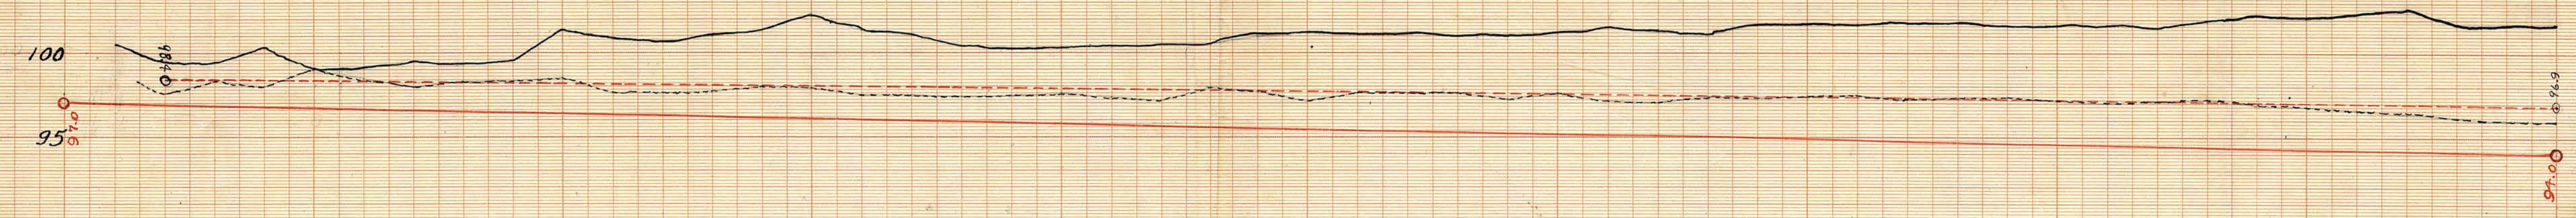
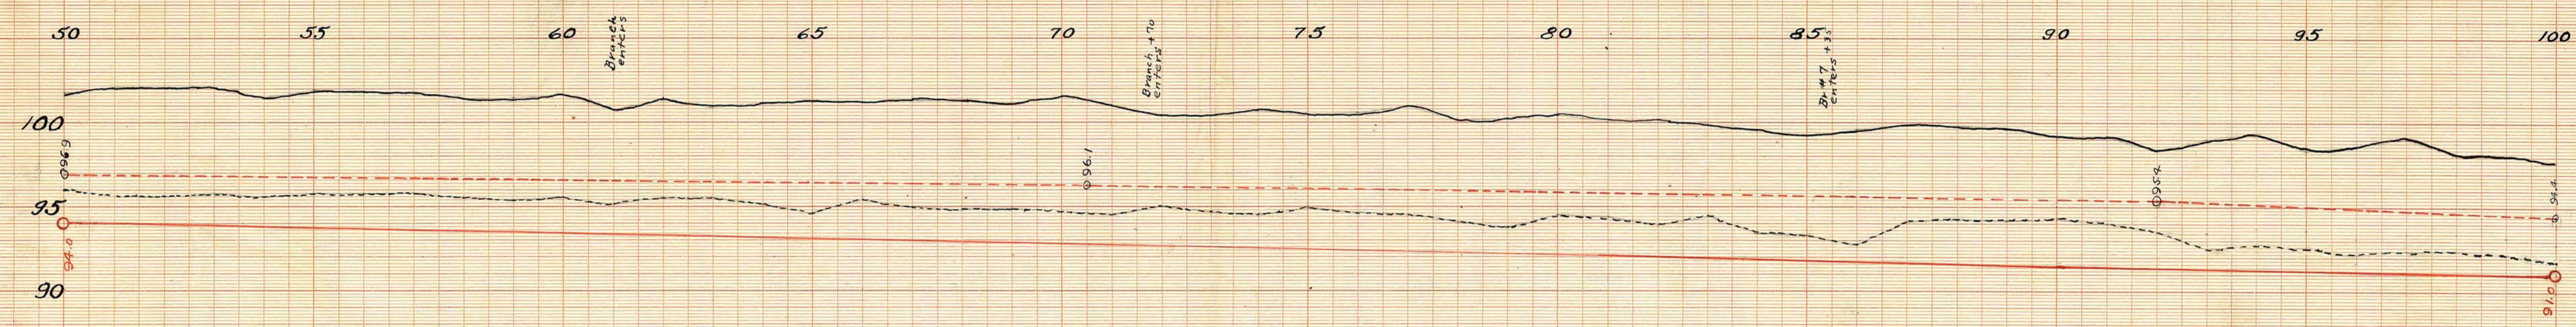
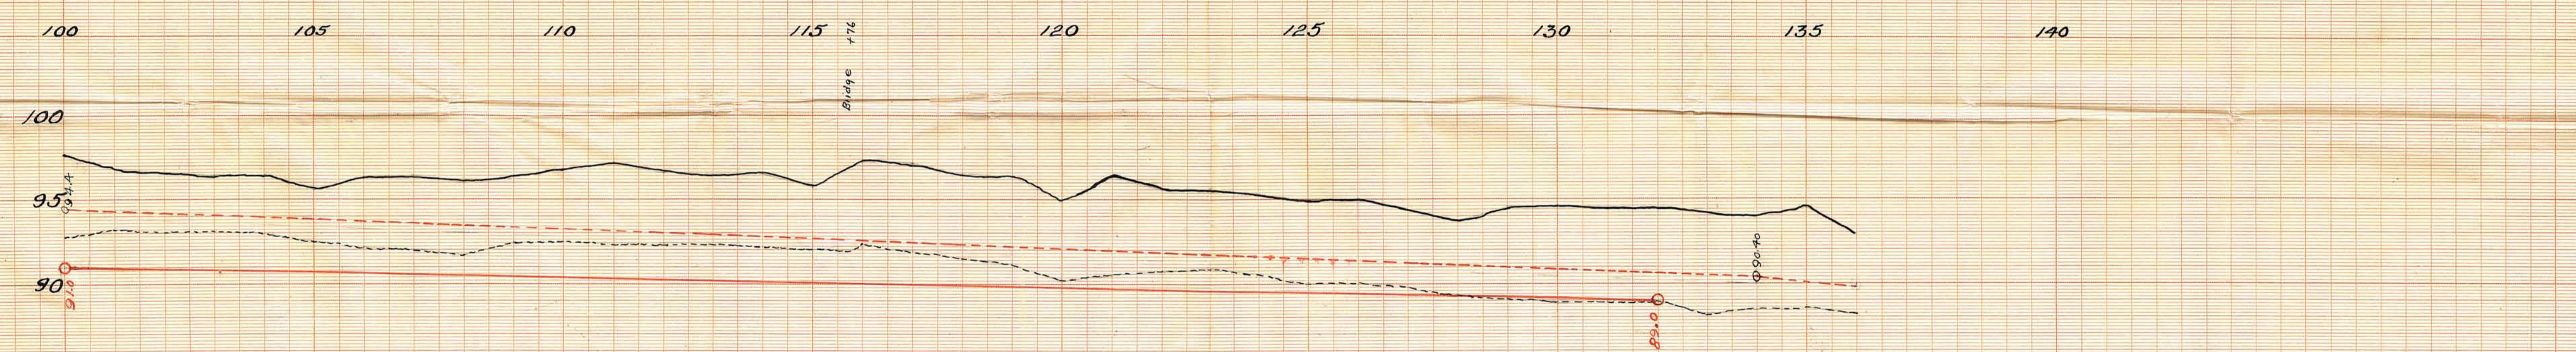
Original Elev. of 100.00 = 99.4' f. Repairs

Dotted Red line - Original Grade
