CERTIFICATE OF LOCATION OF GOVERNMENT CORNER

East 1/4 Corner of Sec. 5 Township 32 Range 23

HISTORY OF GOVERNMENT CORNER

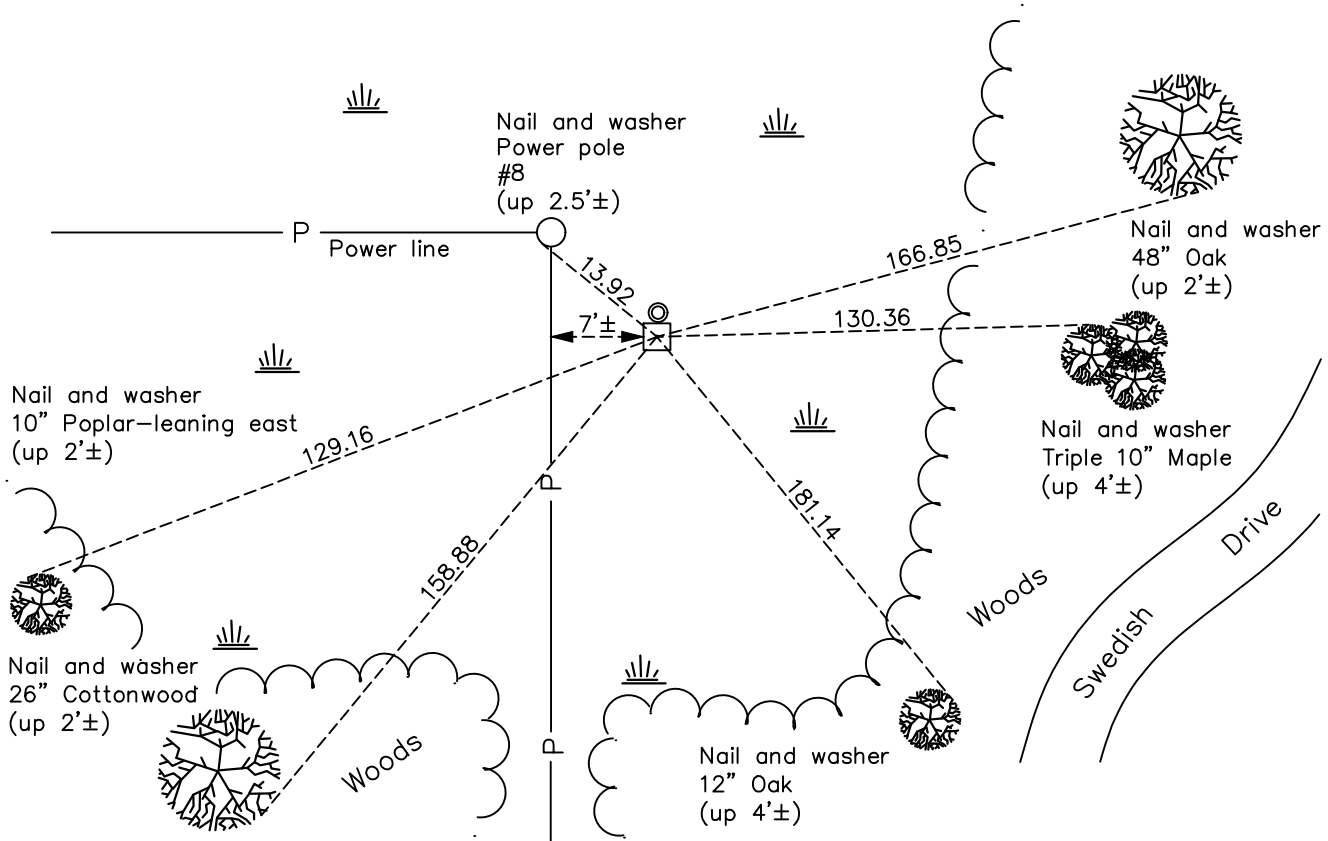
Updated reference ties are as shown below.

August 7, 2017 - Found concrete monument with top broken off. Set temporary spike using VRS GPS methods.

AND on the 24th day of August, 2017, said permanent marker was replaced with a 2" x 2" steel Telspar monument up 1'± w/ "County Surveyor" cap. Updated ties & set sign & post north.

August 24, 2017 - Replaced broken concrete monument with a 2" x 2" steel Telspar w/punch marked cap up 1'± using static GPS methods. Updated ties. Set sign and post on the north side.
