**ANOKA COUNTY**  
**COUNTY DITCH INSPECTION REPORT**

**DITCH #12**

**DATE: 7/8/94**

**CO DIT #12**

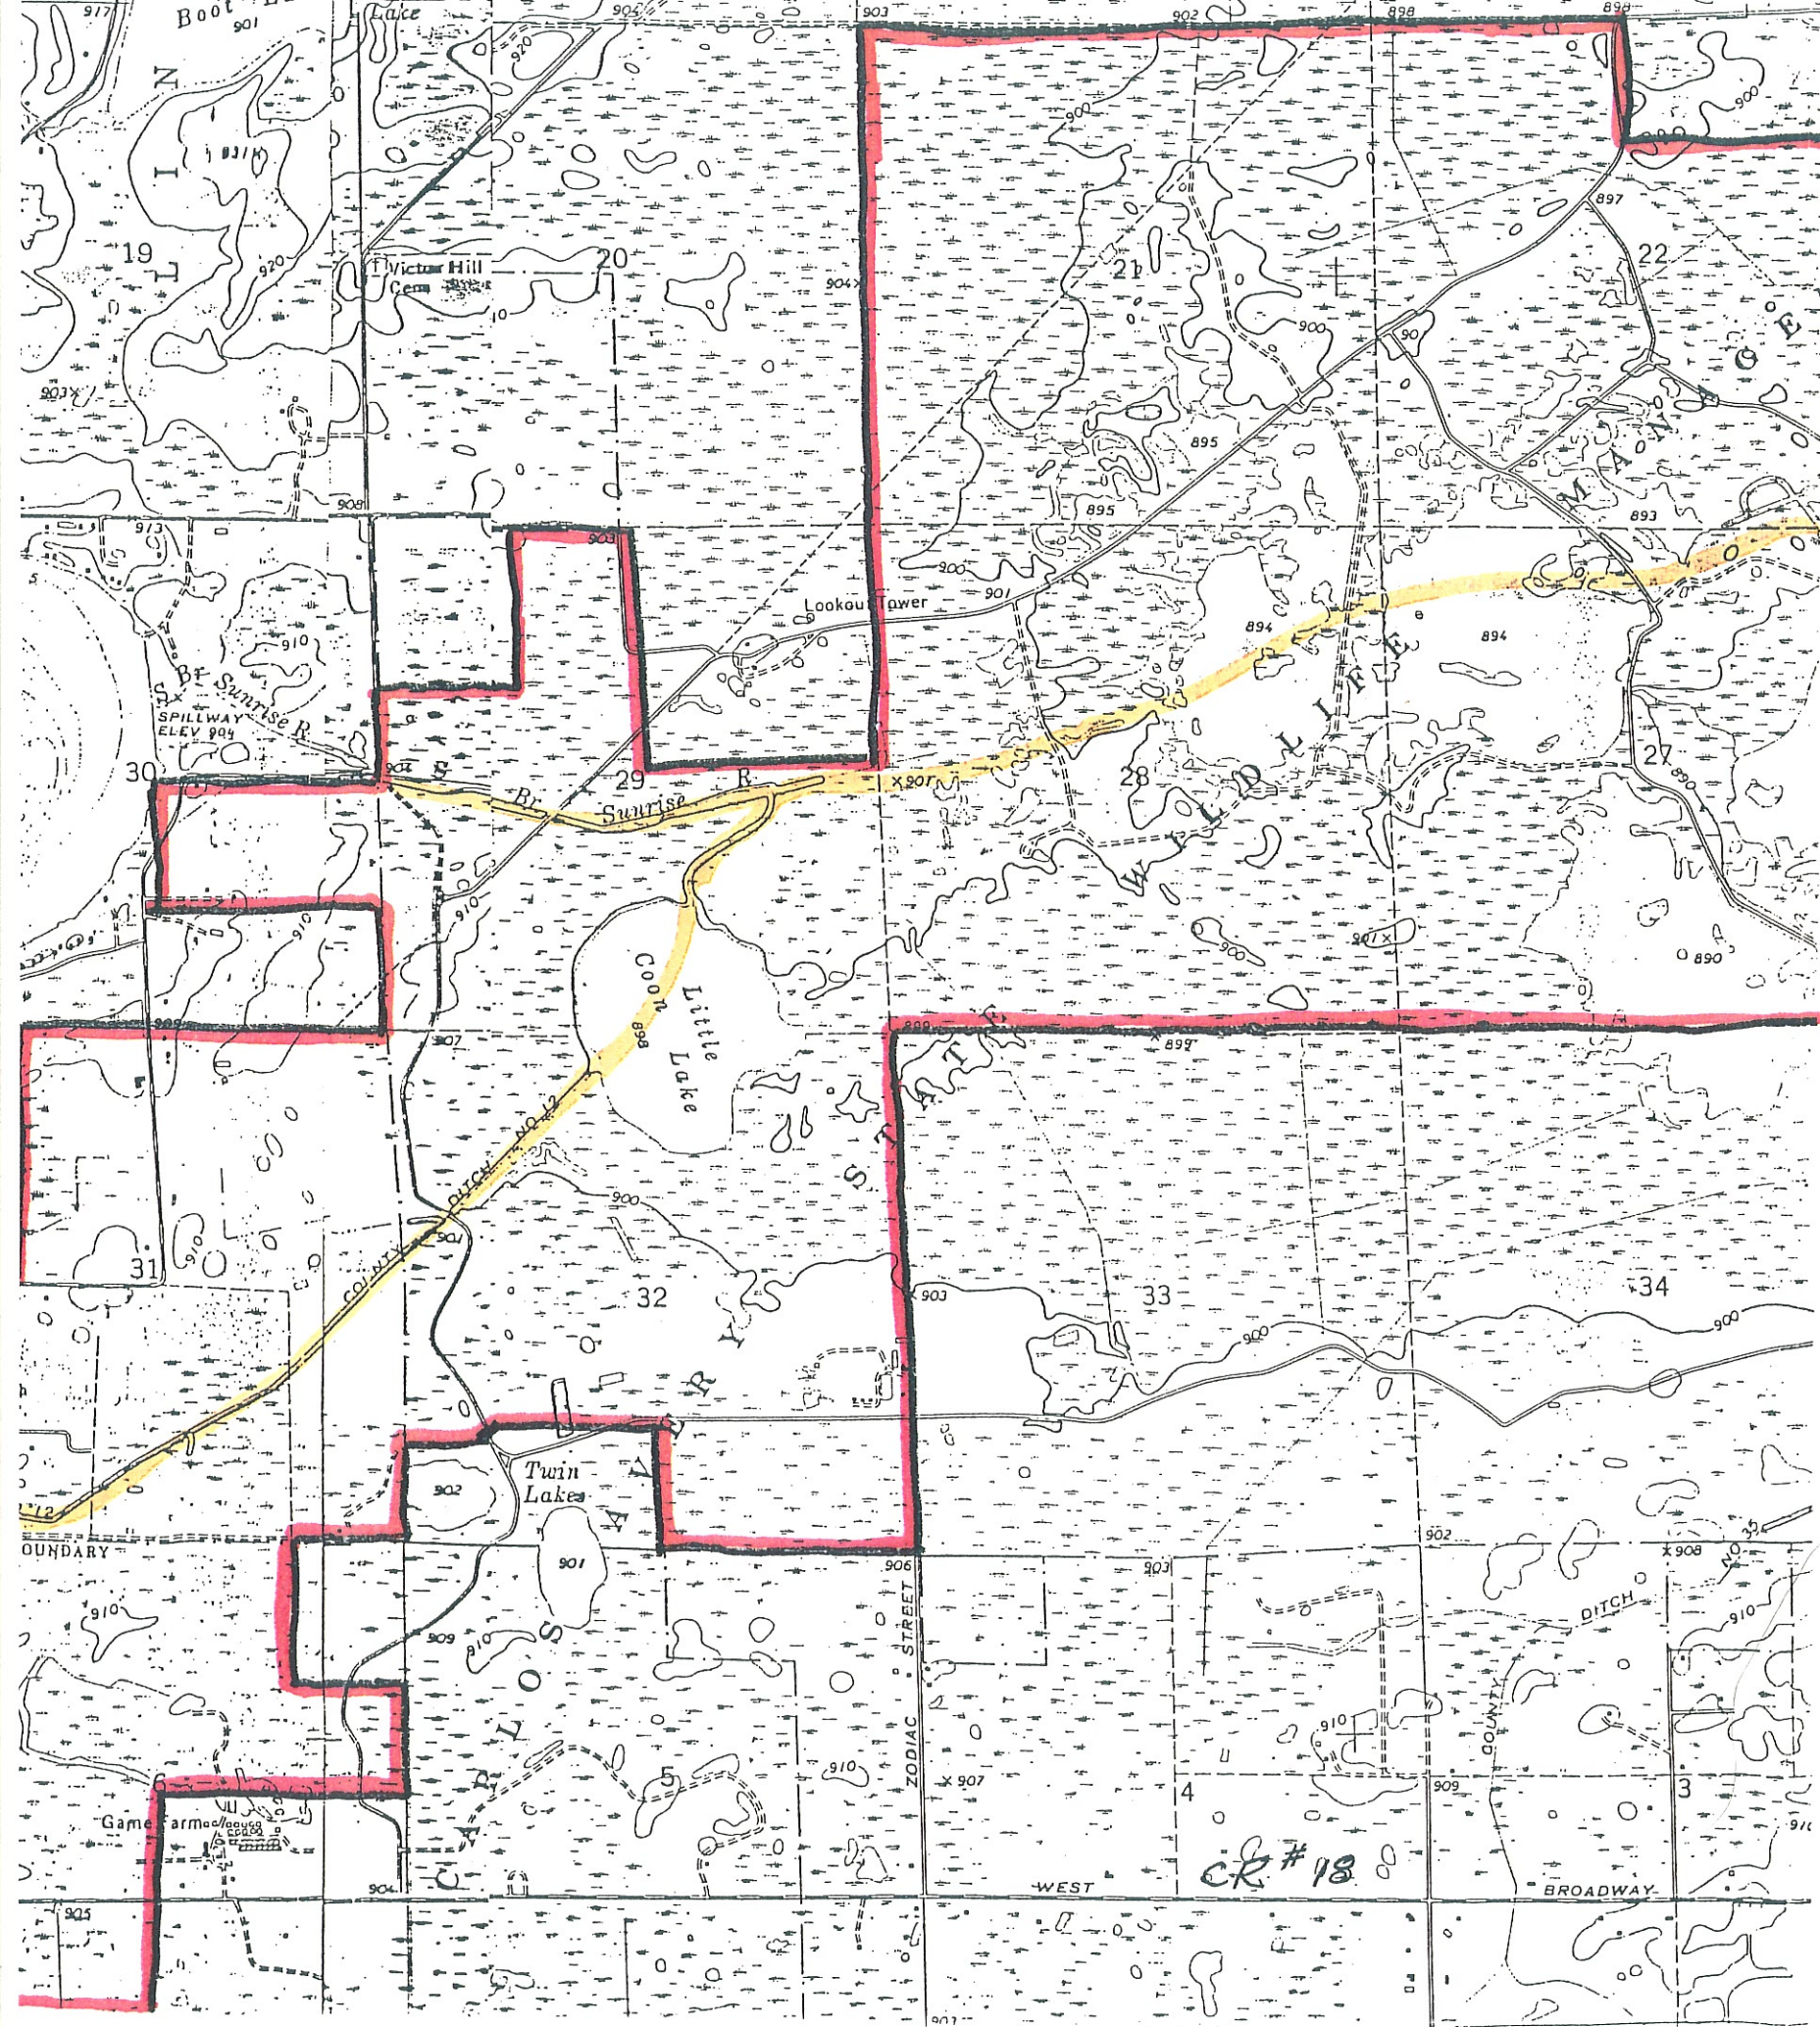
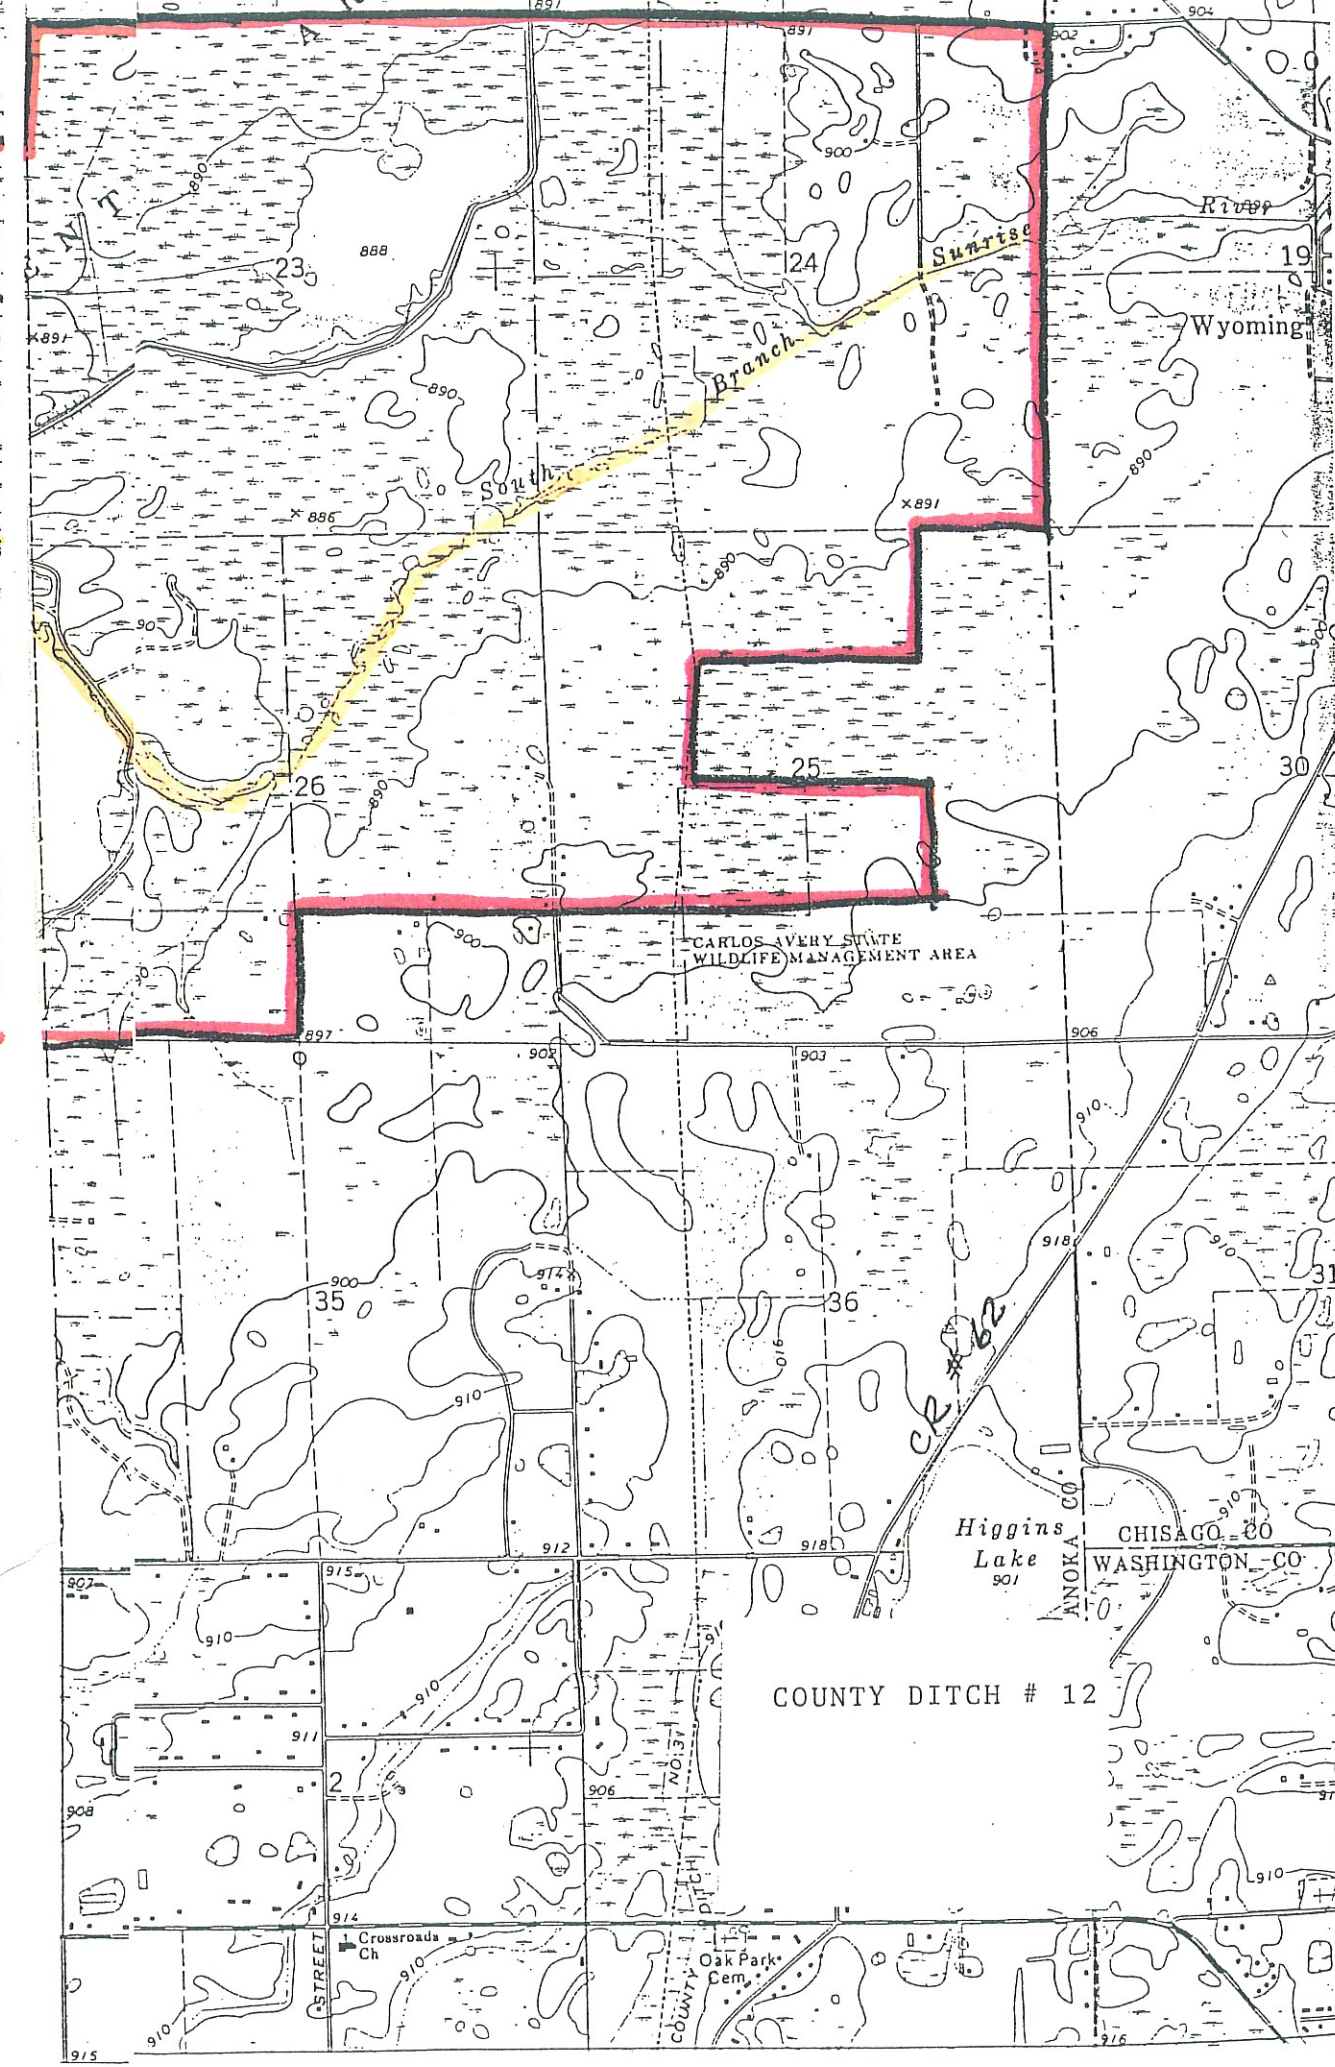
DNR Rd  
SW 1/4 NW 1/4 Sec. 26

Overflow structure (Gage 4.40')

Flowing

Hornsby St.

Clear ditch, flowing well.

Narrow bridge

DNR Rd.  
NE 1/4 NE 1/4 Sec. 27

Could not find.

(High ground @ indicated location.)

Doesn't agree with map, but probably crossing of DNR #12.

DNR Rd  
W line Sec. 32

Clear & flowing freely

Ditch quite full.

Lexington Ave  
1/2 mi. So of #30

Ditch clear & flowing.

Houle's pump running on west side of road.

Road to East

Ditch clear & flowing

Lexington Ave.  
1/4 mi. E. Park Entr.

Ditch clear & flowing - outlet full.

New culverts installed in 1993.

DNR Rd.

Defined, full & flowing.
