ANOKA COUNTY
COUNTY DITCH INSPECTION REPORT

DITCH # 18

DATE: 7/15/94

COMMUNITIES: Oak Grove, St. Francis

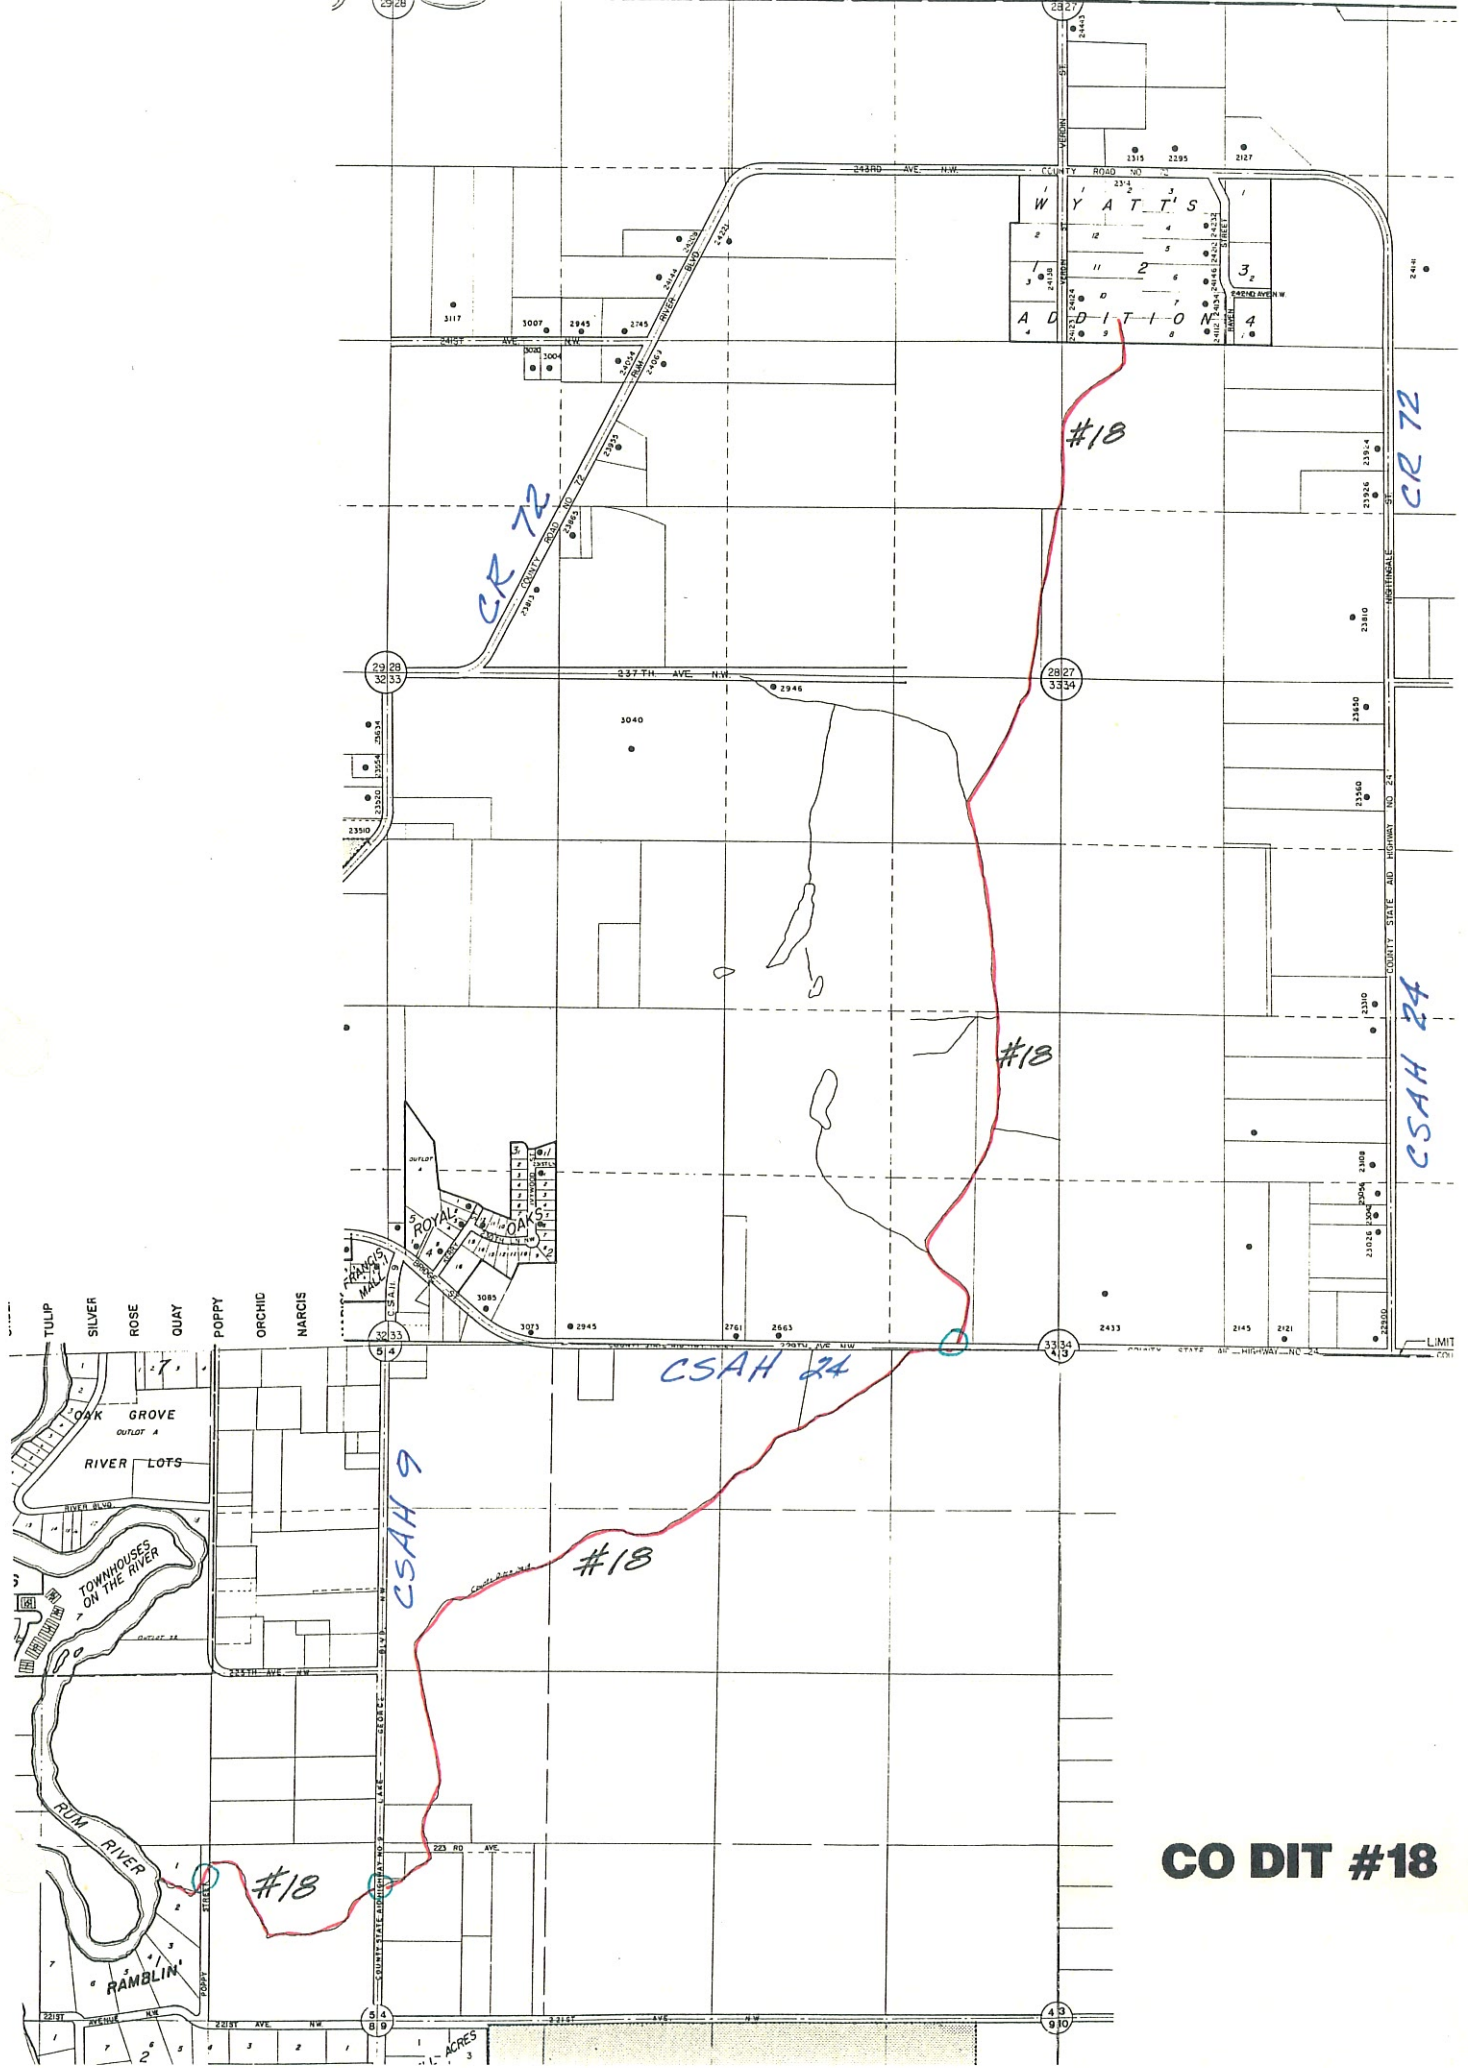
CO DIT #18

Poppy St.

Ditch defined & flowing.

#9

Ditch defined & overgrown
with grass - ditch flowing.

#24

Ditch defined - no apparent flow.
Ditch not blocked.
