ANOKA COUNTY
COUNTY DITCH INSPECTION REPORT

DITCH # 48

DATE: 7/7/94

COMMUNITIES:Oak Grove

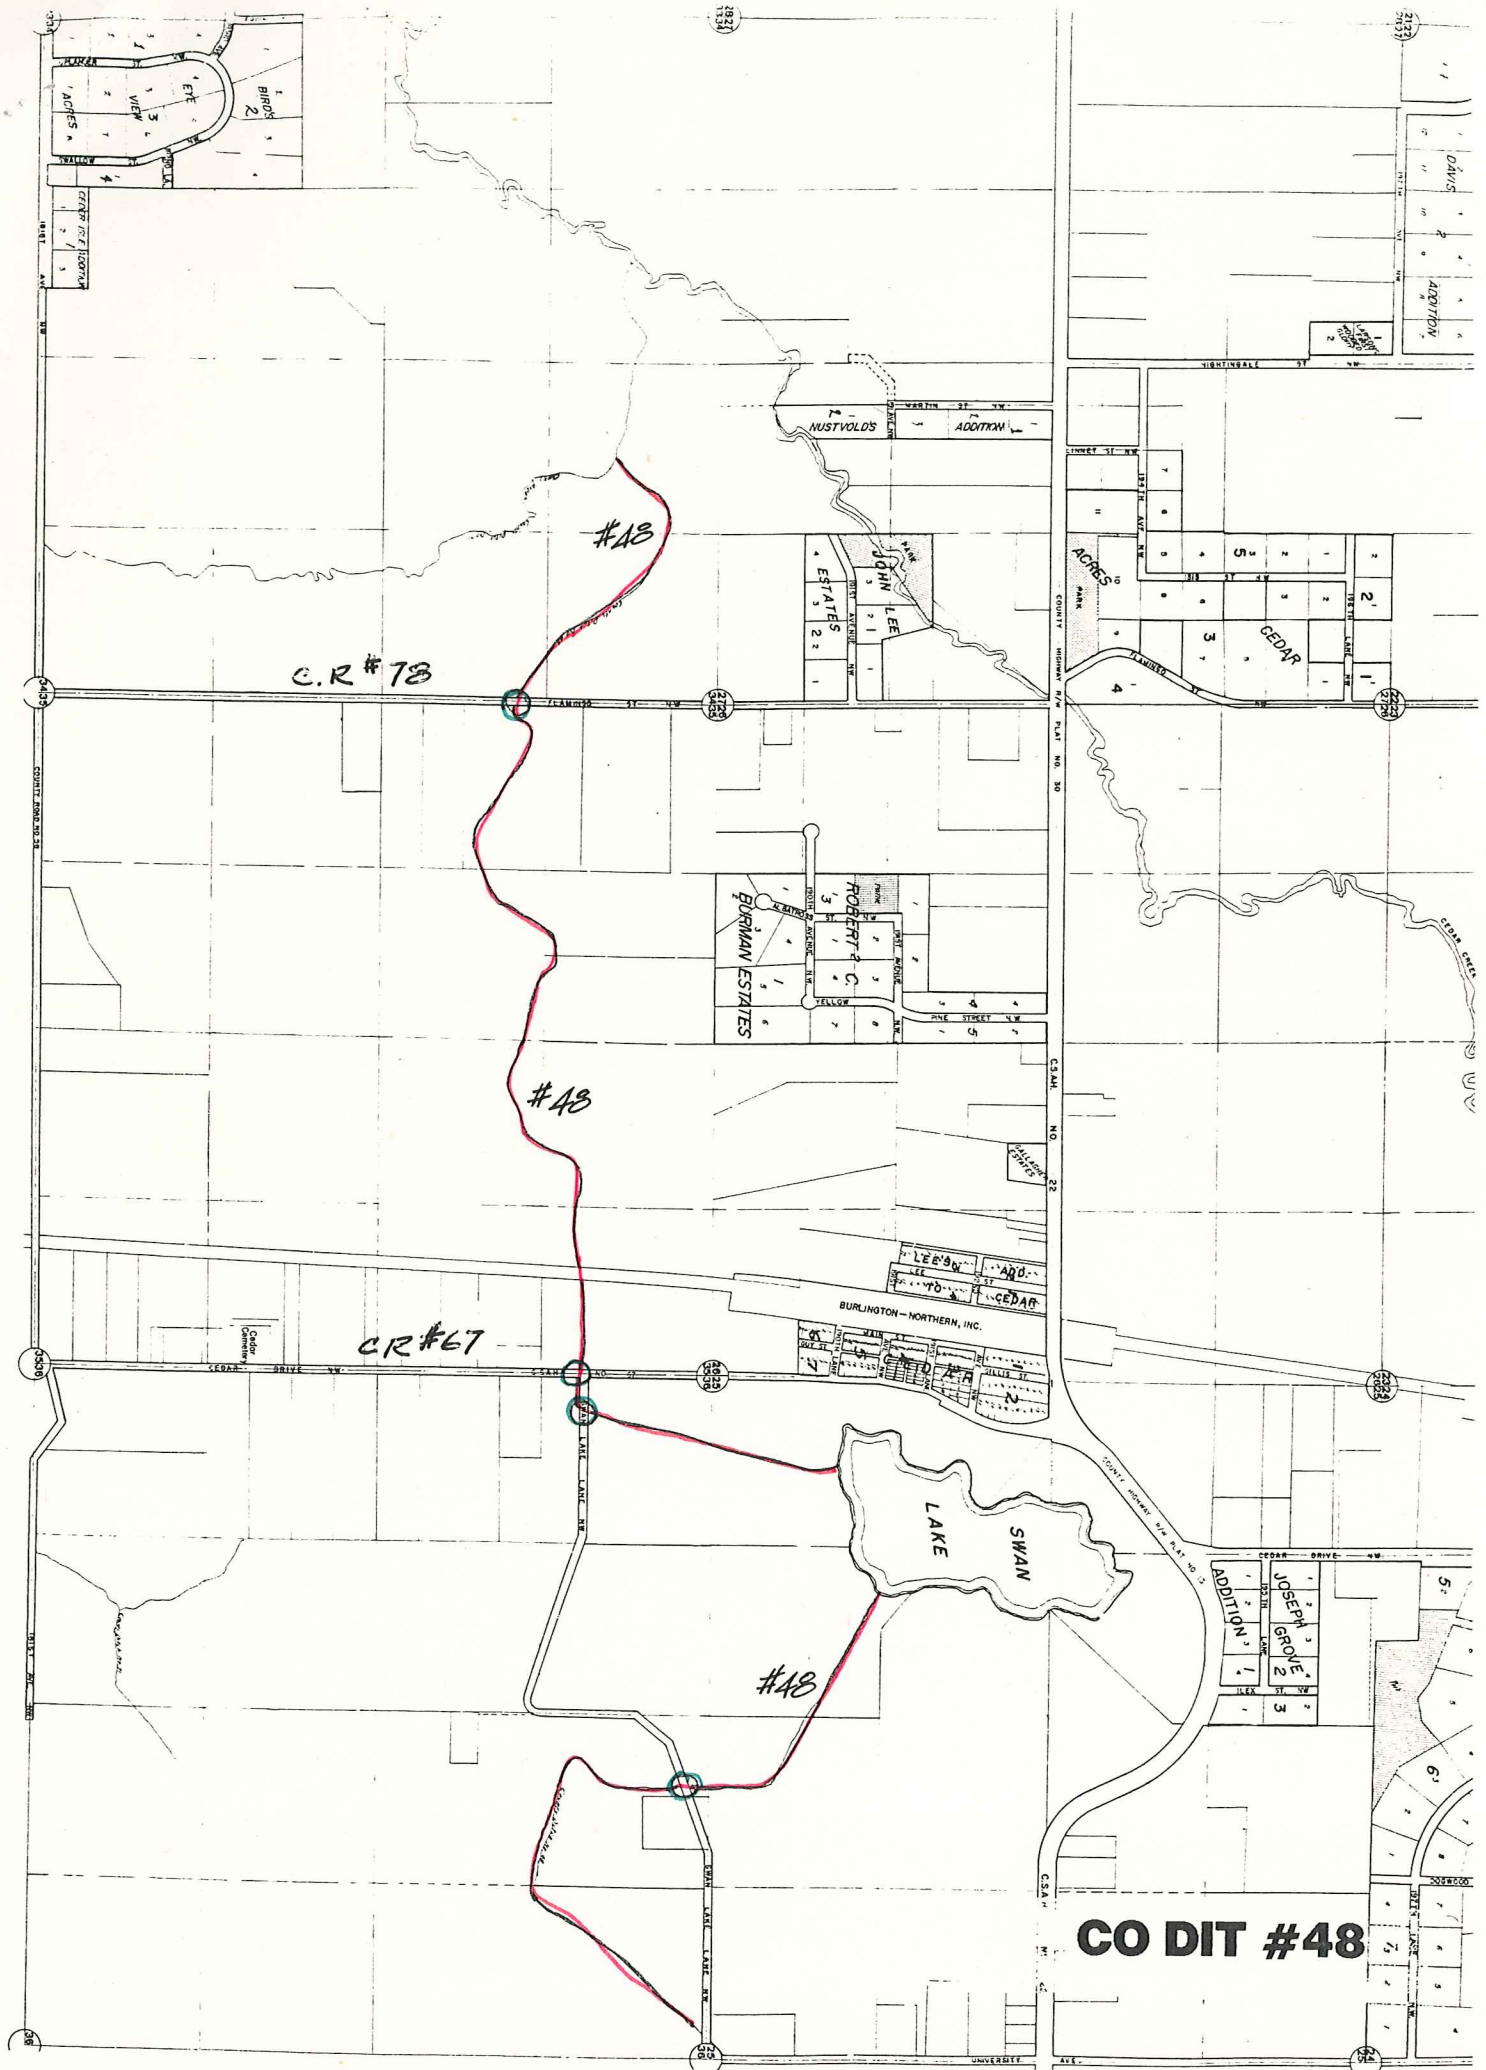
CO DIT #48

- C R # 78 (Flamingo St) Ditch defined in a deep channel but overgrown with grass and brush. Ditch is flowing.
- C R # 67 (Cedar Dr) Ditch defined and flowing. Trees laying in the ditch to the west.
- Swan Lk Dr (West) Ditch defined and flowing.
- Swan Lk Dr (East) Ditch on north side is defined. On the south side, a pond has been excavated in a marsh area. The ditch is visible further south but in poor repair.
