COUNTY DITCH #35

PUBLIC HEARING

On Obstructions in the Ditch

July 25th , 2013

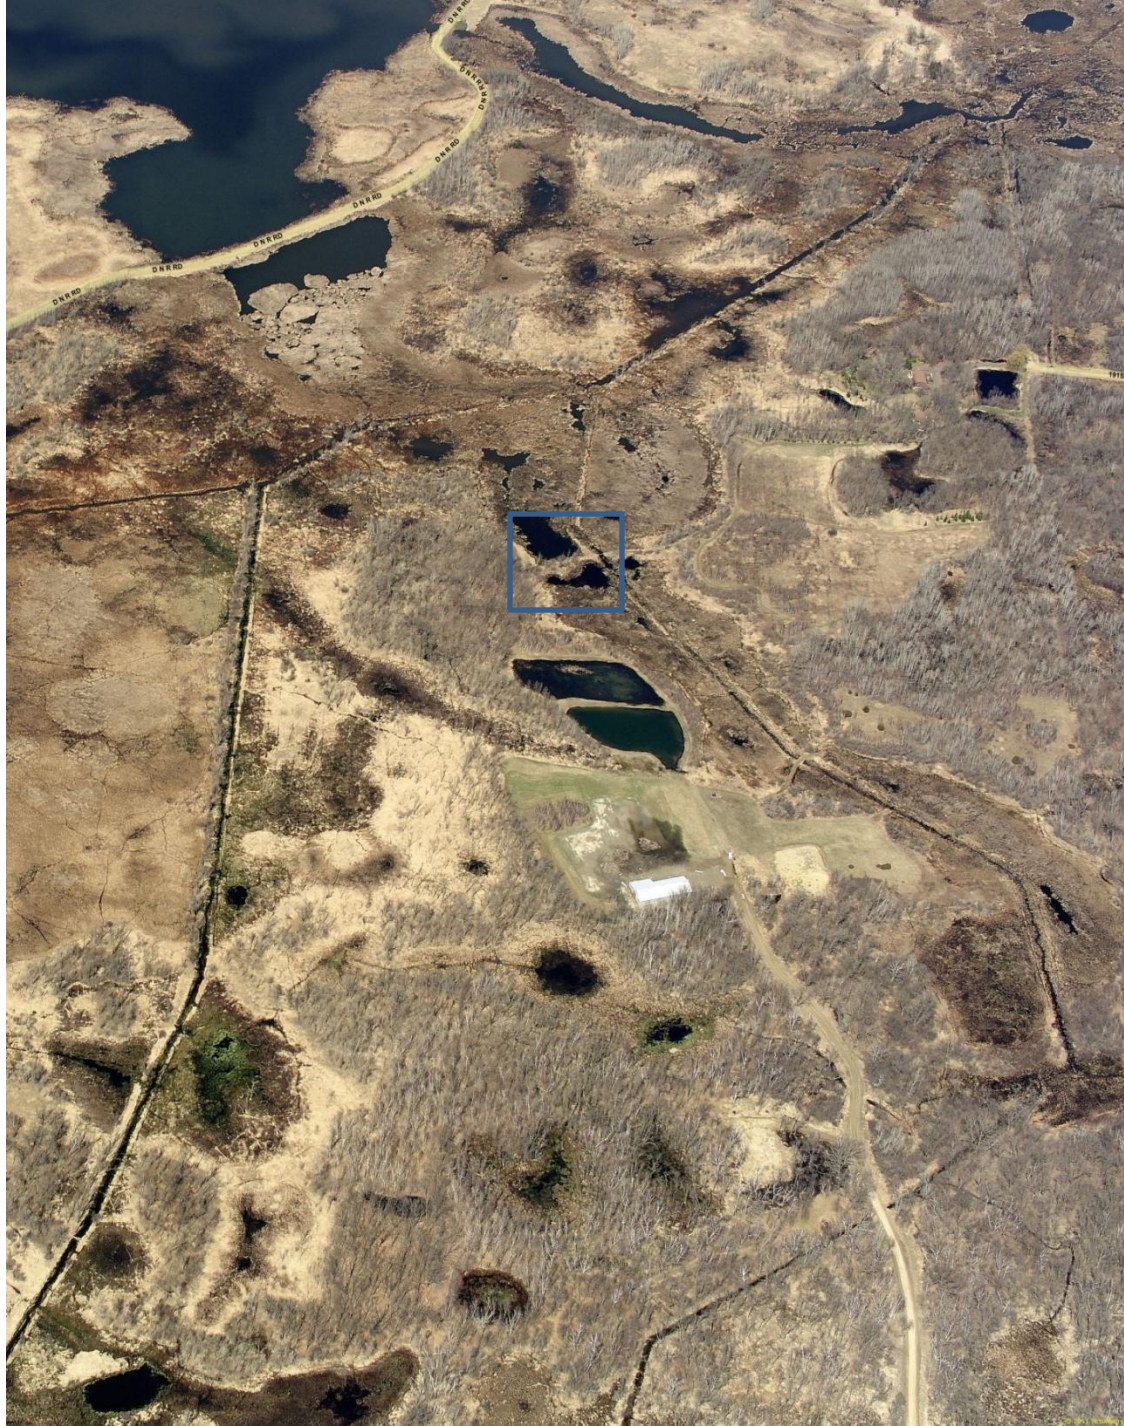
CULVERT 10 BRANCH 1

Bridge-3 - Branch No. 1	PIN 35-33-22-31-0005, Columbus, MN	09/11/2012											Bridge-3	Wooden Bridge Coordinates, Approximate Center: 197503 / 554394	None
Bridge-4 - Branch No. 1	18442 Loyola St. NE., MN	09/11/2012											Bridge-4	Wooden Bridge Coordinates, Approximate Center: 197870 / 554545	REMOVE OR REPLACE BRIDGE or 30" CULVERT
7 - Branch No. 1	PIN 35-33-22-21-0002, Columbus, MN	09/10/2012	RCP	24	19	good	no	0.7 / 0.1	889.2	889.4			7-Up / 7-Down		None
8 - Branch No. 1	PIN 35-33-22-21-0002, Columbus, MN	09/10/2012	CMP	30	40	good	dry	none	890.5	890.4			8-Up / 8-Down	Culvert has flared end section on each end.	None
9 - Branch No. 1	PIN 35-33-22-21-0002, Columbus, MN	09/10/2012	CMP	15	15	good	dry	none	888.9	888.8			9-Up / 9-Down-A, Down-B		REPLACE WITH 30"
10 - Branch No. 1	8538 191st Ave. NE., MN	09/11/2012	CMP	24	16	very poor	no	0.2 / 1.0	887.3 ± - GPS	886.4 ± GPS			10-Up-A, 10-Up-B / 10-Down- A, 10-Down-B	Culvert is rotted away. (See Pictures)	REMOVE OR REPLACE WITH 30"

Remove or replace culvert 10 with 30"

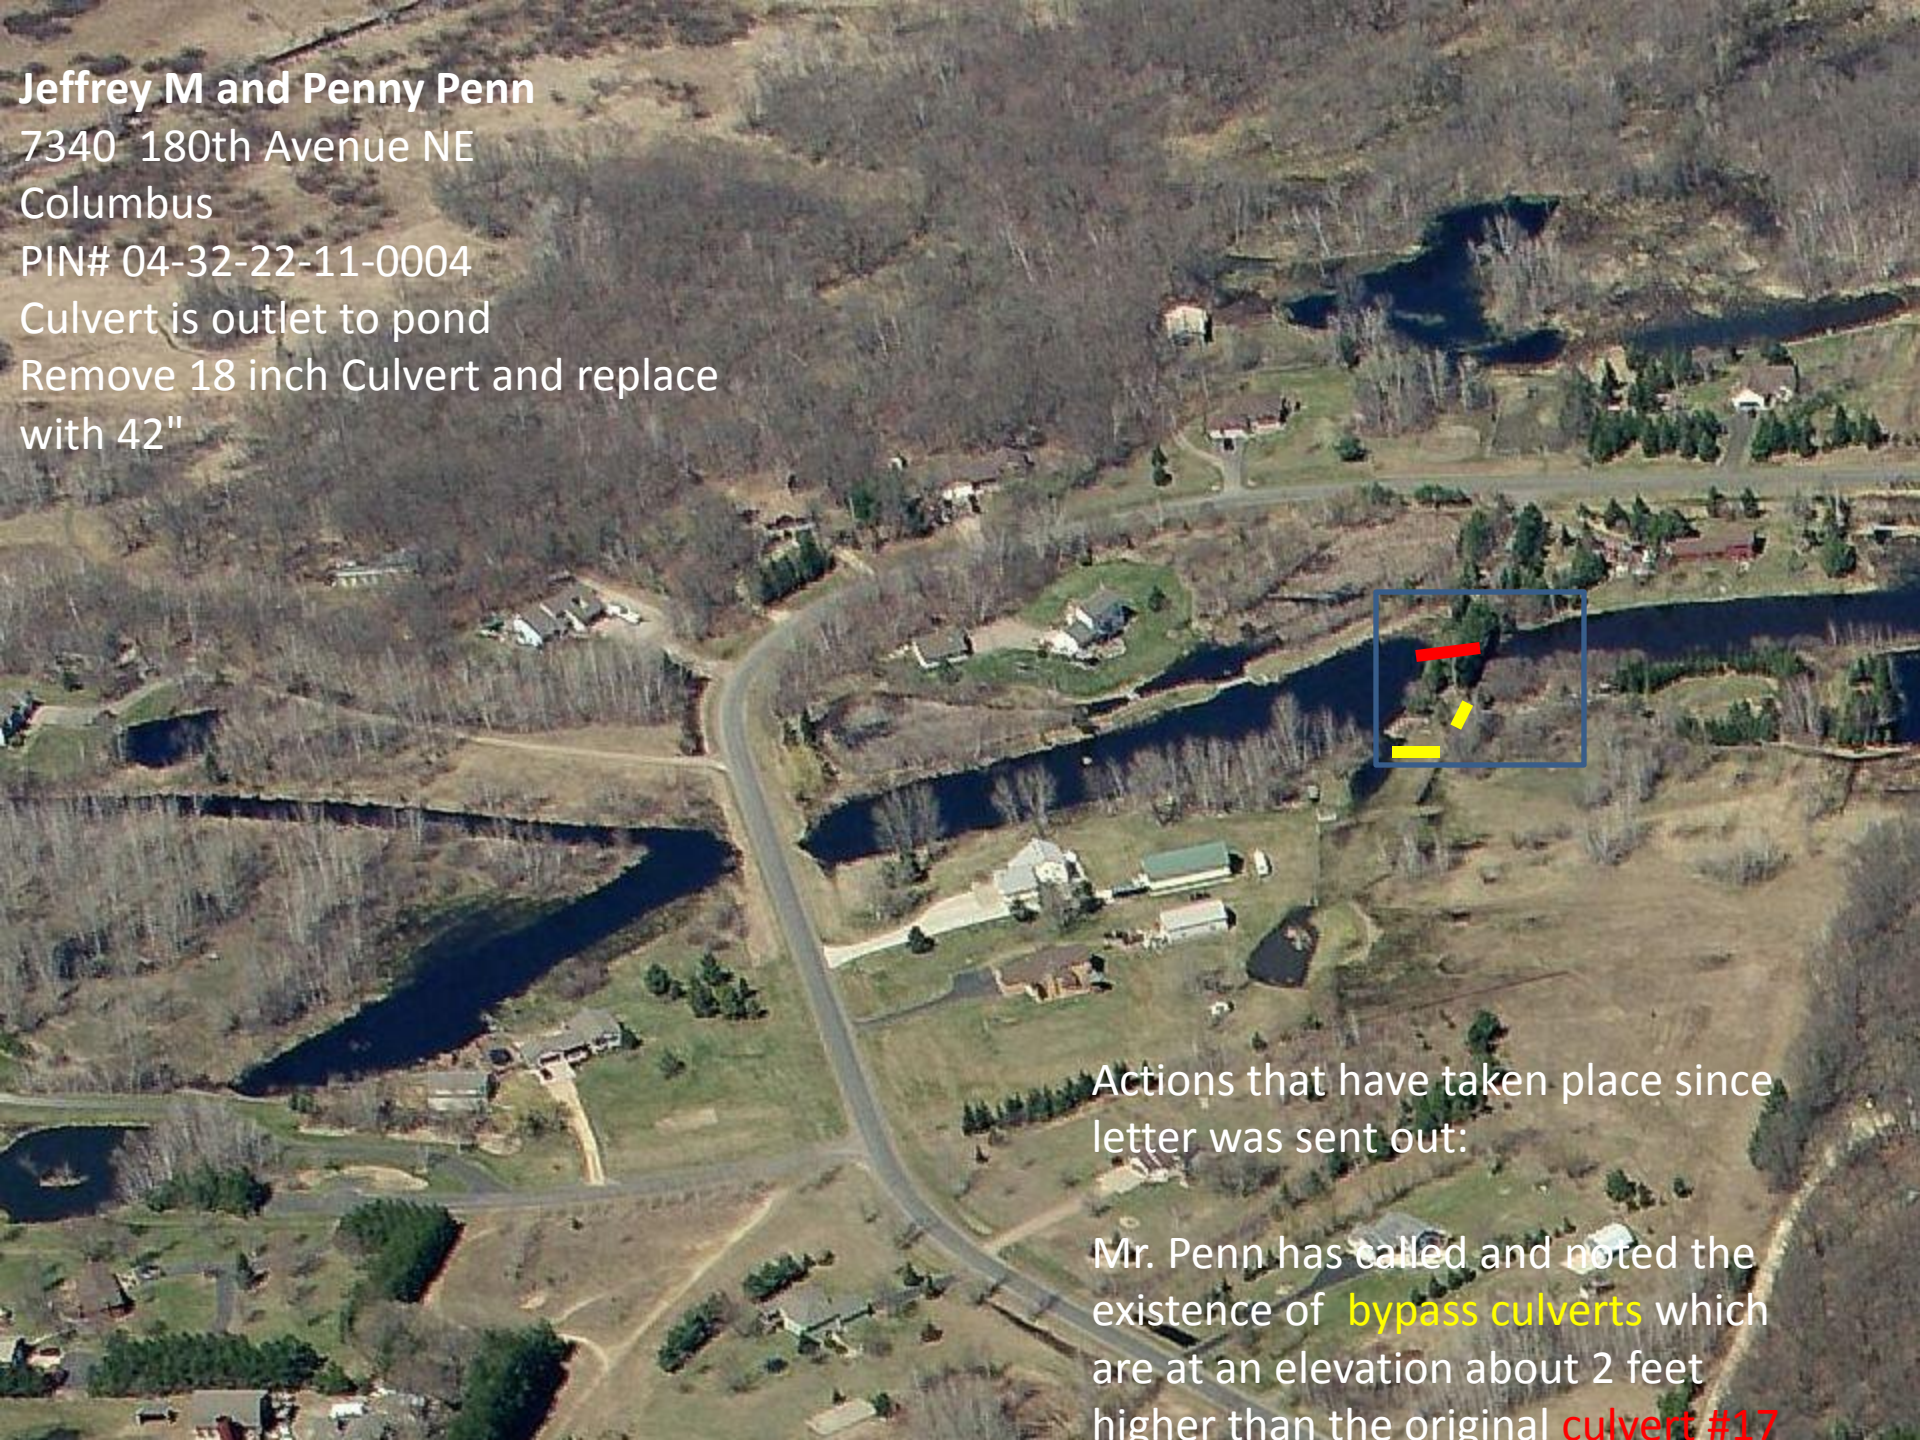
Culvert is outlet to pond

Mr. Penn has called and noted the existence of **bypass culverts** which are at an elevation about 2 feet higher than the original **culvert #17**

Remove 18 inch Culvert and replace

with 42"

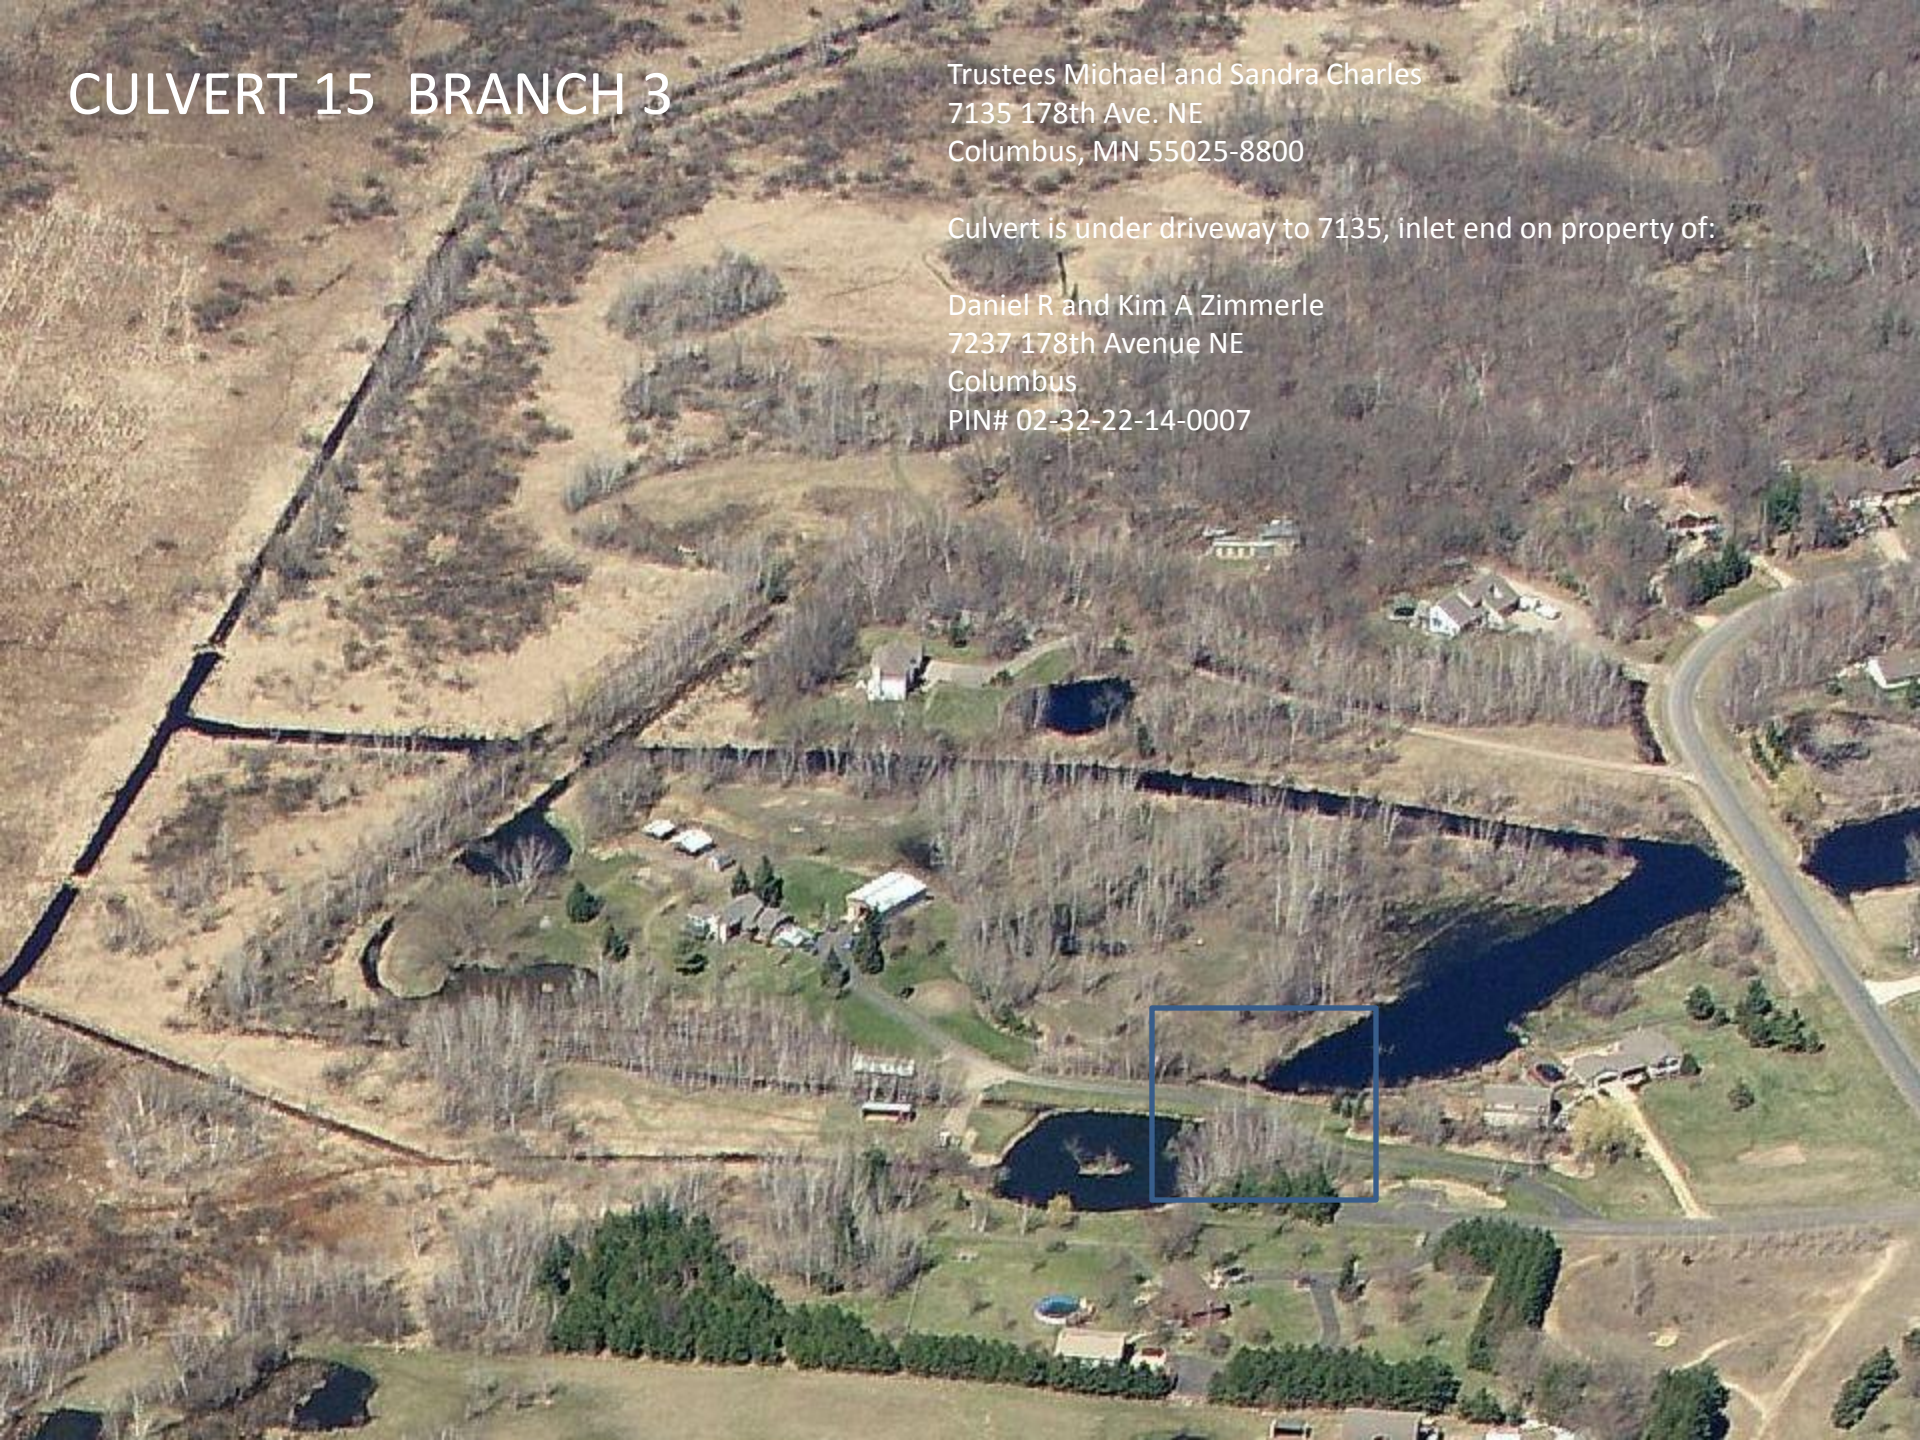
CULVERT 15 BRANCH 3

Culvert is under driveway to 7135, inlet end on property of:

Daniel R and Kim A Zimmerle
7237 178th Avenue NE
Columbus
PIN# 02-32-22-14-0007

Culvert is outlet to pond
Remove 15 inch culvert 15 and replace with 30"

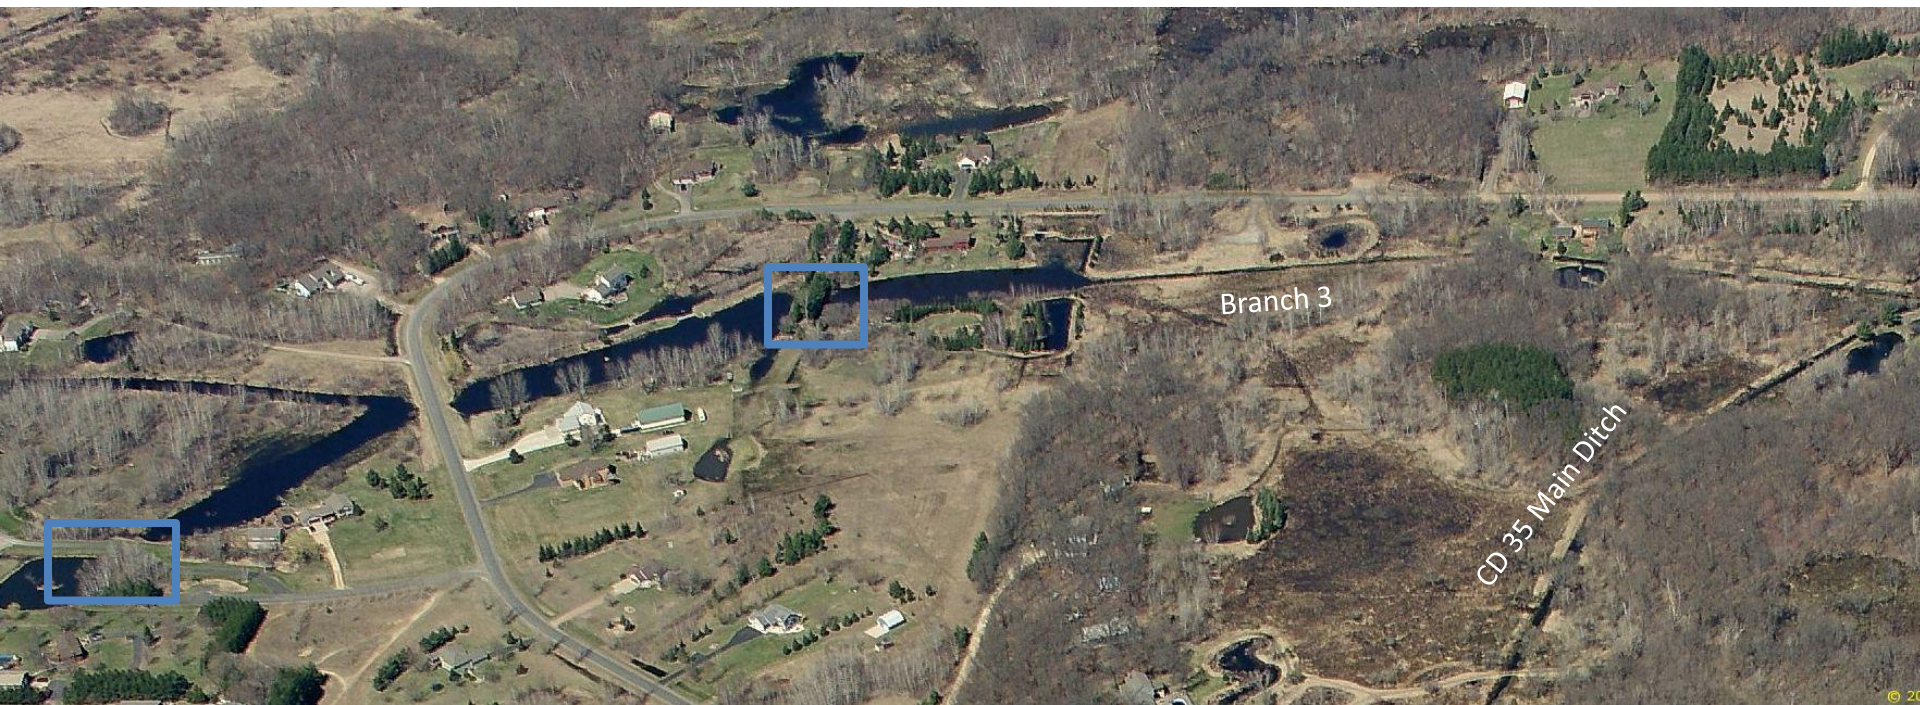
CULVERTS 15 AND 17, ARE ON BRANCH 3 OF COUNTY DITCH 35. THE RESIDENTS HAVE DEVELOPED A SERIES OF PONDS ON THE DITCH AND EVEN AERATE ONE OF THE PONDS. I BELIEVE THESE PONDS HAVE NO EFFECT ON THE MAIN DITCH. I WOULD SUGGEST A LETTER ADVISING THEM THAT THEIR PONDS ARE ON A COUNTY DITCH AND THAT, IN THE UNLIKELY EVENT THAT A PROPERTY OWNER TO THE WEST OF THEM WANTS THE DRAINAGE THEY ARE ENTITLED TO, THESE OWNERS WOULD BE ORDERED TO RESTORE THE DRAINAGE. AN OPTION HERE WOULD BE TO SUGGEST THAT THE OWNERS INVOLVED PETITION TO HAVE BRANCH 3 ABANDONED UNDER MN STATUTE 103E.806 WEST OF THE NORTHWARD EXTENSION OF THE EAST R/W OF POTOMAC STREET.
