# COUNTY DITCH #35

Discussion on obstructions in the  
Ditch

May 28, 2013

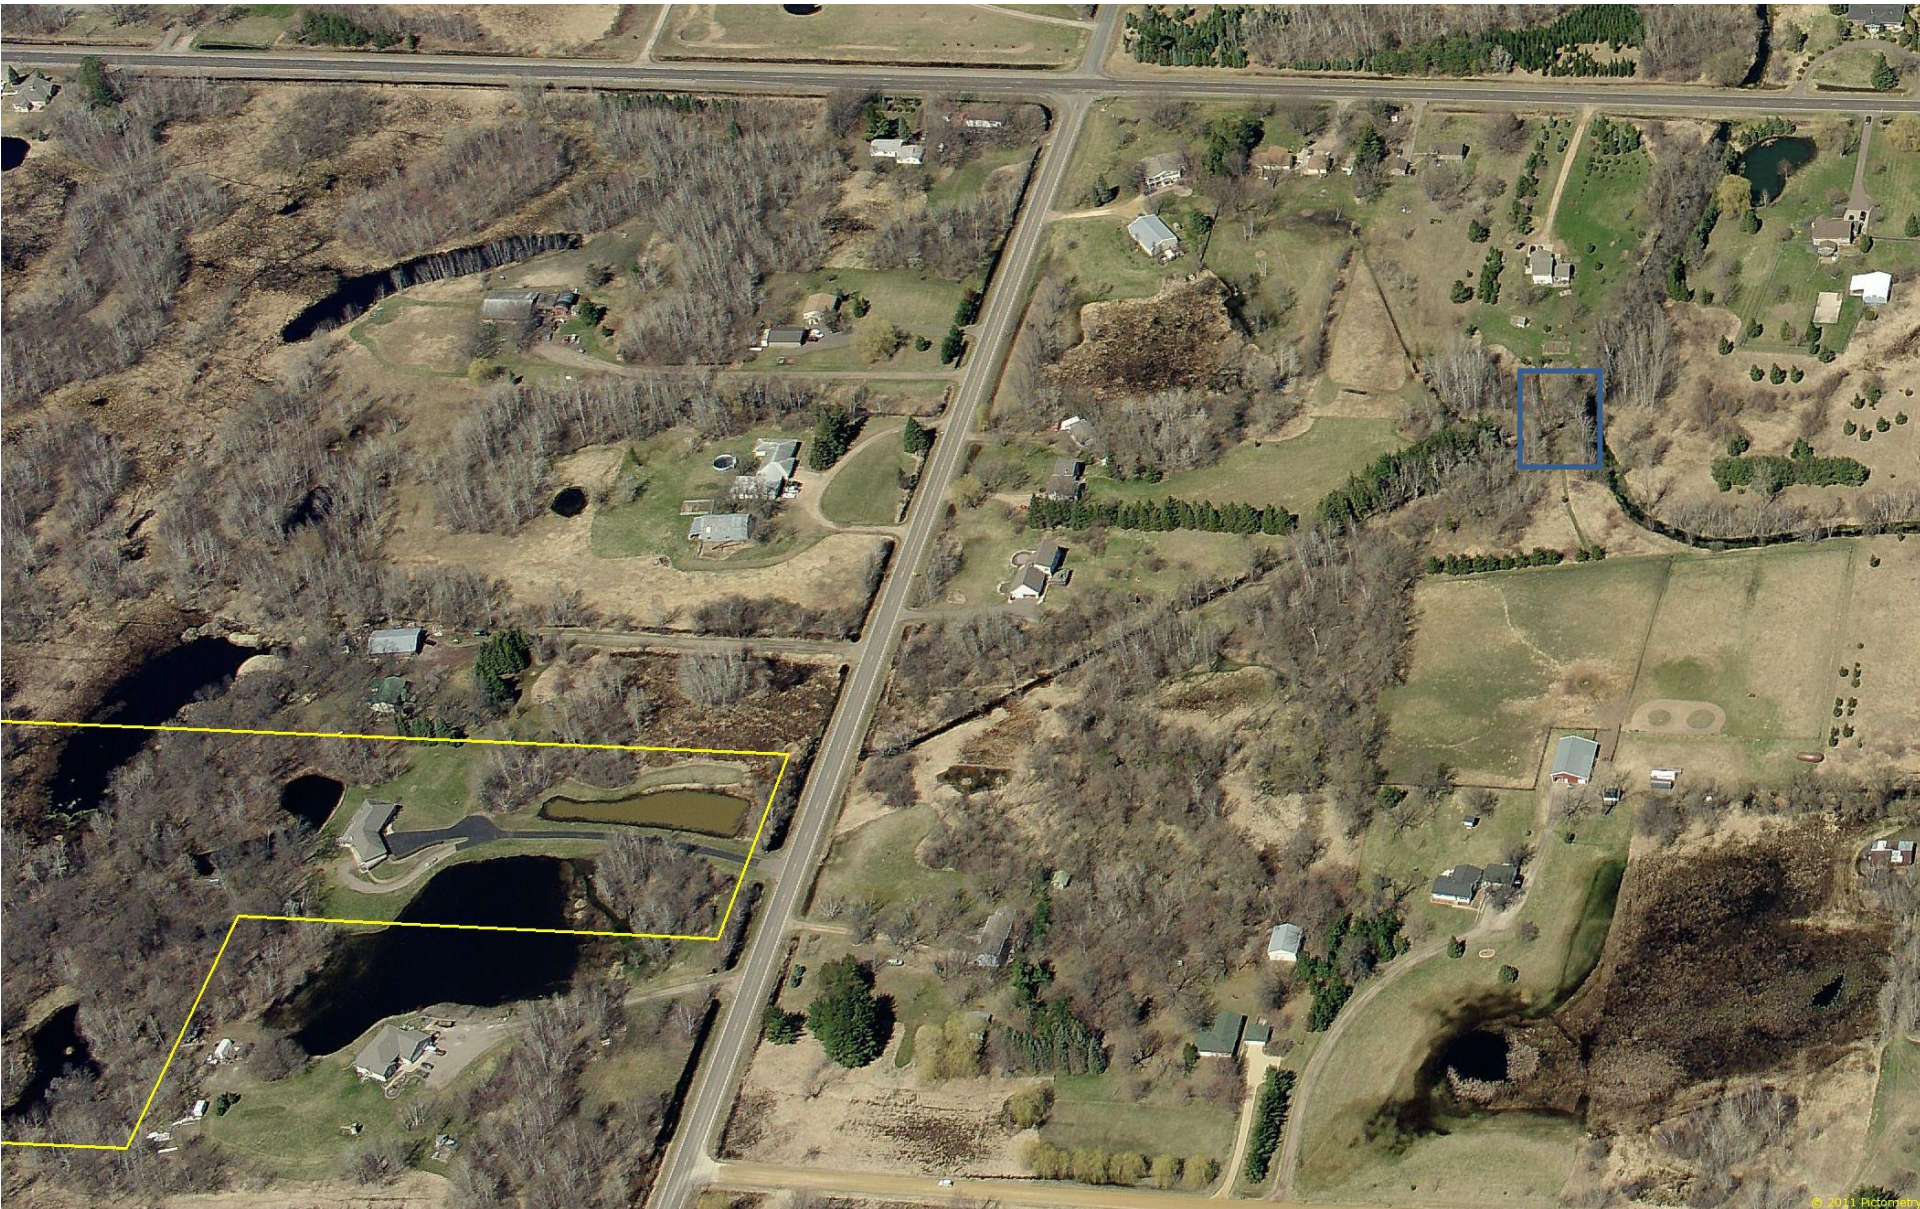
# CULVERTS 2 & 3 MAIN DITCH

Culvert Number	Culvert Location (Cross street or Address)	Date Visited	Culvert Material	Culvert Size (inches)	Culvert Length (feet)	Culvert Condition	Culvert Flowing	Amount of Silt (feet) Up / Down	Upstream Invert Elev. (NGVD 29)	Downstream Invert Elev. (NGVD 29)	Benchmark Location crossings only) (on Road	Benchmark Elevation (NGVD 29)	Picture File Names	Notes	Recommendations
1	County Road No. 19 (Potomac Street), Columbus, MN	09/20/2012	CMP	36	50	good	yes	0.2 / 0.2	898.6	898.5	Anoka County BM at the SE corner of C.S.A.H. No. 18 & County Road No. 19 Rod in ground (Blue 26)	905.03	1-Up / 1-Down	Culvert has flared end section on each end.	None
2	7606 West Broadway Ave., Columbus, MN	09/19/2012	CMP	15	16	poor	dry	0.3 / 0	898.8	898.9			2-Up / 2-Down		REPLACE WITH 36" LOWERE 0.5 FEET
3	7606 West Broadway Ave., Columbus, MN	09/19/2012	RCP	37	9				898.0	898.4			3-Up / 3-Down	Culvert sections are separated and are sitting in ditch. (See Pictures)	REMOVE OR REPLACE WITH 36"

Remove or replace culvert 2, replace 0.5 feet lower with 36 inch

Remove or replace culvert 3, replace at current grade with 36 inch

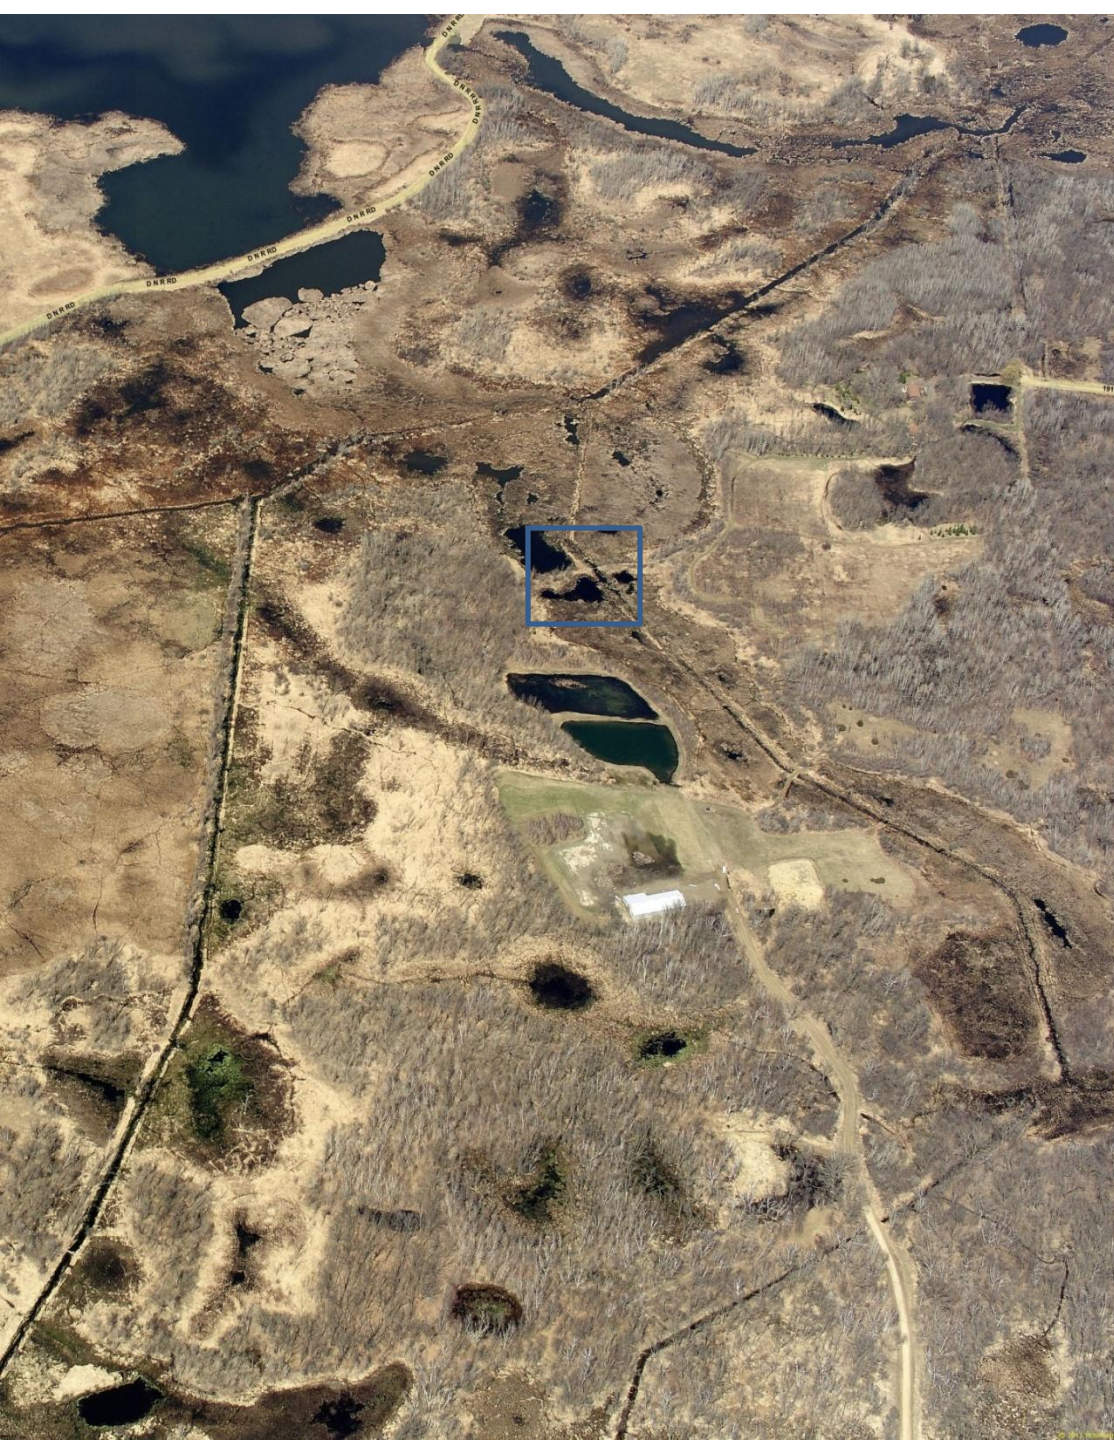
CULVERT 10 BRANCH 1

Bridge-3 - Branch No. 1	PIN 35-33-22-31-0005, Columbus, MN	09/11/2012											Bridge-3	Wooden Bridge Coordinates, Approximate Center: 197503 / 554394	None
Bridge-4 - Branch No. 1	18442 Loyola St. NE., Columbus, MN	09/11/2012											Bridge-4	Wooden Bridge Coordinates, Approximate Center: 197870 / 554545	REMOVE OR REPLACE BRIDGE or 30" CULVERT
7 Branch No. 1	PIN 35-33-22-21-0002, Columbus, MN	09/10/2012	RCP	24	19	good	no	0.7 / 0.1	889.2	889.4			7-Up / 7-Down		None
8 Branch No. 1	PIN 35-33-22-21-0002, Columbus, MN	09/10/2012	CMP	30	40	good	dry	none	890.5	890.4			8-Up / 8-Down	Culvert has flared end section on each end.	None
9 Branch No. 1	PIN 35-33-22-21-0002, Columbus, MN	09/10/2012	CMP	15	15	good	dry	none	888.9	888.8			9-Up / 9-Down-A, Down-B		REPLACE WITH 30"
10 Branch No. 1	8538 191st Ave. NE., Columbus, MN	09/11/2012	CMP	24	16	very poor	no	0.2 / 1.0	887.3 ± - GPS	886.4 ± GPS			10-Up-A, 10-Up-B / 10-Down- A, 10-Down-B	Culvert is rotted away. (See Pictures)	REMOVE OR REPLACE WITH 30"

James L Goergen and L A Walters  
8538 191st Avenue NE  
PIN # 26-33-22-34-0001  
Remove or replace culvert 10 with 30"

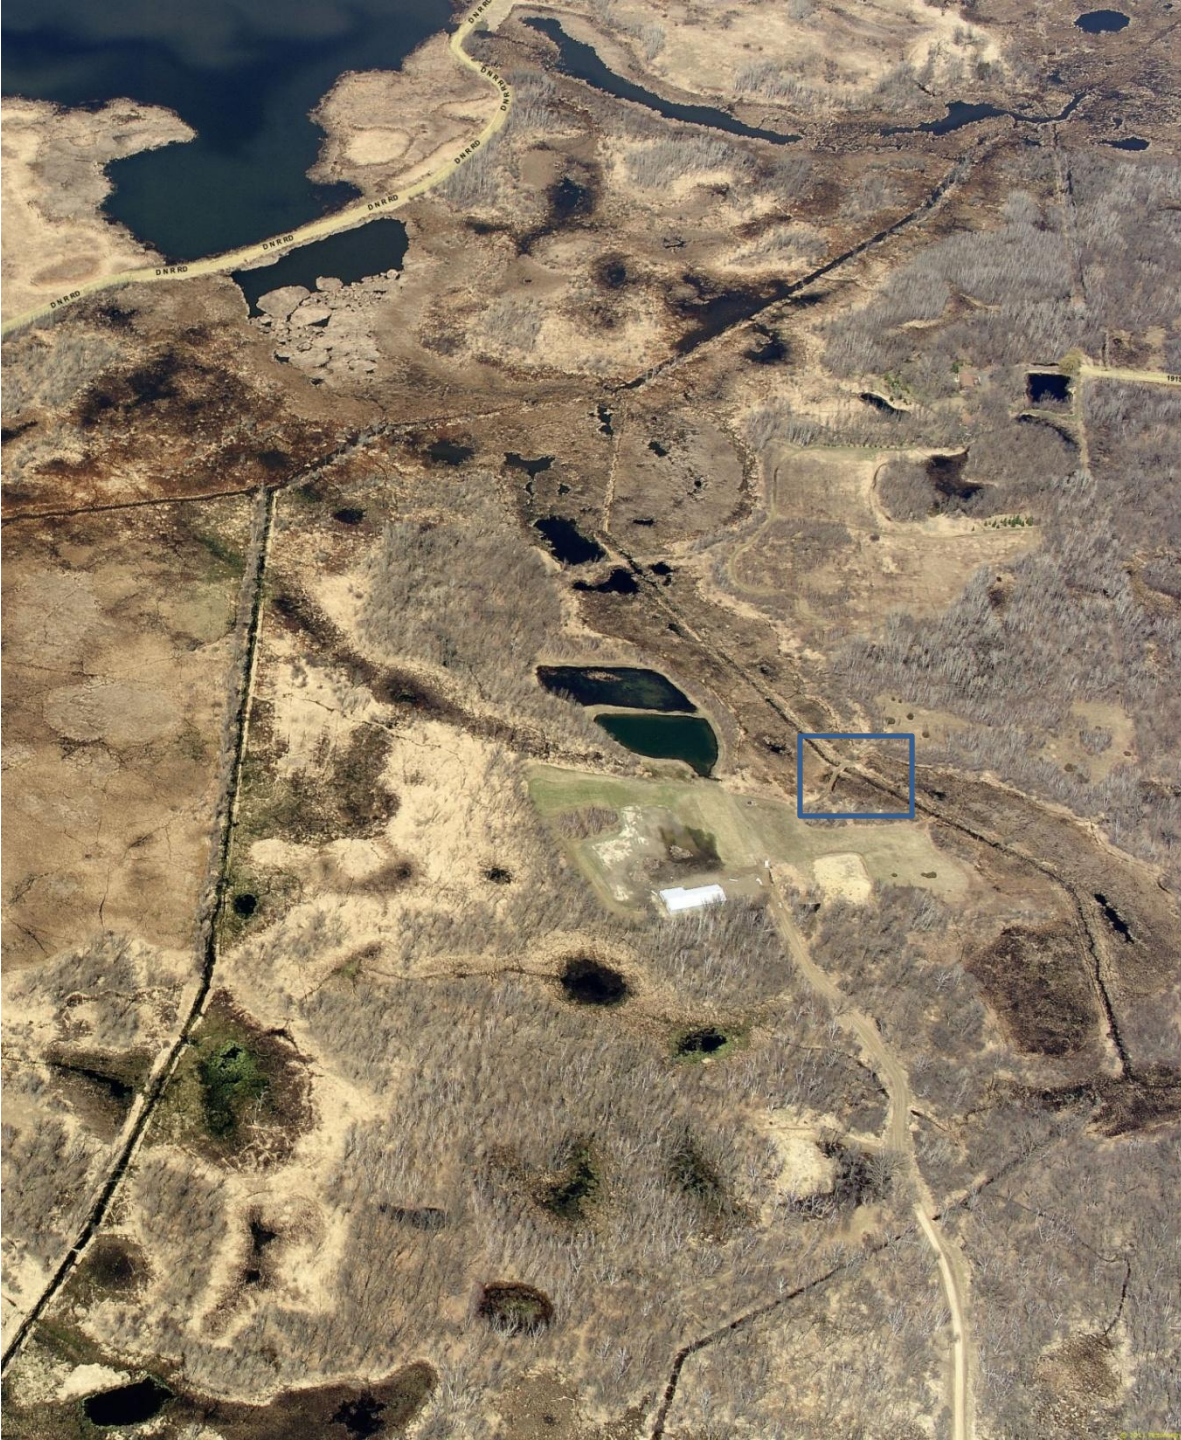
CULVERT 9 BRANCH 1

Bridge 4 while in bad shape is located in an area of the ditch with a lot of fall, about 3.5 feet in 500 feet. Effect on drainage very localized, no impact on main ditch. Culvert 9 is in the same situation however is g

**John Gross**  
PIN # 35-33-22-21-0002  
Remove or replace culvert 9 with 30"

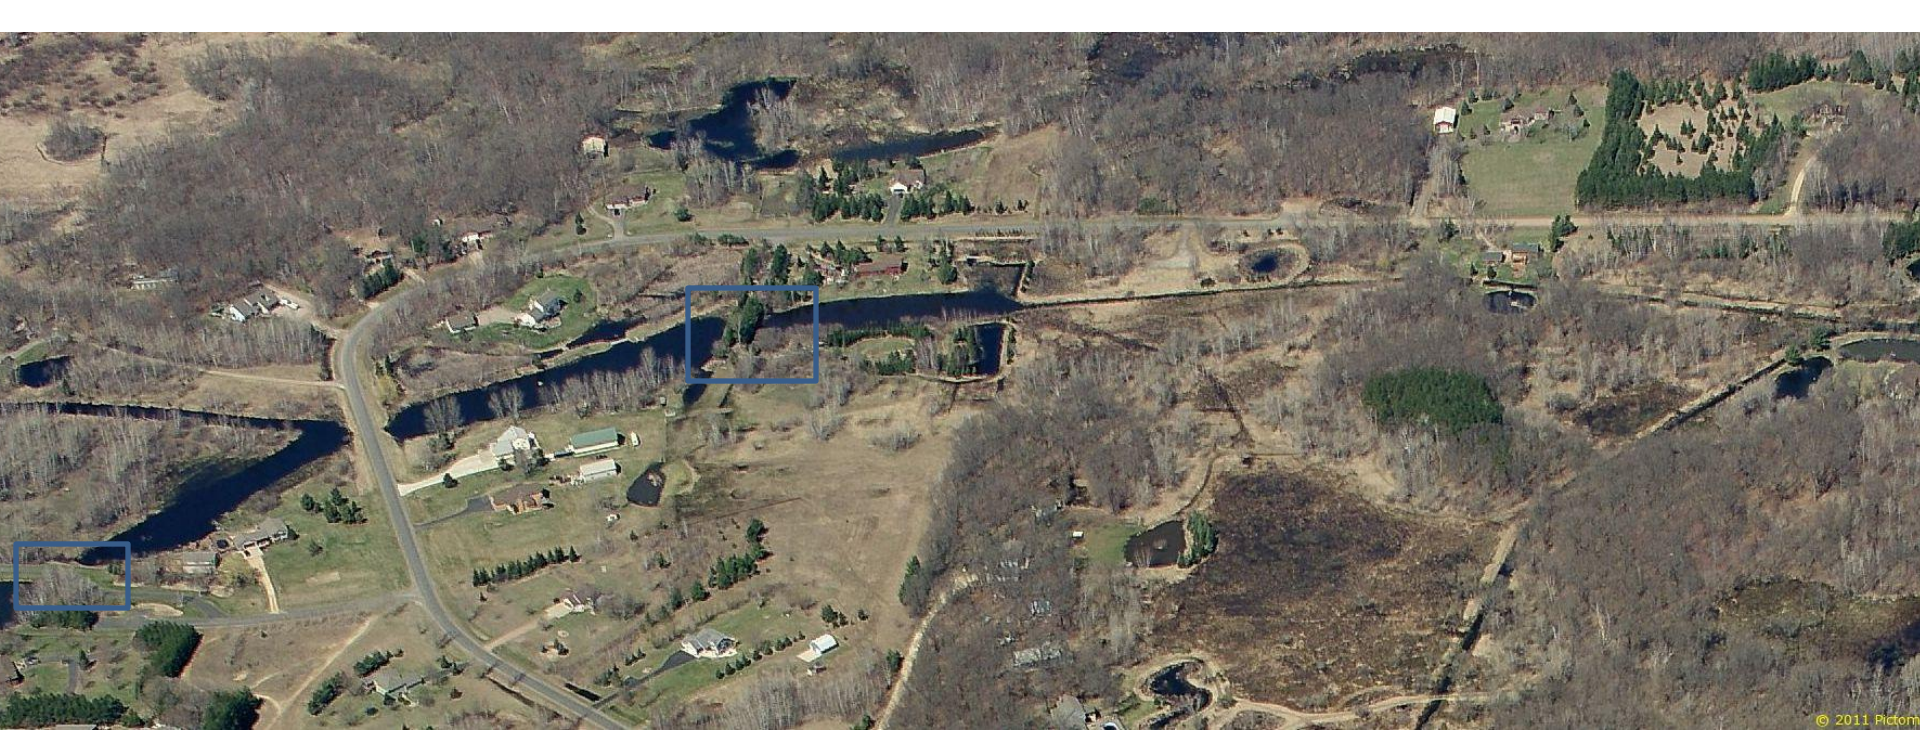
CULVERTS 15 AND 17, ARE ON BRANCH 3 OF COUNTY DITCH 35. THE RESIDENTS HAVE DEVELOPED A SERIES OF PONDS ON THE DITCH AND EVEN AIREATE ONE OF THE PONDS. I BELIEVE THESE PONDS HAVE NO EFFECT ON THE MAIN DITCH. I WOULD SUGGEST A LETTER ADVISING THEM THAT THEIR PONDS ARE ON A COUNTY DITCH AND THAT, IN THE UNLIKELY EVENT THAT A PROPERTY OWNER TO THE WEST OF THEM WANTS THE DRAINAGE THEY ARE ENTITLED TO, THESE OWNERS WOULD BE ORDERED TO RESTORE THE DRAINAGE. AN OPTION HERE WOULD BE TO SUGGEST THAT THE OWNERS INVOLVED PETITION TO HAVE BRANCH 3 ABANDONED UNDER MN STATUTE 103E.806 WEST OF THE NORTHWARD EXTENSION OF THE EAST R/W OF POTOMAC STREET.
