# ANOKA COUNTY

## COUNTY DITCH INSPECTION REPORT

**DITCH # 42**

**DATE: 7/18/94**

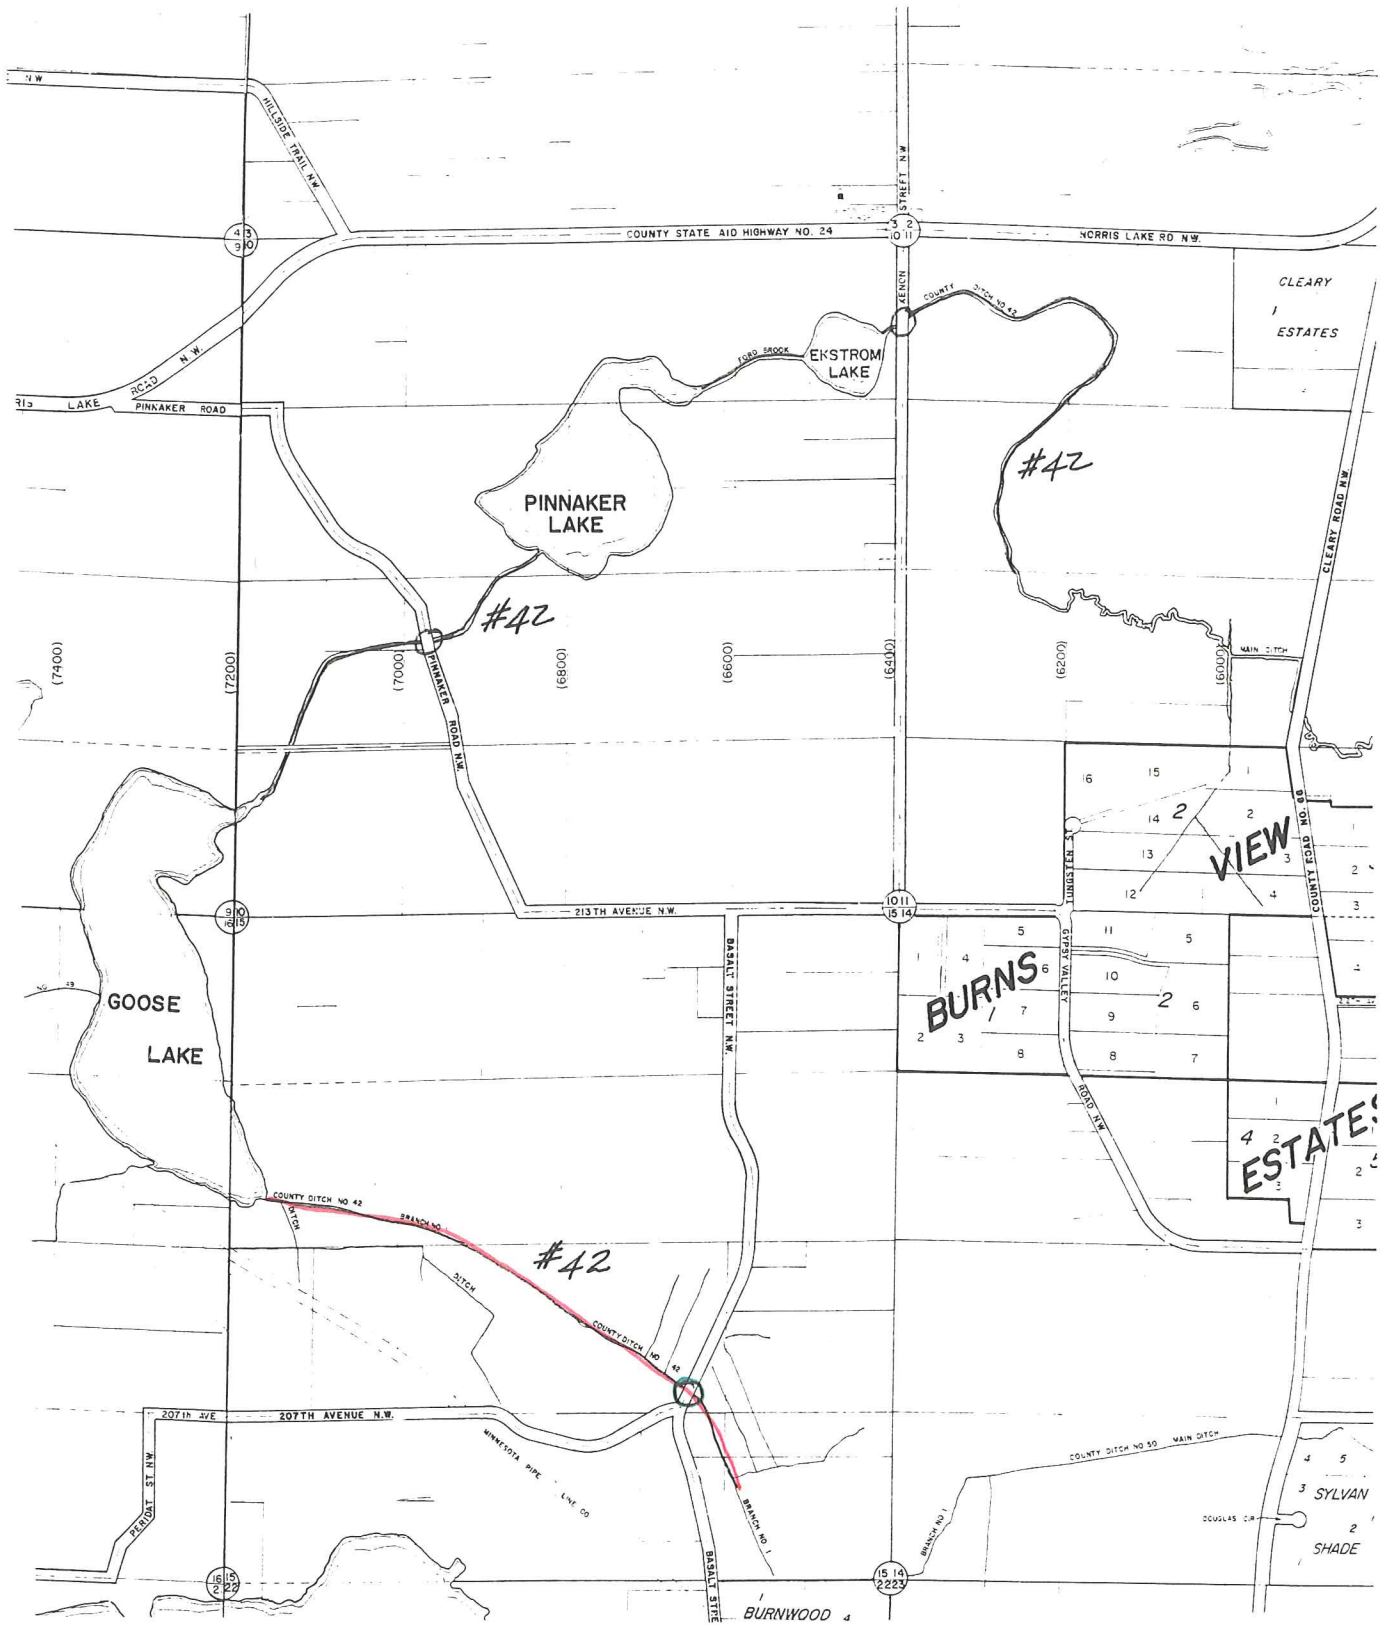
**CO DIT #42**

Xenon St	Good flow to the east thru a well defined ditch. Ekstrom Lake abuts the west side of the street.
Pinnaker Road	Ditch well defined and flowing. Tree laying in the ditch, in water, east of the road. Other trees and brush over-hanging the ditch.
Basalt Street	Ditch defined but overgrown with canary grass. Some use of meadow on each side of the road for hay.
