# CERTIFICATE OF LOCATION OF GOVERNMENT CORNER

County of Anoka

## West 1/4 Corner of Sec. 13 Township 32 Range 25

# HISTORY OF GOVERNMENT CORNER

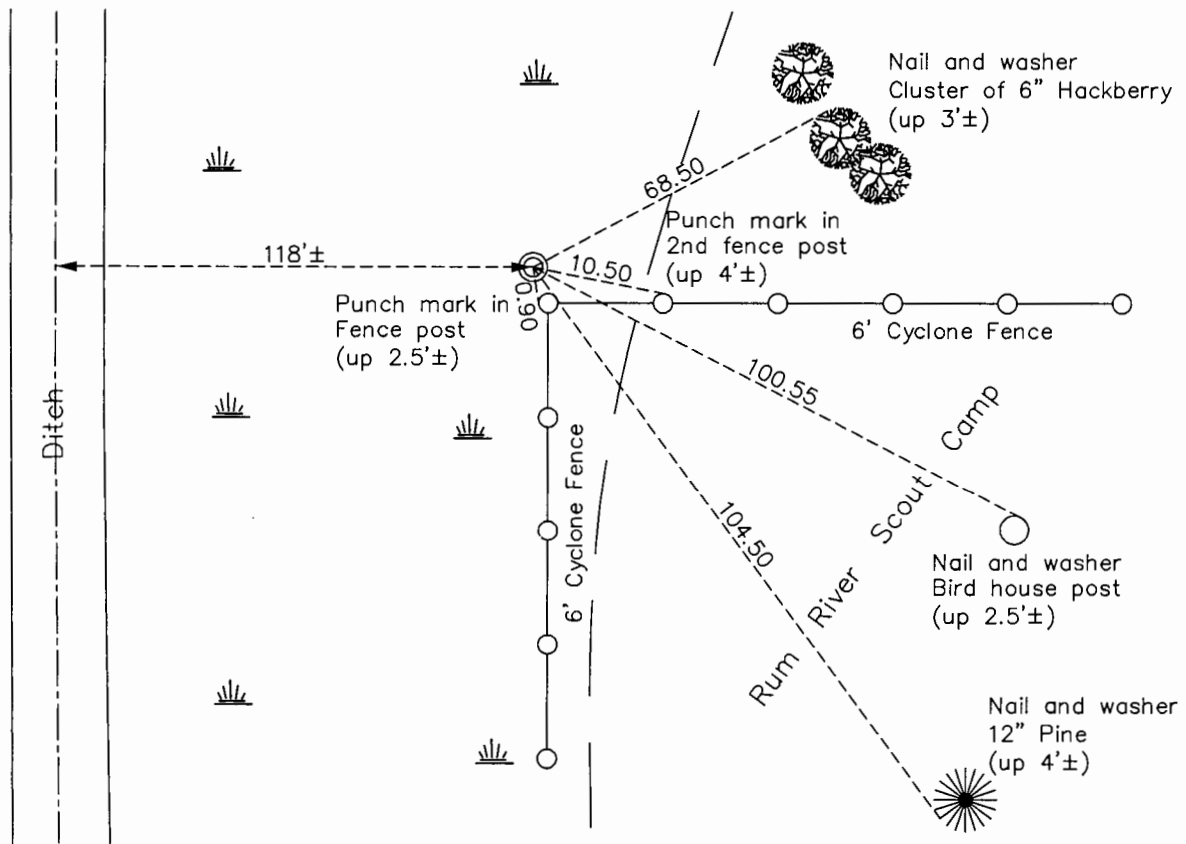
AND on the 1st day of October, 2015, said permanent marker was found 1.5" Red and white iron pipe rusted off 0.6' above ground and the ties were updated

Updated reference ties are as shown below.
