CERTIFICATE OF LOCATION OF GOVERNMENT CORNER

North 1/4 Corner of Sec. 5 Township 32 Range 24

HISTORY OF GOVERNMENT CORNER

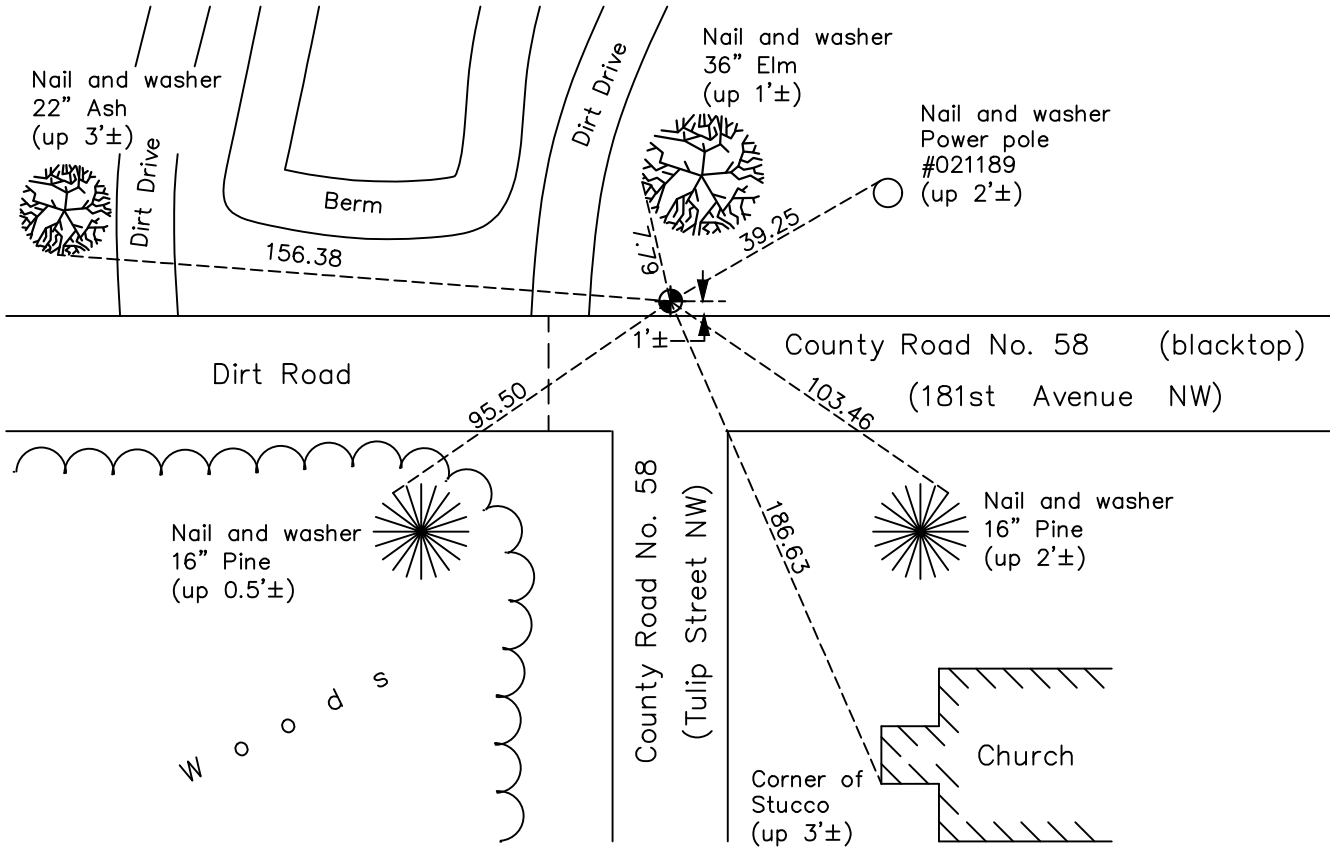
AND on the 24th day of September, 2020, said permanent marker was found 0.7'± down in class 5 and the ties were updated

Updated reference ties are as shown below.
