### CERTIFICATE OF LOCATION OF GOVERNMENT CORNER

# North 1/4 Corner of Sec. 17 Township 32 Range 24

### HISTORY OF GOVERNMENT CORNER

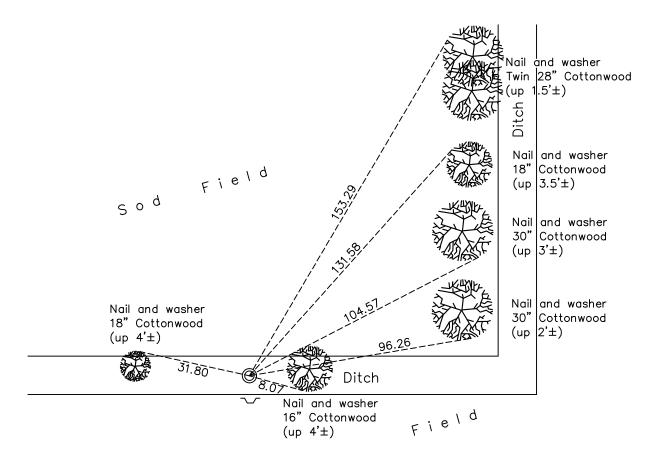
AND on the 9th day of October, 2020, said permanent marker was found with a sign and post south of the monument and ties were updated.

Updated reference ties are as shown below.

October 9, 2020 — Found 2" red and white iron pipe with sign and post  $2'\pm$  south of monument. Updated ties
