CERTIFICATE OF LOCATION OF GOVERNMENT CORNER

County of Anoka

Northeast Corner of Sec. 5 Township 30 Range 23
(RAMSEY COUNTY MONUMENT)

NORTHEAST Corner of Sec. 5 Township 30 ~~31~~ Range 23

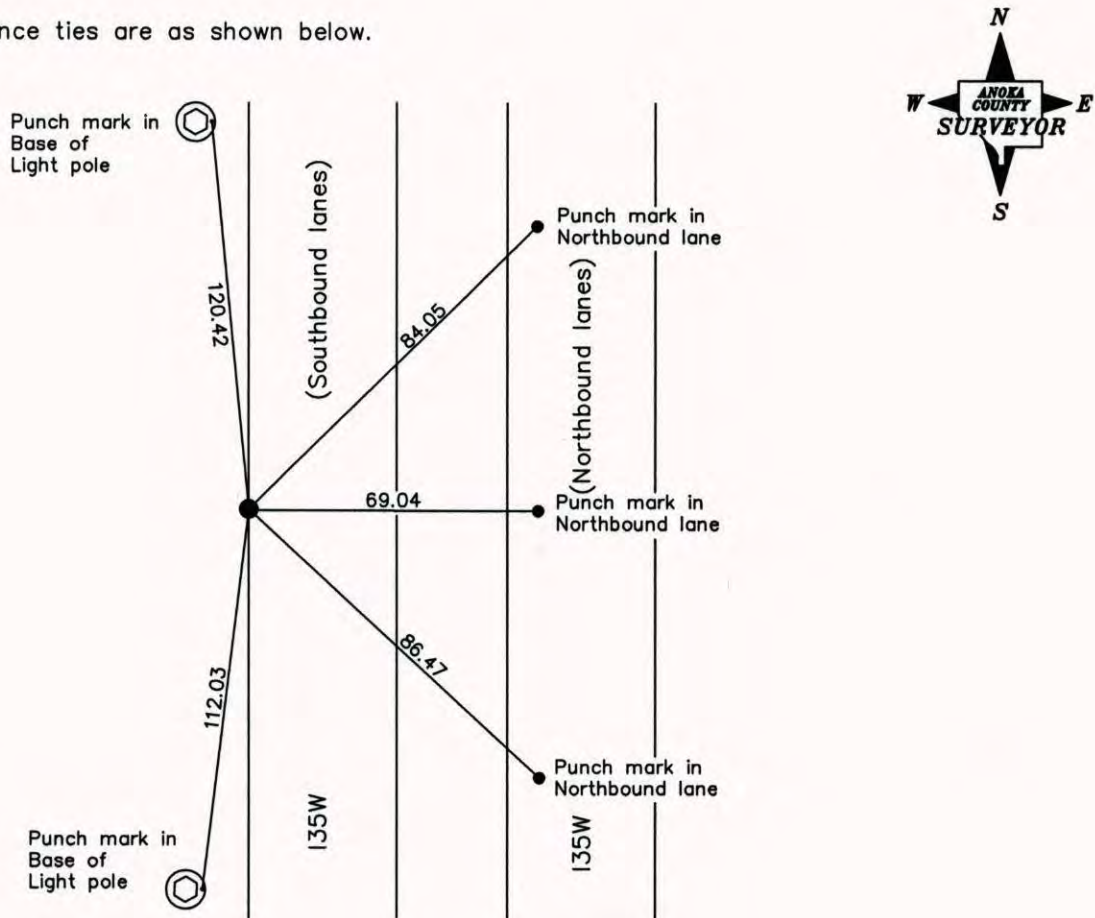
On the 2nd day of October, 1968, the described corner was evidenced by a granite monument

and to perpetuate the location of said corner, at the exact location thereof, a permanent marker was placed consisting of a 3" brass plug epoxied into a seam on the west edge of Southbound I35W

AND on the 3rd day of August, 1999, said permanent marker was not able to be found

Updated reference ties are as shown below.

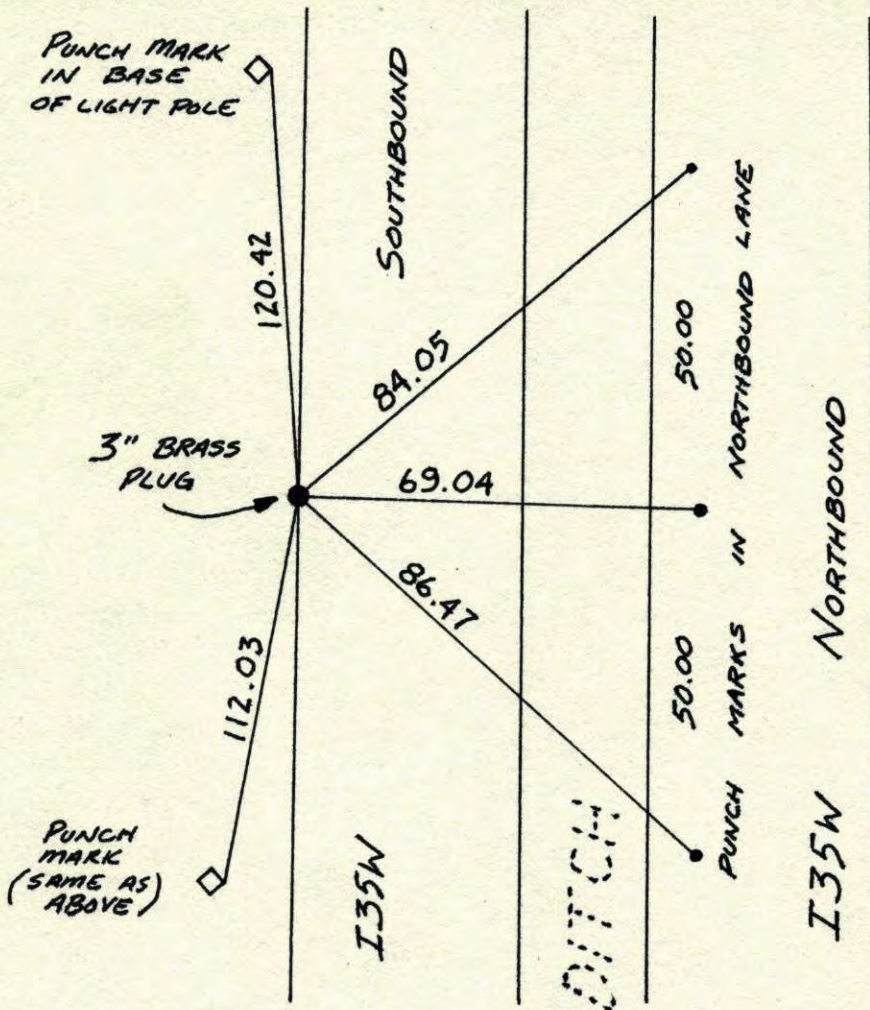
I hereby certify that on the 2 day of OCT., 1968, I found the described corner which was evidenced by GRANITE MON.

and I further certify that to perpetuate the location of said corner, I did, at the exact location thereof, place a permanent marker consisting of 3" BRASS PLUG EPOXIED INTO SEAM ON WEST EDGE OF SOUTHBOUND I-35W which reference or witness monuments are located in the manner following:

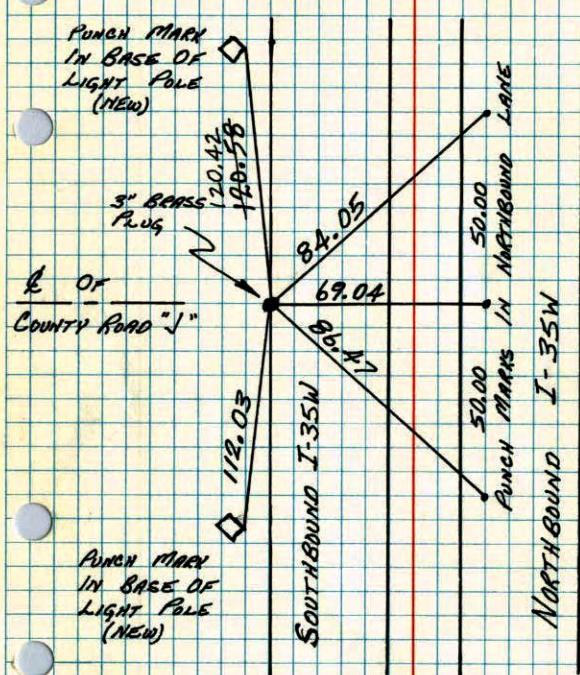
NE Cor. Sec. 5 T30 R23

SEPT. 6-1977
 H. LARSON
 B. GUETZKO
 J. BOETTCHER

TIE CHECK
 6-13-80
 B. STEPHENS
 P. ROSS
 P. HORNBY

Reset corner from construction ties
Set 3" brass plug in seam on west
edge of Southbound Lane, I-35W
monument under Co. Rd. J. bridge

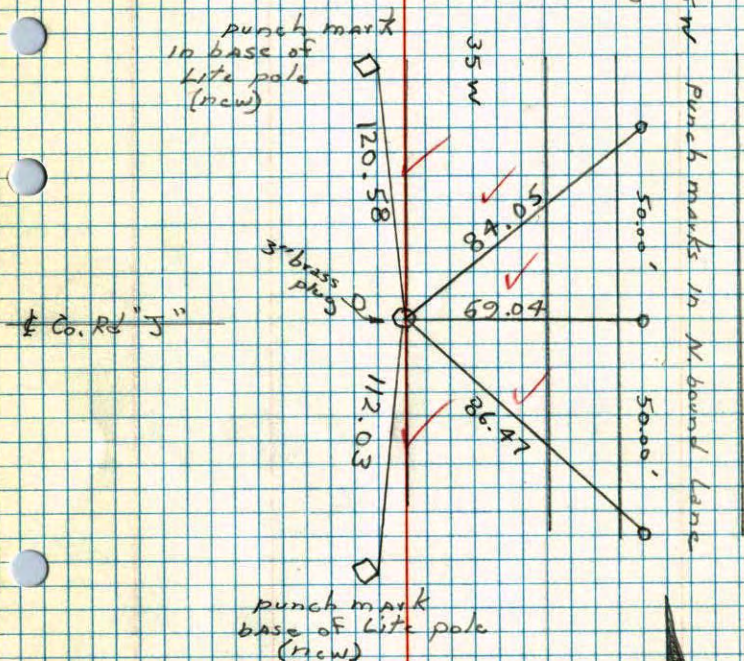
NE Cor. Sec. 5 - T30 - R23

*7 70°
 9-6-77
 H. Larson
 B. Guetzko
 J. Boettcher

Granite Monument to be destroyed.
Monument under bridge in concrete road.
(US #8)

October 2, 1968
M. D. Anderson
H. J. Larson
R. A. Olson

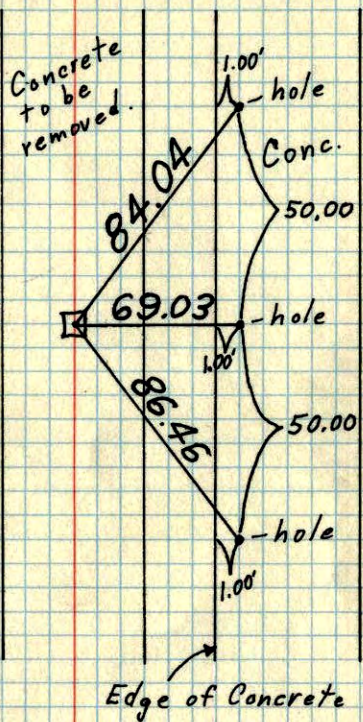
NE Cor. Sec. 5 - T30 - R23

9-27-71
H. Larson
F. Waks
M. Jensen

Granite Mon. to be destroyed
Mon. under bridge in Conc. Road (US #8)

Oct. 2, 1968
M. D. Anderson
H. J. Larson
R. A. Olson

Temp. 48° ✓
Tape #5 ✓

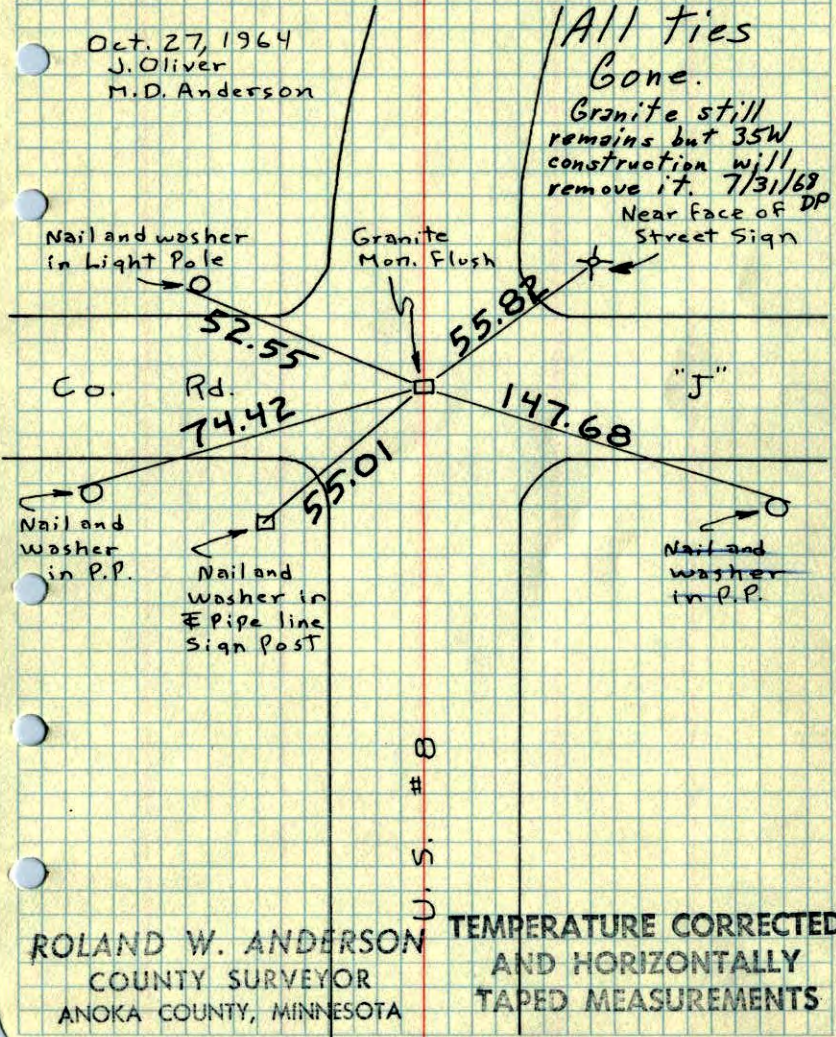
NE Cor. Sec. 5, T30, R23

Found 6" Sq. Granite Monument with drill hole in center (Ramsey Co. Granite) Flush with Concrete Pavement of U.S. Highway #8.

Oct. 27, 1964
J. Oliver
M.D. Anderson

All ties gone. Granite still remains but 35W construction will probably remove it. 7/31/68
Near face of DP Street Sign

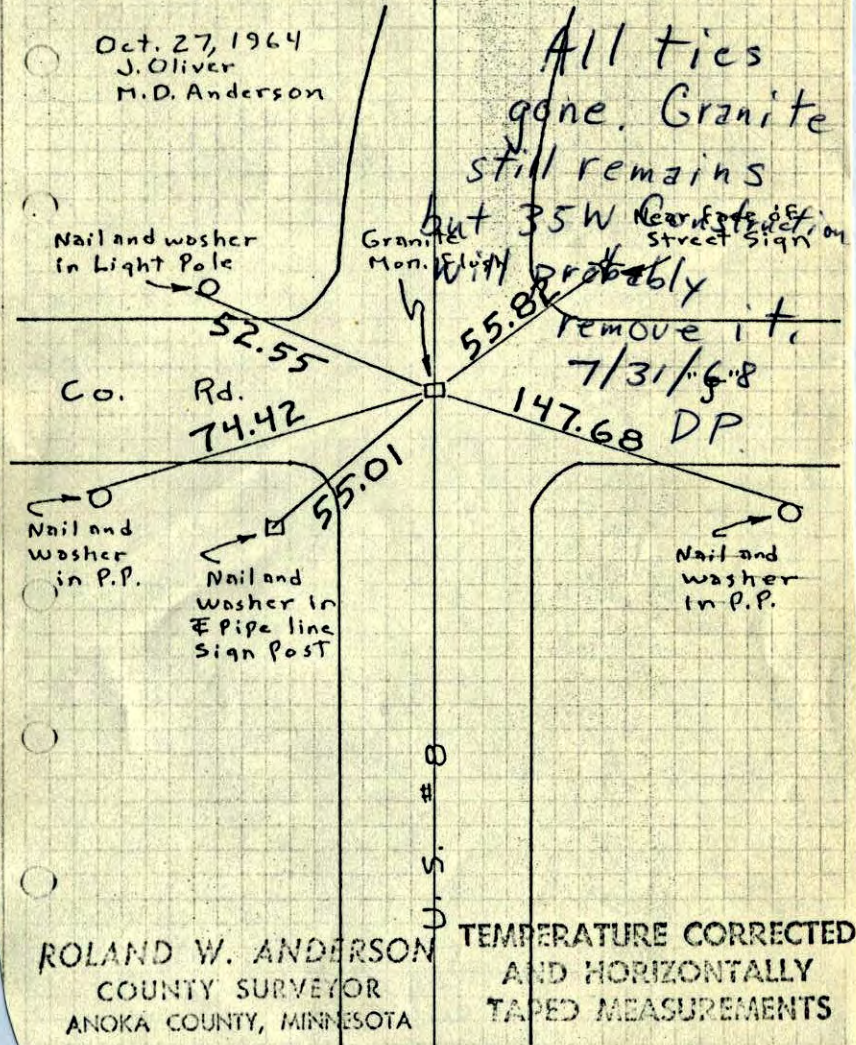
NE Cor. Sec. 5, T30, R23

Found 6" Sq. Granite with drill hole in
center (Ramsey Co. Granite) flush with
conc. Pvm't. of U.S. #8
