CERTIFICATE OF LOCATION OF GOVERNMENT CORNER

East 1/4 Corner of Sec. 26 Township 33 Range 22

HISTORY OF GOVERNMENT CORNER

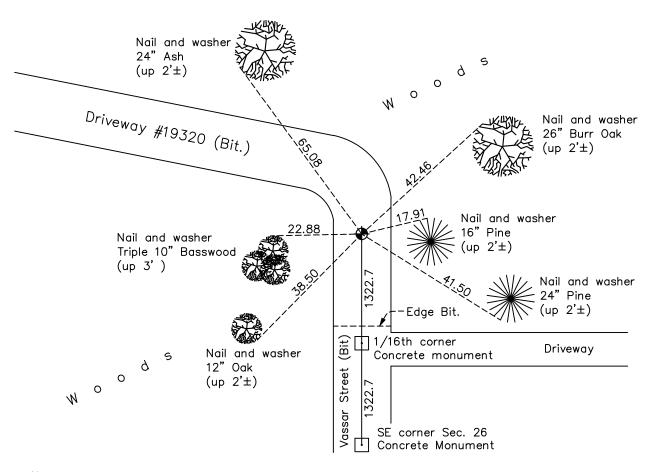
AND on the <u>3rd</u> day of <u>March</u>, <u>2023</u>, said permanent marker was <u>found flush and the</u> position was verified to published coordinates by ACS RTK GPS method

Updated reference ties are as shown below.
