CERTIFICATE OF LOCATION OF GOVERNMENT CORNER

South 1/4 Corner of Sec. 15 Township 32 Range 23

HISTORY OF GOVERNMENT CORNER

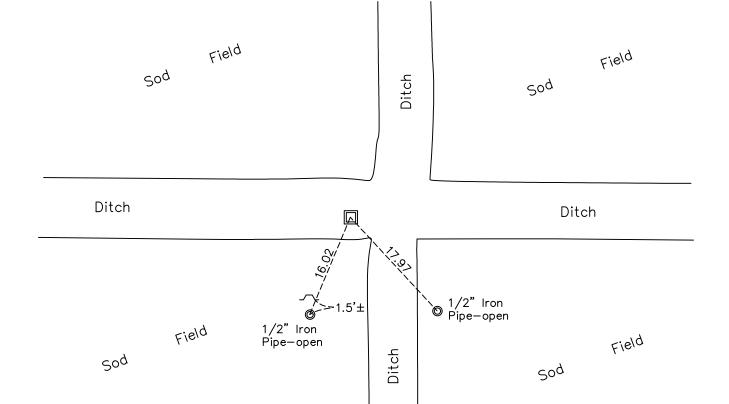
AND on the <u>22nd</u> day of <u>February</u>, <u>2021</u>, said permanent marker was <u>found 2" square steel</u> Telespar monument up 2'± w/"County Surveyor" cap. The ties were updated.

Updated reference ties are as shown below.
