CERTIFICATE OF LOCATION OF GOVERNMENT CORNER

Meander Corner of Sec. 17 Township 32 Range 23

HISTORY OF GOVERNMENT CORNER

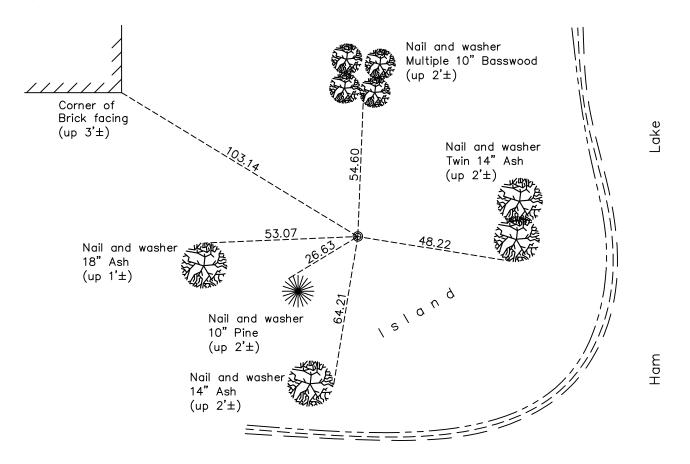
AND on the 17th day of February, 2021, said permanent marker was Found and the ties were updated.

Updated reference ties are as shown below.
