CERTIFICATE OF LOCATION OF GOVERNMENT CORNER

County of Anoka

Northwest Corner of Sec. 3 Township 31 Range 22

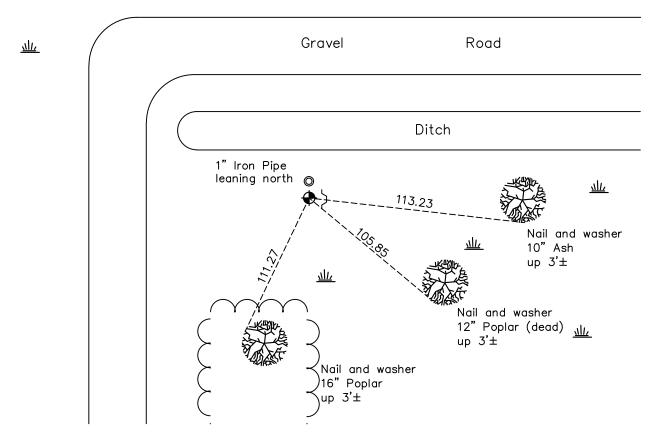
AND on the <u>8th</u> day of <u>June</u>, <u>2021</u>, said permanent marker was <u>Set 2x2 Telspar w/cap</u> and punchmark up 0.5'± sign and post on East side

Updated reference ties are as shown below.
