CERTIFICATE OF LOCATION OF GOVERNMENT CORNER

County of Anoka

North 1/4 Corner of Sec. 6 Township 30 Range 22

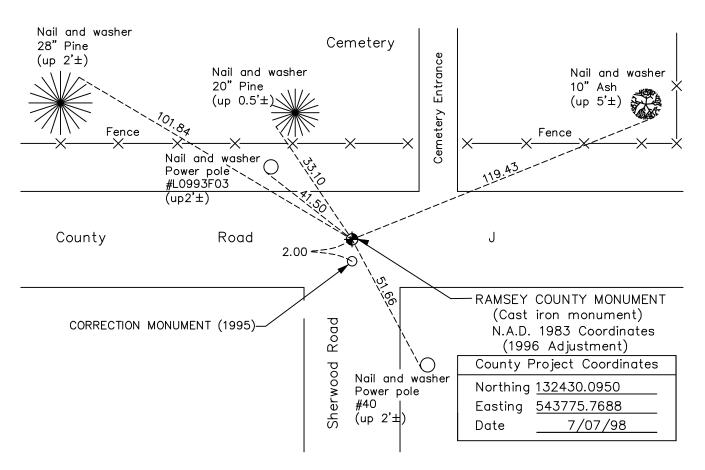
and to perpetuate the location of said corner, at the exact location thereof, a permanent marker was placed consisting of a cast iron monument top set in concrete

Updated reference ties are as shown below.

June 4, 2021 — Found Cast Iron Monument down 0.3'± in steel tube and verified location of corner by VRS GPS methods. Updated ties.
