CERTIFICATE OF LOCATION OF GOVERNMENT CORNER

Northwest Corner of Sec. 17 Township 33 Range 25

HISTORY OF GOVERNMENT CORNER

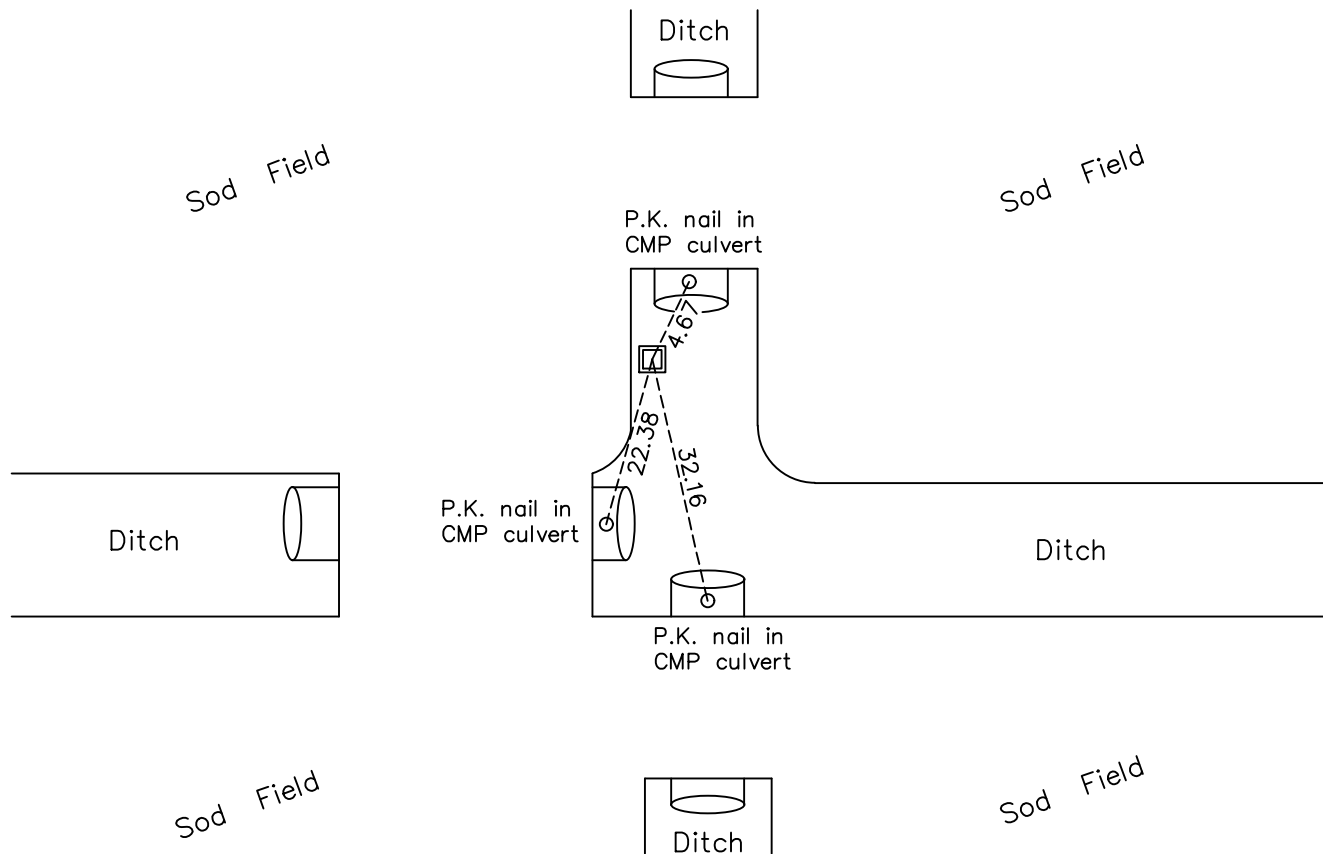
AND on the 23rd day of March, 2018, said permanent marker was found up 5'± and the position was verified by VRS GPS methods. Unable to update ties.

Updated reference ties are as shown below.
