CERTIFICATE OF LOCATION OF GOVERNMENT CORNER

West 1/4 Corner of Sec. 31 Township 33 Range 25

HISTORY OF GOVERNMENT CORNER

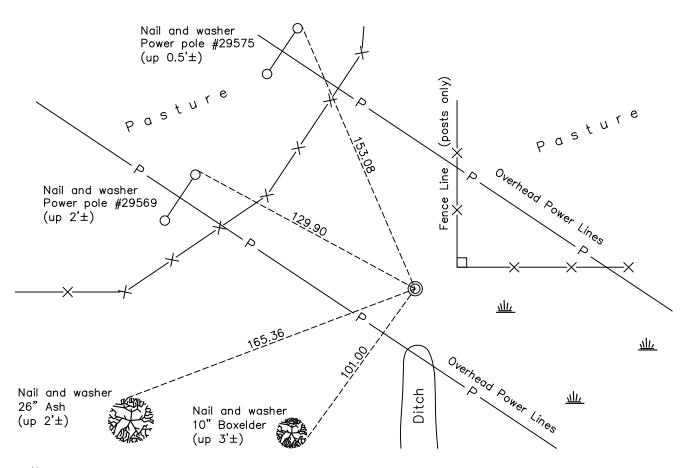
AND on the <u>20th</u> day of <u>March</u>, <u>2018</u>, said permanent marker was <u>found up 4'± and</u> leaning southerly 0.2'± with the paint worn off. The ties were updated

Updated reference ties are as shown below.

March 20, 2018 - Found red and white iron pipe up 4'± and leaning southerly 0.2'± with the paint worn off. Verified position by VRS GPS methods. Updated ties.
