# CERTIFICATE OF LOCATION OF GOVERNMENT CORNER

## Northeast Corner of Sec. 33 Township 34 Range 24

# HISTORY OF GOVERNMENT CORNER

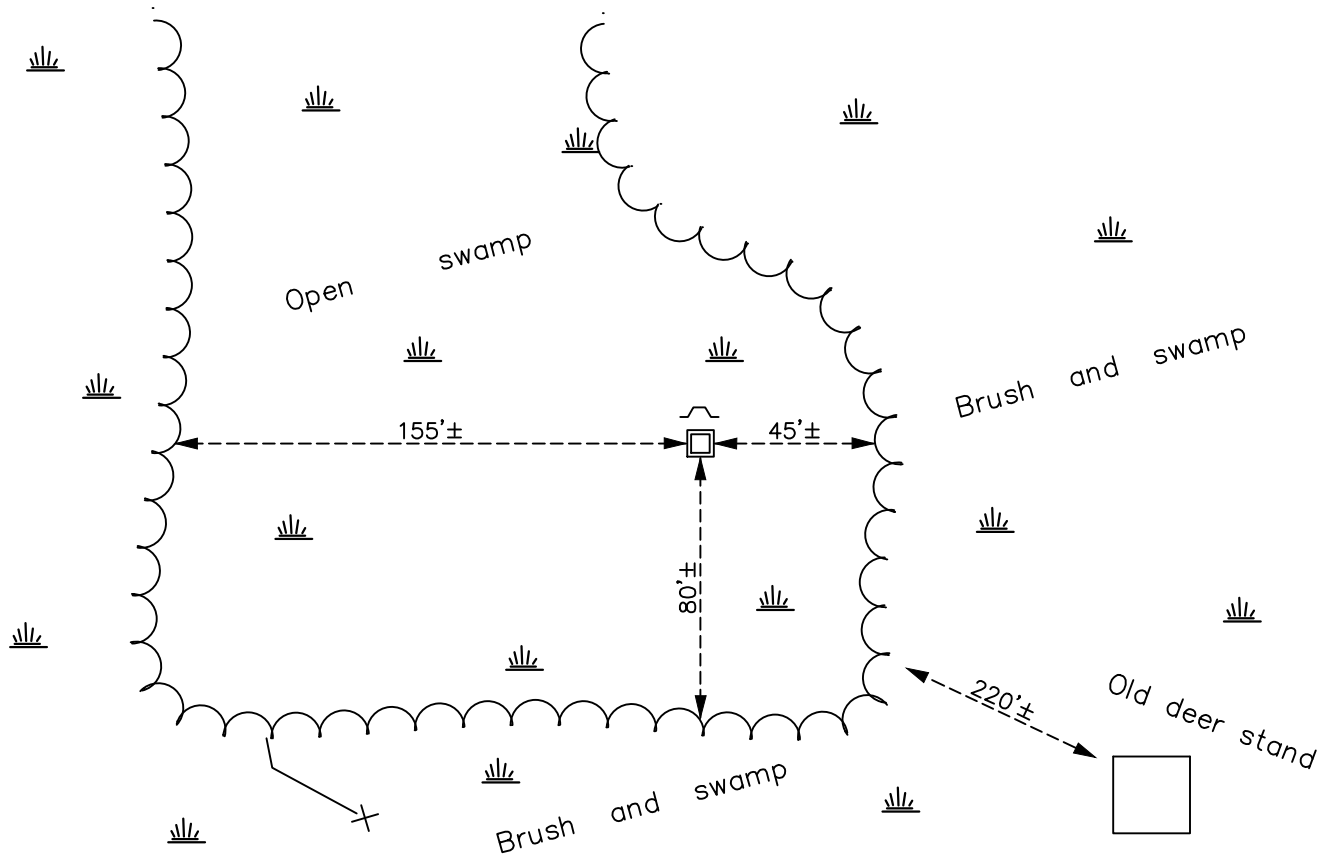
AND on the 17th day of November, 2022, said permanent marker was found steel Telspar up 1'± with cap and punch mark and a sign/ post to the north. No ties available.

Updated reference ties are as shown below.

and to perpetuate the location of said corner, at the exact location thereof, a permanent marker was placed consisting of a 8' steel Telspar with a cap and punchmark
